Fire Risk Assessment

Newbury House

**Arley Close,
Oldbury,
B69 1EB**

Date Completed: 4th Aug 2025

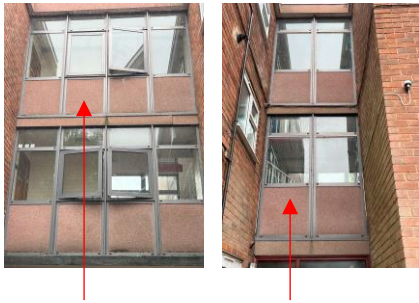
- 3) On the front and rear elevation of the building, there are Spandrel panels installed under the aluminium window units.

Front and Rear Spandrel panelling under the window units

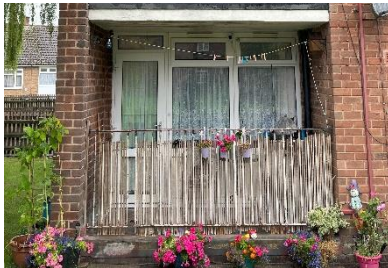
- 5) Flat 3 has wicker type screening attached to the balcony railings.

Question/ Ref No	Required Action	Supporting photograph	Priority	Timescale and Person Responsible	Date Completed
6.5	Flat 3 has wicker type screening attached to the balcony railings. Need Removing

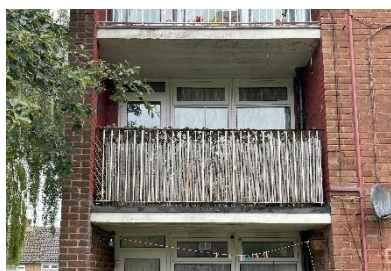
- 7) Flat 6 has wicker type screening attached to the balcony railings.

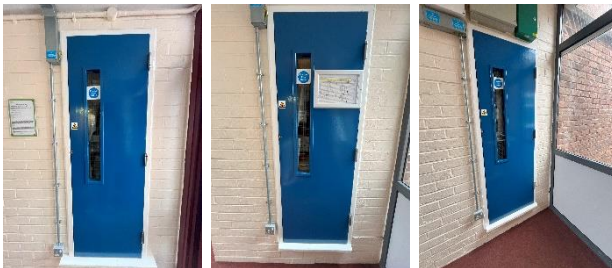
Ground, 1st and 2nd floor electrical cupboards.

FD30s fire rated doors are used for the electrical cupboards.

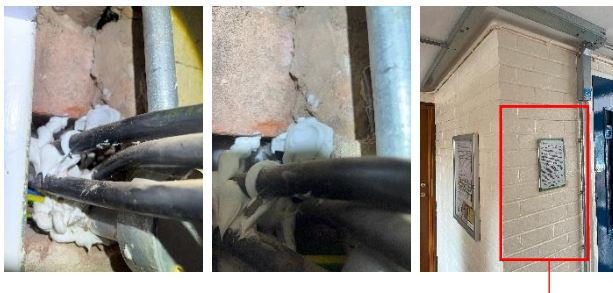
- 9) Ground floor electrical cupboard requires enhanced fire stopping around pipework and electrical cables that are fed through the blockwork cavities to the left handside of the cupboard.

Fire stopping required Area of where cables run through.
