# **Fire Risk Assessment**

## **1-6 Richards House**

**Kempsey close, Oldbury,  
B69 1BN**

**Date Completed: 10/06/2025**

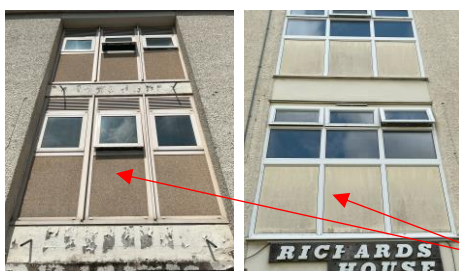
Spandrel Panels

- 2) UPVC double glazing units are installed to each flat and to the communal stairwell. Spandrel panels are below each stairwell window on the front and rear.

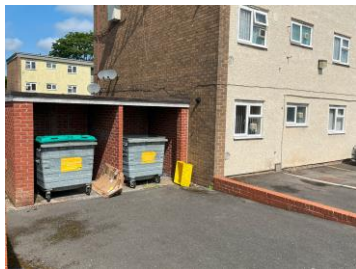
- 5) There is a sheltered bin compound on the front elevation that is attached to the left-hand side of the building. This houses two waste bins with secure lids. The compound is constructed of brick with a felt roof

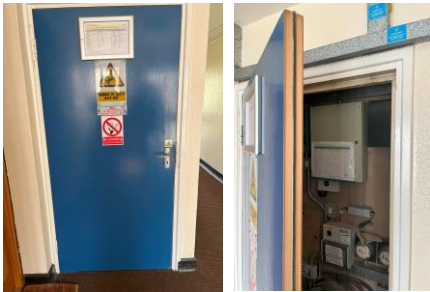
- 1) Service cupboard containing the landlords supply on the ground floor is secured by a type 54 suited mortice lock. The door to this service cupboard is notional fire door which has been upgraded with combined intumescent strips & cold smoke seals (FD30s).

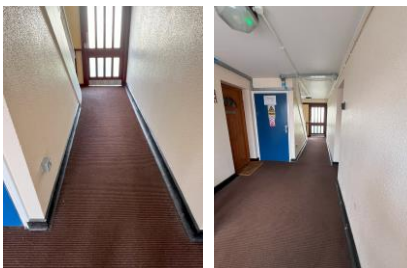
- 3) All corridors were measured at a width of 1050mm at least, these will be maintained clear to keep to that measurement as a minimum.

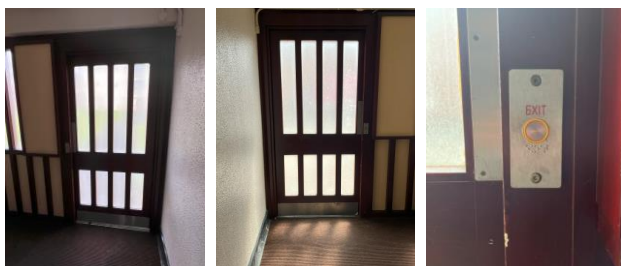
- 6) Both front and rear exit doors are fitted with automatic closing devices and are secured by a maglock when door is shut, residents can exit via a release button from the inside, in the event of emergency this is made fail safe and overrides the maglock for safe exit.

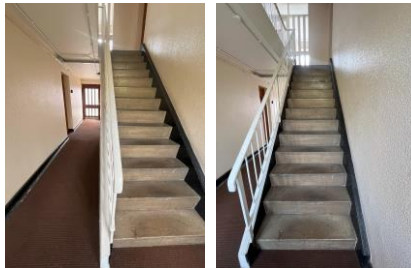
- 8) The single communal staircase was measure at 1010mm wide, this provides adequate clear means of escape

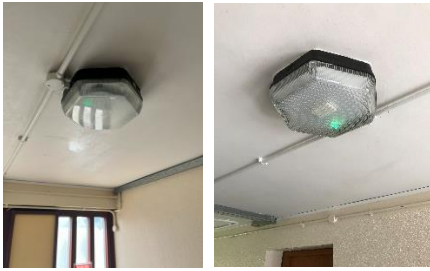
- 10) The communal area has emergency escape lighting installed on both The ground, 1<sup>st</sup> and 2<sup>nd</sup> floor.

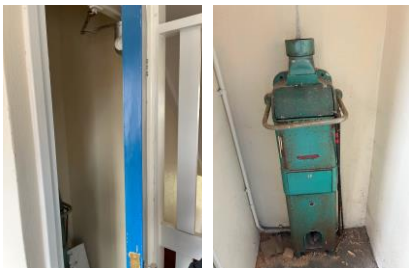
- 13) First floor resident drying area has a decommissioned incinerator, this is secured behind a notional FD30 rated fire door secured by type 54 mortice lock.

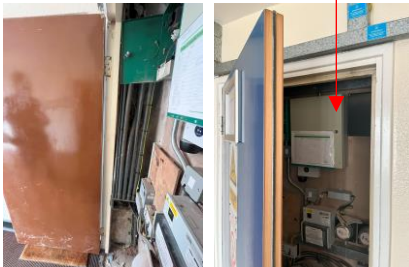
- 6) Service cupboard on the ground floor housing electrical meter, has an upgraded notional door, it is secured via 2 hinges, the door is 44mm and the door stop is 25mm(1inch)

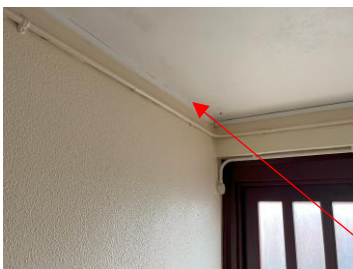
- 8) There is small run of plastic cable trunking at ceiling level.

Plastic trunking on ceiling.

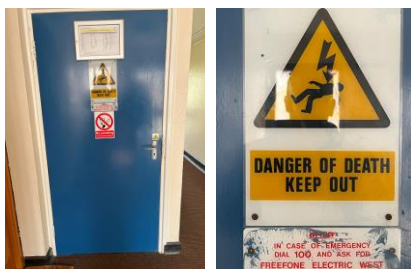
- 3) Additionally there is signage on the service cupboard door indicating No smoking and risk of danger.

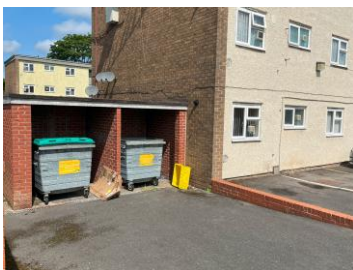
- 2) Refuse containers are stored in a brick built compound that is a adjoined to the main building. On the day of the inspection there was evidence of some cardboard and a plastic container near the bins.

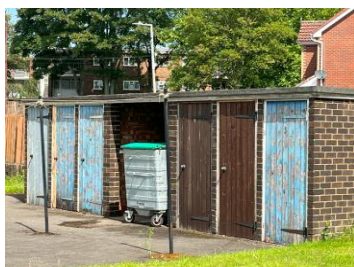
- 3) The rear court yard also houses a refuse bin in brick-built compound which is at a safe distance away from the residential building
