Fire Risk Assessment

Smestow House (1-9)

**Queensway, Oldbury
B68 0HQ.**

Date Completed: 30.04.25

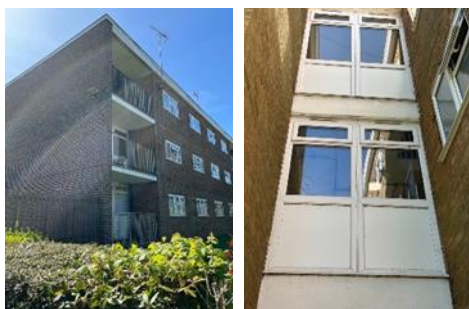
- 1) The external envelope of the premises is predominantly traditional brick, concrete construction, surmounted by a flat concrete roof, accessed externally. There is a small amount of spandrel panels under windows. Flats have balconies. These are of concrete construction with a steel balustrade and are vertically aligned.

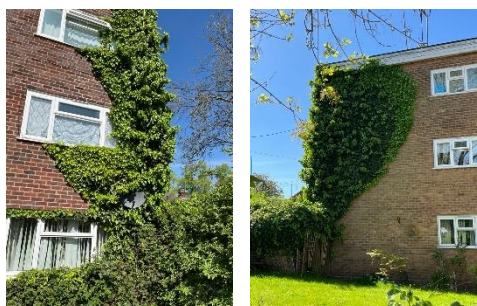
- 2) **There is a significant amount of vegetation spreading across the fabric of the building. This vegetation could lead to fire spread across the surface of the building and therefore requires removal.**

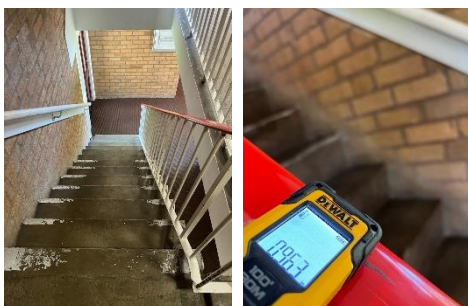
- 1) The site has a single staircase that provides a means of escape and is **900mm in width**.

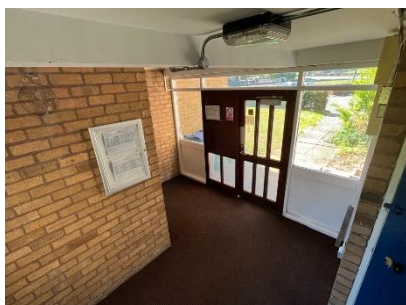
- 8) Surface coatings to the walls in the staircases appear to be Class 0 rated.
- 9) At the time of the assessment, it was noted that ground floor is fitted with carpet. It is understood that carpets have been procured in accordance with BS 5287: 1988 specification for assessment and labelling of textile floor coverings and BS 4790 Fire Test to Textile Floor Coverings. These carpets have been procured by SMBC utilising third party approved contractors. Therefore, it is understood that carpets fitted meet the approved standard. See observations.

Observations	
At the time of the assessment, it was noted that the ground floors are fitted with carpet. It is understood that carpets have been procured in accordance with BS 5287: 1988 specification for assessment and labelling of textile floor coverings and & BS 4790 Fire Test to Textile Floor Coverings.	When any refurbishment of the building takes place consideration should be given to replace existing flooring for an approved floor covering that has appropriate fire resistance.
Residents' storage cupboard doors	Upgrade as part of next improvement works
Resident's front doors	Upgrade as part of next improvement works

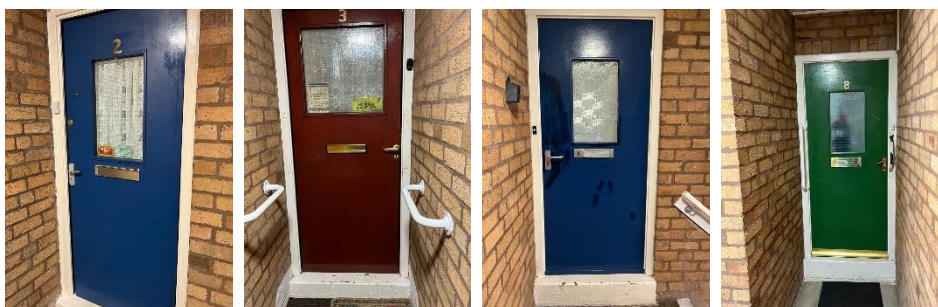
- 10) Flat entrance doors appear to be notional original fitment timber entrance doors. These should be upgraded to certified FD30s as part of any future refurbishments. See observations.

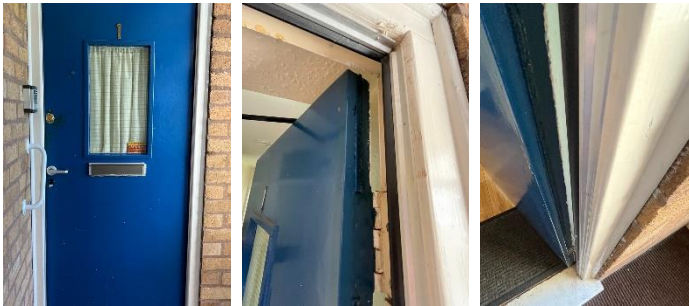
- 11) **Accessed Flat 1 has a paint contaminated hinge side smoke seal, this seal is required to be replaced.**

07/11	Flat 1 entrance door has a paint contaminated, hinge side smoke seal. This seal is required to be replaced.	 	P2	Fire Rapid response. 1-3 months.	
-------	---	--	----	---	--

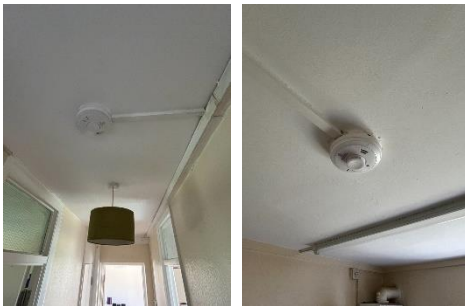
- 1) Early warning is limited to hard wired or battery smoke alarms within each of the resident's flats. The equipment is subjected to a cyclical test.
- 2) Based on the sample of properties accessed during the fire risk assessment the smoke alarms within resident's flats are installed to an LD2/3 Standard.
- 3) Flat 1 was accessed and has a smoke detector in the hallway and a heat detector in the kitchen.
