# Fire Risk Assessment

## Shelley House

Tudor road,  
Oldbury,  
B68 9RE

**Date Completed: 12<sup>th</sup> July 2022**

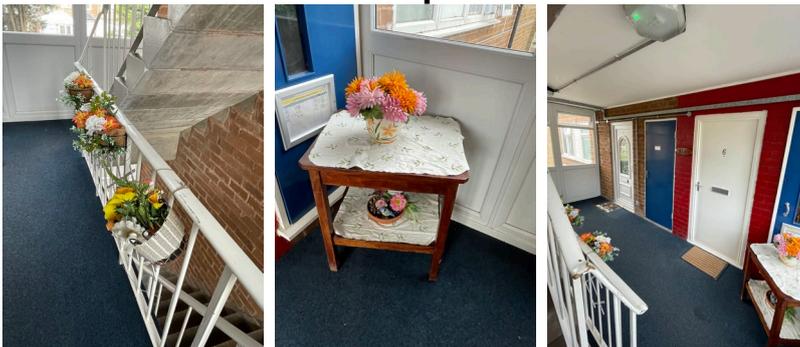
- 18) Table and artificial flowers adjacent flats 5 & 6 to be removed from the means of escape.**

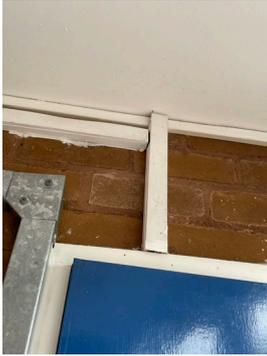
- 19) Plastic conduit has been used in communal areas for cable runs. This will be removed as part of a future upgrade program.
-

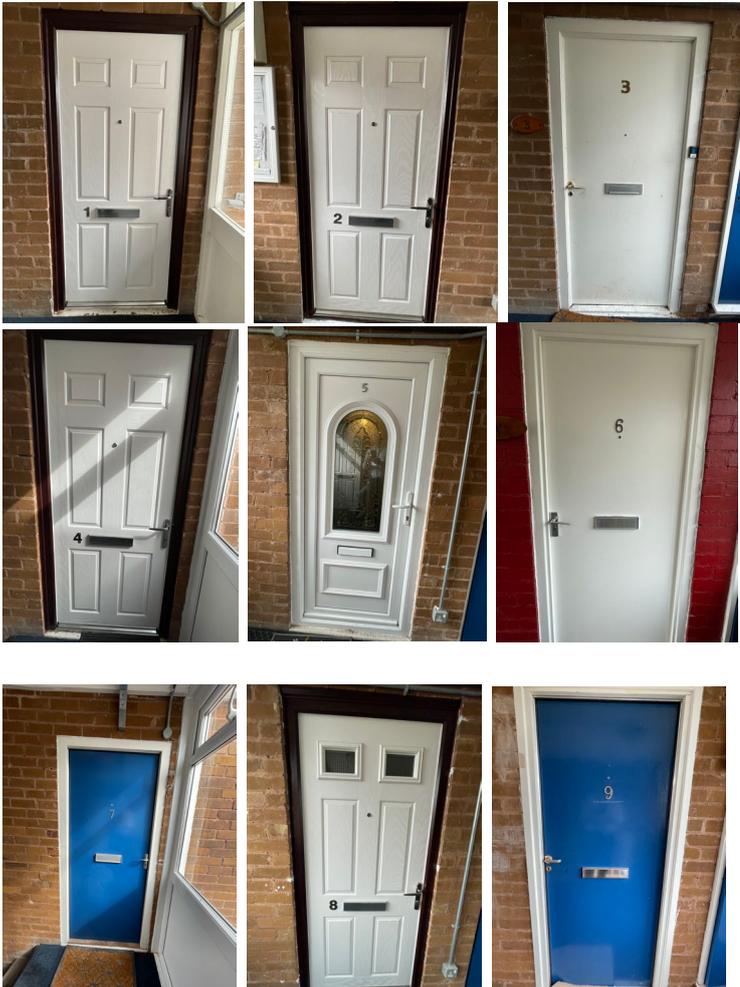
6) Individual flat doors are not all FD30s rated fire doors. It was communicated by the leaseholder occupier of flat 3 that he was to source his own certified FD30S replacement door. The previous FRA records that the leaseholder occupier of flat 5 has been contacted reference fire door upgrade.

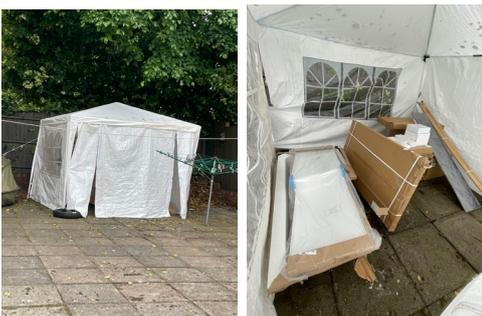
- 5) A temporary structure (gazebo) has been erected in the rear enclosed yard approximately 6 feet from the building. The occupier of flat 3 confirmed that the structure is to temporary house new bathroom fittings protecting them from the elements prior to installation. He advised that the structure will be removed within 2 weeks.

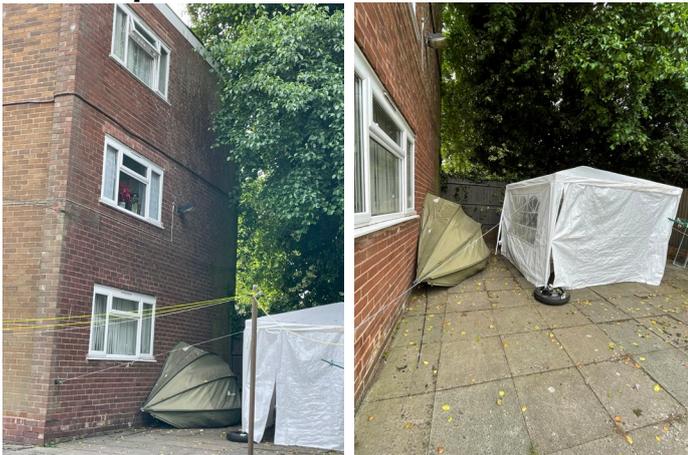
- 6) A PU coated polyester type material has been erected and fixed to the side elevation wall for the purpose of storing a motorcycle. This is located in the rear enclosed yard. The motorcycle provides a possible ignition source and fuel to which could affect the adjacent flats windows above should a fire occur. The occupier of flat 3 (leaseholder) stated that he has submitted an application for one of the nearby local authority garage facilities and that there is currently nowhere else to park his vehicle.

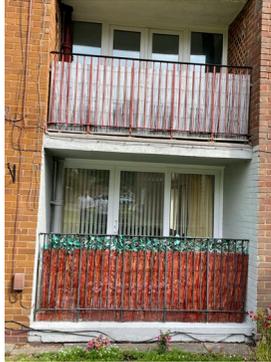
- 3) Each flat has a balcony with steel railings. **Flats 2 & 5 have wicker screening to the balcony railings which should be removed.**

Question/ Ref No	Required Action	Supporting photograph	Risk Rating	Timescale and Person Responsible	Date Completed
06/03	Remove wicker screening from balconies of flats 2 & 5.

3	Housing Manager August 2022	03/11/2022
