Fire Risk Assessment

Shelley House

**Tudor Road, Oldbury
B68 9RE**

Date Completed: 02/06/2025.

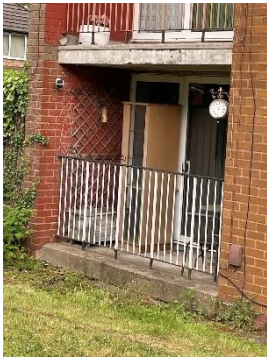
- 4) **A tall timber display / storage unit on flat 3 balcony deemed excessive fire loading (Leaseholder).**

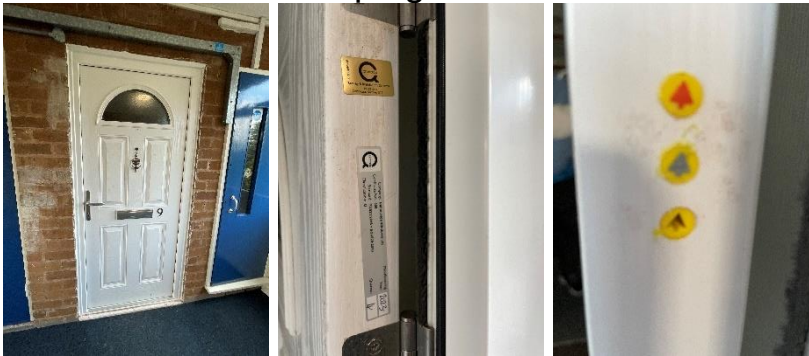
- 1) Individual flat doors are predominantly FD30s rated composite fire doors.
- 2) Access was gained to Flat 9. The inspection revealed the BM Trada Q Mark identification plugs. This FD30s door was correct.

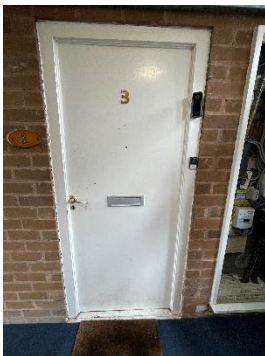
- 3) Flat 3 – It was recorded in the previous FRA (July 2022) that the Leaseholder of this flat was sourcing their own certified FD30s fire door for installation. Previous images from 2022 suggest the door hasn't been replaced. Access was not gained to facilitate further inspection of this door. **Update – The entrance door was inspected on 3/7/25 and confirmed as an acceptable 30 minute notional fire door with over-head self-closing device.**

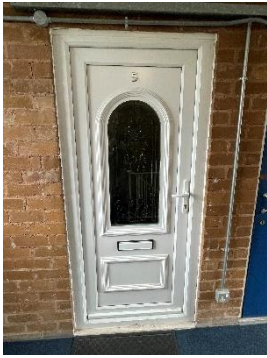
- 4) Flat 5 – The door to this flat appears not to be a fire rated door set. It was recorded in the previous FRA (July 2022) that the leaseholder of this flat has been contacted reference an FD30s fire door installation. Access was not gained during this survey to inspect the door on both sides.

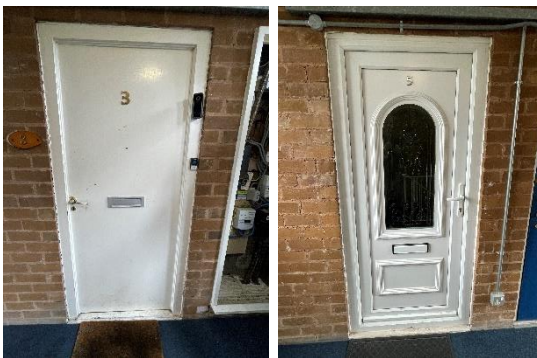
- 4) Flats 3 and 5 are leaseholder properties which appear to have non fire rated entrance doors. This has been detailed in section 7/3 & 7/4.

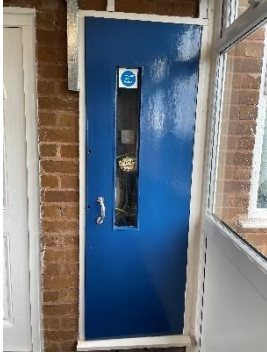
- 5) Doors to the meter cupboards are non-fire rated 40mm timber doors. The doors are secured with budget locks. Consideration should be given to upgrading the cupboards doors /frames to FD30s standard. This observation has been recorded within section 19.

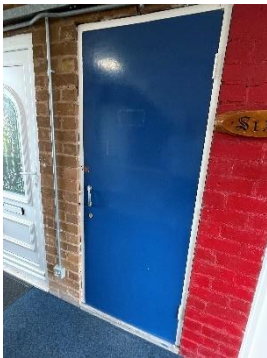
- 6) 1st and 2nd floor cupboard doors are 44mm timber doors, with 2 hinges and a 25mm stop. Consideration should be given to upgrading the cupboards doors /frames to FD30s standard. This observation has been recorded within section 19.

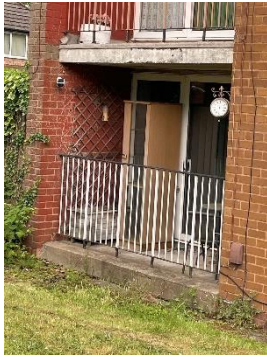
Question/ Ref No	Required Action	Supporting photograph	Priority	Timescale and Person Responsible	Date Completed
6/4	Flat 3 – Remove tall timber display unit from balcony / excessive fire loading.

P2	Within 1-3 months Leasehold management

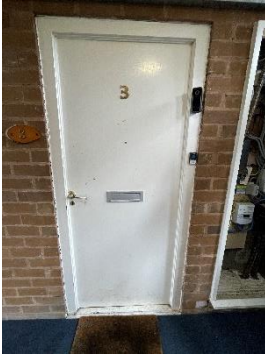
7/3	Flat 3 – Leaseholder to replace existing entrance door with a certified FD30s fire door set, installed by an accredited installer. <i>(Previous FRA from 2022 states the leaseholder was sourcing their own FD30s door. Access wasn't gained to inspect the door during this survey).</i>

N/A	N/A	N/A Door inspected 3/7/25 and confirmed as an acceptable 30 minute notional fire door
7/4	Flat 5 – Leaseholder to replace existing entrance door with a certified FD30s fire door set, installed by an accredited installer.
