# Fire Risk Assessment

**Showell House,  
Oldbury,  
B69 4JJ**

**Date Completed:** 11/09/2025

**Current Risk Rating = Tolerable**

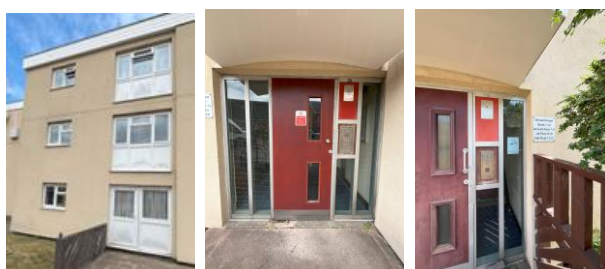
- 2) **The building currently has several areas of damaged render that require repair to maintain fire safety standards. Recommend a joint visit with the repairs team and Fire Risk Assessor to identify areas. Also, to carry out a review of the fire risk assessment every 12 months.**
- 3) UPVC double glazed units have been installed to each flat and communal stairway. There is a canopy situated over the front and rear entrance to the block. Entrance & rear door are timber with steel framework.

Question/ Ref No	Required Action	Supporting photograph	Priority	Timescale and Person Responsible	Date Completed
6/2	Repair several areas of damaged render to maintain fire safety standards. Recommend a joint visit with the repairs team and Fire Risk Assessor to identify areas.

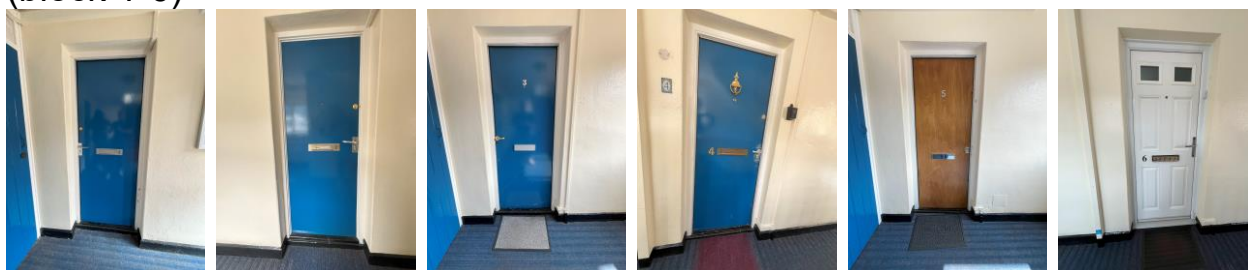
(block 1-6)

- 4) Individual flats are fitted with a minimum FD30 rated door. Access was gained to a sample of properties as part of the fire risk assessment to ensure the doors have not been tampered with. Majority of flat doors are nominal FD30 doors, these doors do not fit current regulatory requirements as they do not have self-closers, smoke seals or intumescent strips, and rely on drop hinges and concealed chain units. Flat doors are required to be replaced in future refurbishment programs to composite FD30s doors.

**Majority of flat doors are nominal FD30 doors, these doors do not fit current regulatory requirements as they do not have self-closers, smoke seals or intumescent strips, and rely on drop hinges and concealed chain units. Look to replace flat doors in future refurbishment programs to composite FD30s doors**

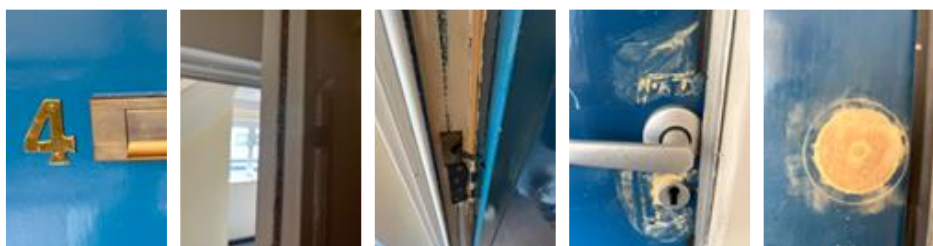
- a) **Flat 4: concealed chain door closer in place, slow to close, also the smoke seal has paint on it. New smoke seal required. Perco door closers are inadequate and should be replaced with a suitable self-closing device.**

7/4a	Flat 4: Replace smoke seal due to existing one having paint over it. Fit a self-closing device and fit intumescent strip

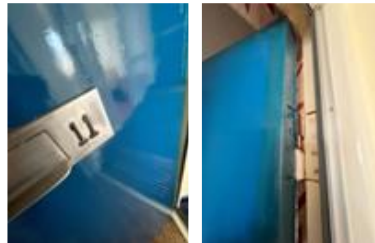
- b) Flat 11: Door does not shut without assistance, drop hinges fitted. No smoke seal or intumescent strips fitted. Fit new smoke seal and intumescent strips, Replace drop hinges with a suitable fire rated hinge set, and fit a suitable self-closing device**

P3	Within 3-6 months Fire Rapid Response	
7/4b	Flat 11: Replace drop hinges with a suitable fire rated hinge set, fit a self-closing device and install smoke seal and intumescent strips.

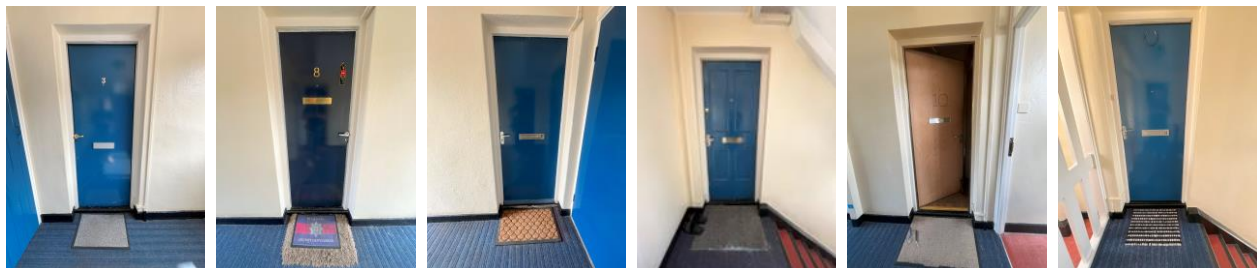
- 5) A number of flats have door mats present at the entrances; the fire rating is not known on these door mats, these are deemed to be low risk.

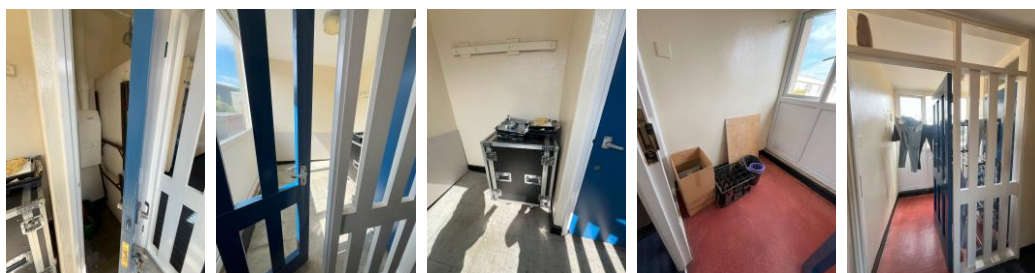
10) Drying areas: These areas are for drying clothes only and NOT for storing items, they are situated off the landings on each floor. The door and frame are timber structure with open panels to allow ventilation for the drying of washing also in times to assist in ventilation. Within this area is a locked cupboard only accessible by SMBC staff. Letter has been sent out to residents to remind them that the areas are for drying of laundry only 27/08/2025.

- Some drying areas are being used as storage areas and left open

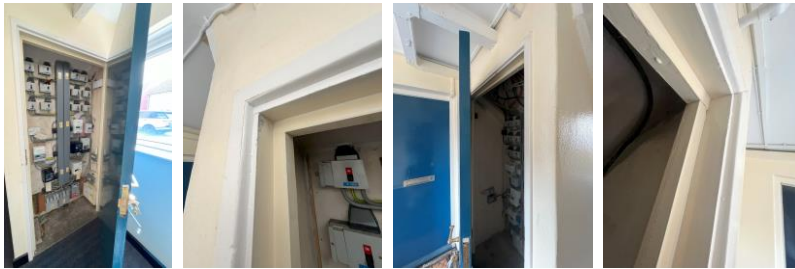
a) **Service cupboards within block 1-6 requires smoke seal and intumescent strips fitting.**

b) **Service cupboards within block 7-12 requires smoke seal and intumescent strips fitting.**

P3	Within 3-6 months Fire Rapid Response	
10/7a	Fit smoke seals and intumescent strips to service cupboards within block 1-6

10/7b	Fit smoke seals and intumescent strips to service cupboards within block 7-12	 	P2	Within 1-3 months Fire Rapid Team	
-------	---	--	----	--------------------------------------	--

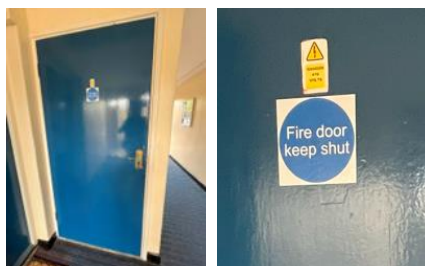
- 5) Portable heaters are not allowed in any common parts of the premises.
- 6) All Residents service cupboards on each floor are housed behind a FD30 fire rated doors. All cupboards are free from any combustibles. Fire door keep shut signage is to be displayed on the doors. The service cupboards within both blocks require smoke seal and intumescent strips fitting.
