Fire Risk Assessment

1-9 Tennyson House

**Tudor Road, Oldbury,
B68 9RD**

Date Completed: 03/06/2025.

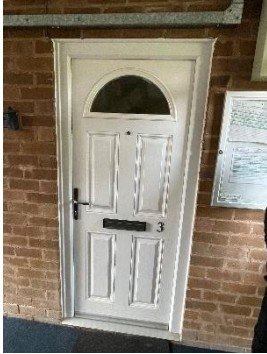
- 1) Individual flat doors are FD30s rated composite fire doors.
- 2) Access was gained to Flat 3. This FD30s door was correct.

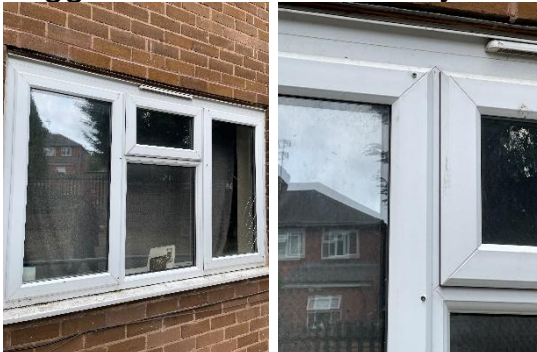
The windows to flat 1 (1st floor) are a concern because they appear to have been screwed shut. This compromises the occupant's secondary means of escape. Information gained suggests the dwelling is in the process of becoming vacant.

- 3) **Flat 1 window appeared to be screwed shut therefore, potentially compromising a secondary means of escape.** Information suggests the flat will shortly undergo a change of tenancy.

Question/ Ref No	Required Action	Supporting photograph	Priority	Timescale and Person Responsible	Date Completed
7/3	Flat 1 windows have been screwed shut. Remove all screws and ensure windows open as designed to do so.

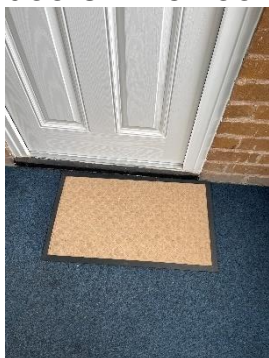
- 13) A number of residents have floor mats outside their flat entrance doors. The floor mats are deemed a trivial risk.

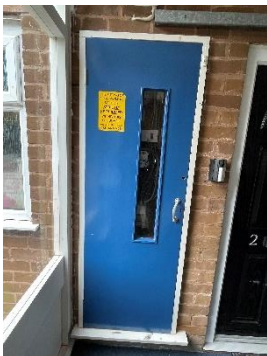
- 4) Doors to the meter cupboards are non-fire rated 40mm timber doors. The doors are secured with budget locks. Consideration should be given to upgrading the cupboards doors /frames to FD30s standard. This observation has been recorded within section 19.

Upgrade 3 x meter cupboard door and frame sets with FD30s.

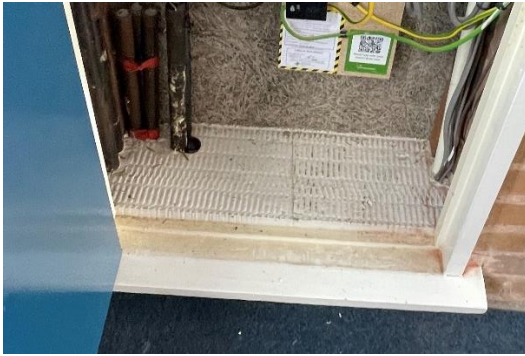
- 5) 1st and 2nd floor cupboard doors are 44mm timber doors, with 2 hinges and a 25mm stop. Consideration should be given to upgrading the cupboards doors /frames to FD30s standard. This observation has been recorded within section 19.
- 6) A variety of methods / materials have been used to achieve fire-stopping such as intumescent mastic, ablative batt and intumescent pad or pillows (trunking).
-

Upgrade 2 x cupboards on 1st & 2nd floor landings with FD30s door and frame sets.

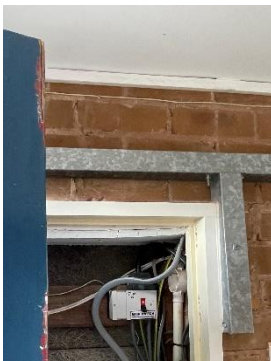
- 7) Cabling from service cupboards is contained within metal trunking with intumescent pads or pillows.
