Fire Risk Assessment

1-11 Shelsley Avenue

**Shelsley Avenue, Oldbury,
B69 1BP**

Date Completed: 12.06.25.

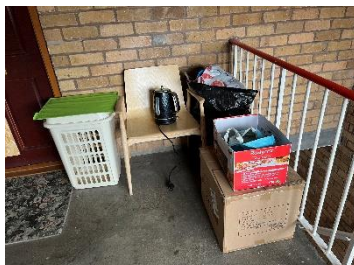
- 6) The communal area on the first floor has many residents' items present. These items should be removed. An email was sent to the Housing Officer. The communal areas should be checked on a regular basis by Caretaking / Cleaning teams and all items of rubbish removed.

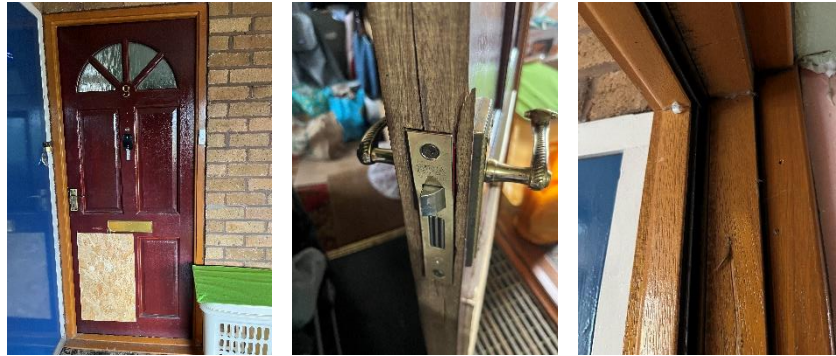
- 11) Accessed Flat 9 front door has a damaged door leaf. This door has no self-closing device and no combined intumescent and cold smoke strips. The glazing cannot be confirmed as being fire resistant. A replacement FD30s door set is required to be fitted. See action 7/11.**

Question/ Ref No	Required Action	Supporting photograph	Priority	Timescale and Person Responsible	Date Completed
7/11	Flat 9 front door has a damaged door leaf, no intumescent/cold smoke strips or self-closing device and non-fire rated glazing. A new FD30s door is required to be fitted.

P3	Asset Management. 3-6 months

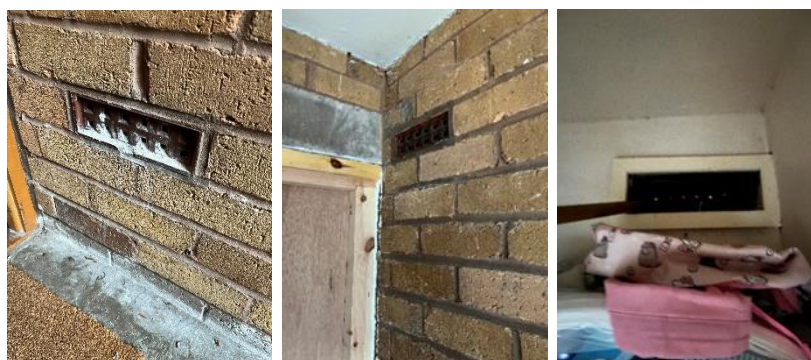
- 11) **Airbricks are fitted in the flat walls that separate the flats 1, 5, 7, and 11 from the common area. There was no intumescent grill fitted in the sampled flat, 11. Intumescent grills are to be fitted over the air bricks in the above flats, where the airbricks vent into the common area. See action 10/11.**

10/11	<p>Airbricks are fitted in the flat walls that separate the flats 1, 5, 7, and 11 from the common area. Intumescent grills are to be fitted over the air bricks in the above flats, where the airbricks vent into the common area.</p>

P3	<p>Fire Rapid Response. 3-6 months</p>	
-------	--	--	----	---	--

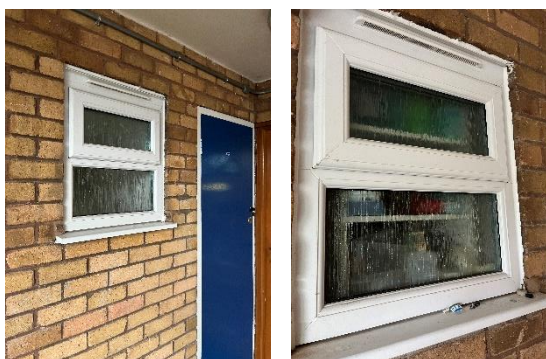
- 12) Flats 9 and 3 have UPVC windows fitted in the wall separating the flats from the common area. These window frames, including the glazing, do not appear to be fire-rated. Accessed flat 9's window was located in the bathroom. These non-fire rated windows should be replaced with a fire-resistant alternative during any future refurbishment of the block. See observations.

Observations	
When any refurbishment of the building takes place consideration should be given to the loft hatch being upgraded to a suitably fire-resistant unit.	
When any refurbishment of the building takes place consideration should be given to replacing the UPVC windows between flats 3 and 9 and the common area with suitable fire-resistant glazing units.	
It is recommended that the roof void over the communal area is periodically check for fire compliance issues, such as compartmentation, inappropriate storage and pest infestation.

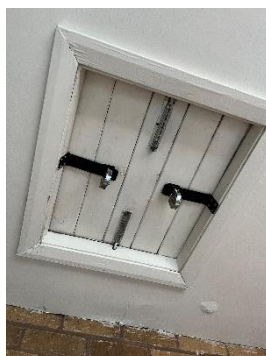
- 13) The block is fitted with a pitched roof, not accessible from the common area, due to no keys available. The loft hatch appears to be non-fire rated. This loft hatch should be upgraded to a suitably fire-resistant loft hatch during any future refurbishment of the block. See observations.
