Fire Risk Assessment Wordsworth House 1-9

Tudor Road Oldbury B68 9RA.

Date Completed: 01.06.25. Review Period: 3 years. Officer: A. Froggatt Building Safety Manager Checked By: C. Hill Building Safety Manager

Current Risk Rating = Tolerable

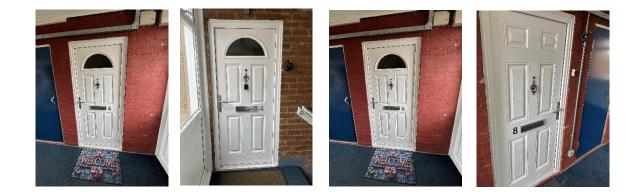
- 8) Surface coatings to the walls in the staircases appear to be Class 0 rated.
- 9) The building has sufficient passive controls that provide effective compartmentation to support a Stay Put Policy. Therefore, residents are advised to remain in their flat unless the fire directly affects them.
- 10) Flat entrance doors are replacement FD30s composite door sets.

11) Accessed Flat 8 door was correct.

12) Flat 7 has a damaged letterbox. See Action 7/12.

Question/ Ref No	Required Action	Supporting photograph	Priority	Timescale and Person Responsible	Date Completed
7/12	Flat 7 front door requires a repair to its letterbox.		P3	Fire Rapid Response. 3-6 months
