Fire Risk Assessment

9-12 Salop Drive

**Salop Drive, Oldbury,
B68 9AG**

Date Completed: 27.05.25.

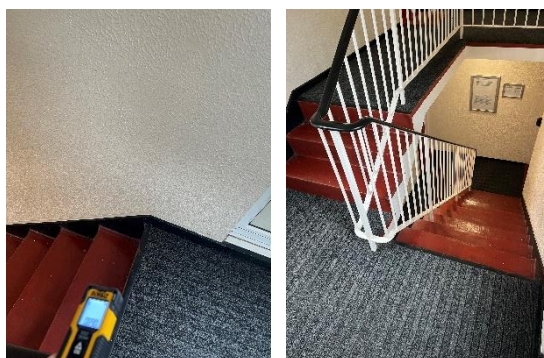
- 1) The block has a single staircase that provides a means of escape and is **880mm in width**.

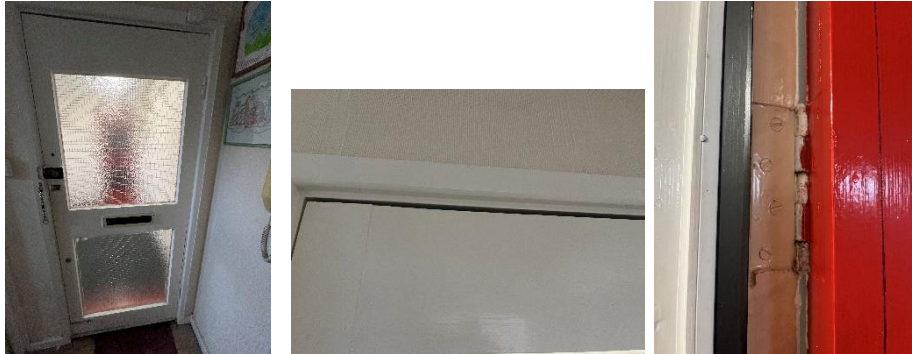
- 11) Accessed Flat 12 has no self-closing device, or combined smoke seal and intumescent strip. A self-closing device and combined smoke seal and intumescent strip are required to be fitted. See Action 7/11.**

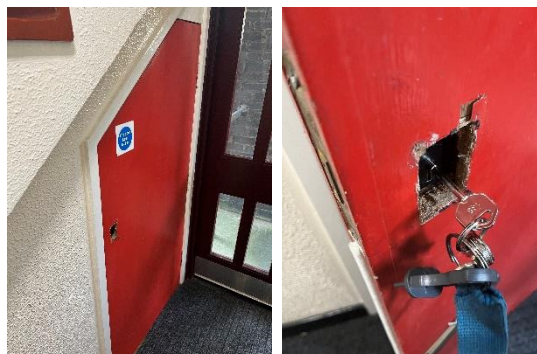
- 14) The electrical service cupboard door is nominal FD30s rated, secured with type 138 suited lock. There is damage around the electrical cupboard door lock requiring repair. See Action 7/14**

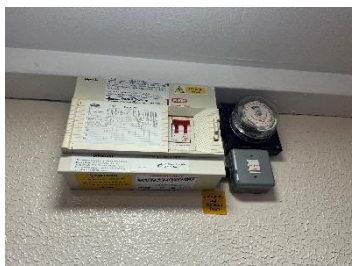
- 15) The block has a landlords' electrical distribution board at high level on the ground floor of the common area. When any refurbishment of the building takes place consideration should be given to enclosing this electrical distribution board in a suitably fire-resistant cabinet.

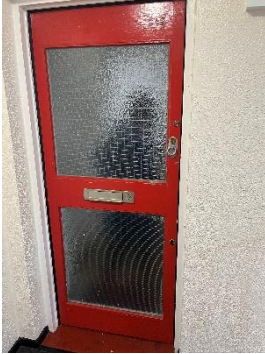
Question/ Ref No	Required Action	Supporting photograph	Priority	Timescale and Person Responsible	Date Completed
7/11	Flat 12 requires a self-closing device and combined smoke seal and intumescent seals to be fitted.

P3	Fire Rapid Response. 3-6 months	
7/14	There is damage around the under stairs electrical cupboard door lock requiring repair.
