Fire Risk Assessment Bowness House

Lovett Avenue, Oldbury, B69 1DQ

Date Completed: 8th July 2025

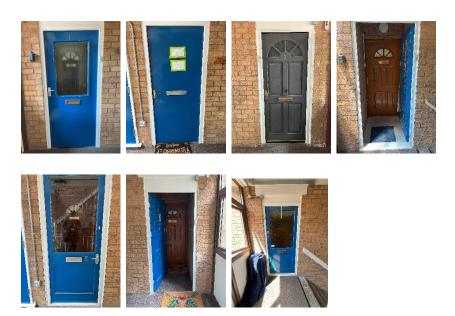
- 1) All flats are equipped with minimum LD3 detection to aid means of escape.
- 2) Flats 1,2,3,4,5,6,7 have a variety of non-fire rated notional doors installed on the front of the alcove by residents. The doors are secured by a mixture of Mortice and Yale type key locks. These doors should be considered for replacement, to certified self-closing FD30s door sets, on the next refurbishment of the block. Email sent to Capital Investments.

Flats 1,2,3,4,5,6,7 have a variety of non-fire rated notional doors installed on the front of the alcoves. The doors are secured by a mixture of Mortice and Yale type key locks. These doors should be considered for replacement, to certified self-closing FD30s door sets, on the next refurbishment of the block.

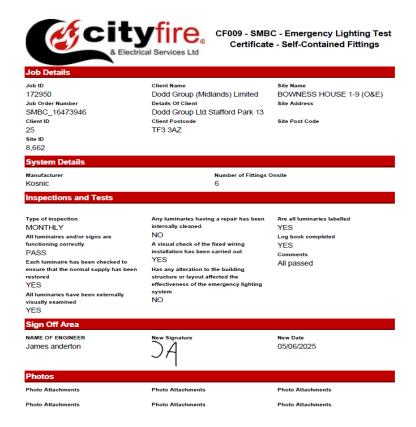
- 1) The premises have a sufficient emergency / escape lighting system in accordance with BS 5266.
- 2) Emergency lighting has been serviced by City Fire Electrical Services on 05/06/25.

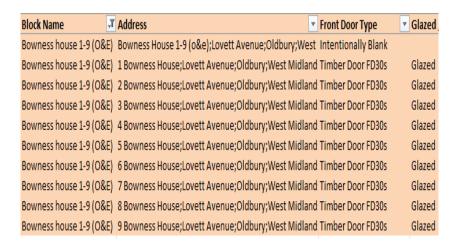
- A variety of methods and materials have been used to achieve firestopping including Rockwool and intumescent pillows were needed.
- 6) All individual flats are installed with FD30s rated composite doors, however flats 1,2,3,4,5,6,7 have a variety of non-fire rated notional doors installed on the front of the alcove that leads to the main composite FD30s fire door of the flat. The installation of these door to when they were installed is not known. Please see Observations section. Email sent to Housing Manager, Leaseholder Management and Capital Investment.

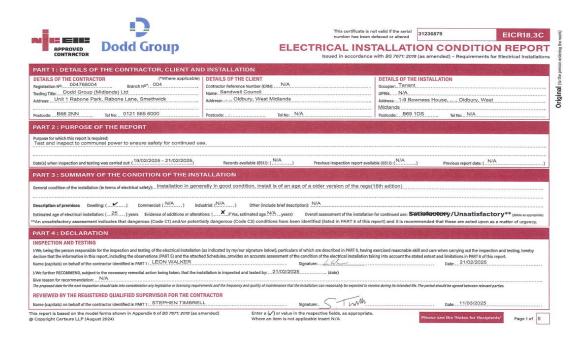
- 1) Smoking is prohibited on entrance and within any communal parts of the building in line with Smoke Free England legislation.
- 2) Hot working is not normally carried out. If essential maintenance requires the use of hot work processes, then corporate policies and procedures are to be followed.
- 3) Portable electrical equipment used as part of the Caretaking / Cleaning regime is subject to annual PAT Testing. This information is held by the Estate Services Manager.
- Other portable electrical equipment as used by residents in communal areas is also subject to periodic PAT testing.
- 5) The fixed electrical installation shall be tested every 5 years. The date of the last test was 19/02/25.
