Fire Risk Assessment

21 - 31

**Chaddesley Close,
Oldbury,
B69 1EL**

Date Completed: 07/08/2025

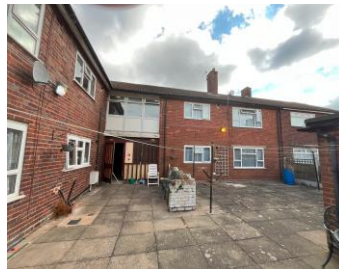
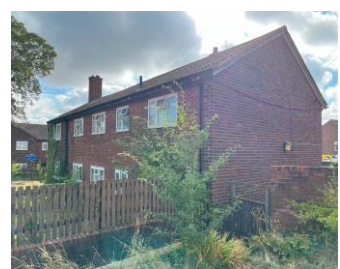
- 1) The external surface of the building is predominantly brick structure with wooden soffits and fascia. The roof is pitched and fitted with Marley concrete interlocking roof tiles are fitted on the roof.

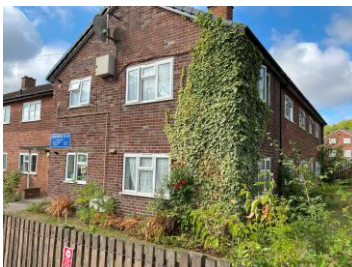
- 2) Large amount of ivy growing up the frontage of the premises. This has been reported to the housing manager for removing due to the potential fire risk and reported rodent infestation in the loft area.

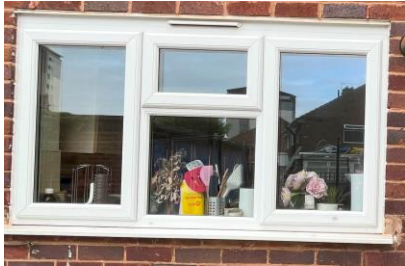
- 3) UPVC double glazed units have been installed to each flat and communal stairway. There is a canopy situated over the entrance to the block. Entrance & rear door are timber units.

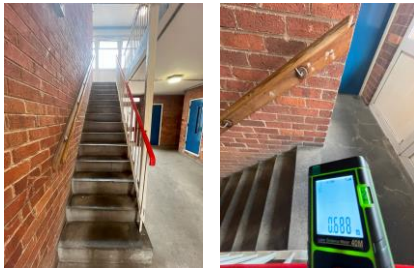
- 1) The first floor is accessed via a single staircase that provides a means of escape and has a width of 750mm reducing to 688mm between the handrails. The stairwell width has been reduced slightly due to added handrail, this reduction in width is unlikely to affect acceptable evacuation times.

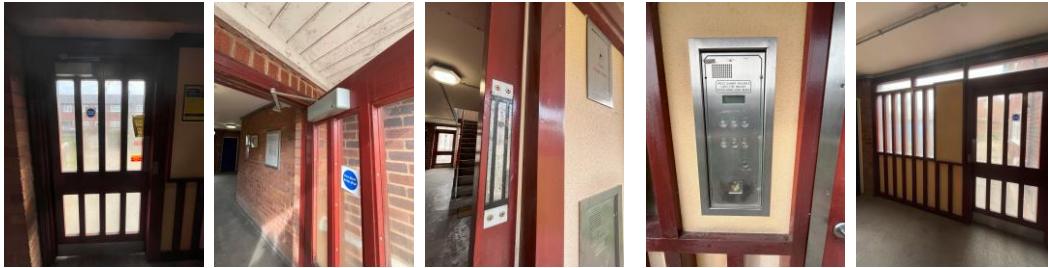
- 4) The only communal doors within the block are the final exit doors, which are fitted with automatic closing devices that are checked on a regular basis by caretaking teams as part of their checks. Defective closing devices are replaced either by the Caretaking Team(s) or the in-house repairs team(s). The final exit doors have door entry systems installed. These systems are designed to fail safe i.e. door unlocked in the event of a power failure. This prevents residents being locked in or out of the building.

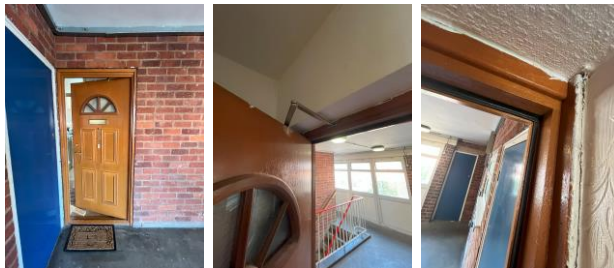
- 5) Individual flat doors are FD30s rated composite doors sets. Access is gained to a sample of properties as part of the fire risk assessment to ensure the doors have not been tampered with. Flat 29 accessed at the time of the assessment and the door was noted as correct.

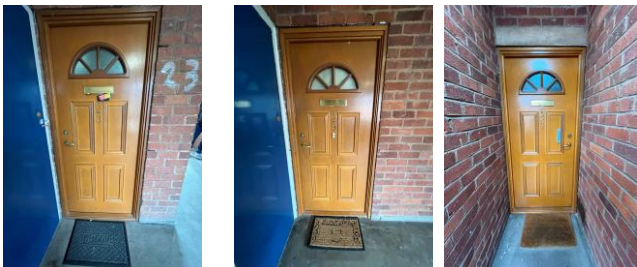
- 6) A number of flats had mats present at the entrances; the fire rating is not known on these door mats and are deemed to be low risk.

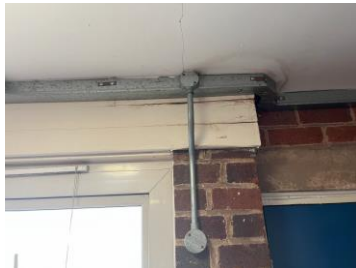
- 8) All cabling that runs through the communal area is encased within metal trunking.

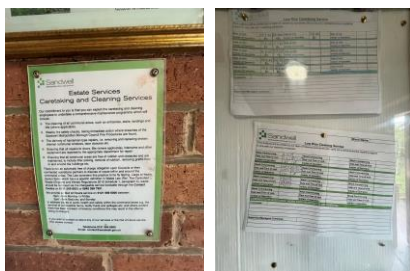
- 9) Communal areas are kept free of flammable items. The communal areas are checked on a regular basis by Caretaking / Cleaning teams 365 days per year and all items of rubbish are immediately removed. There is also an out of hour's service that allows combustible items of furniture / rubbish to be removed.

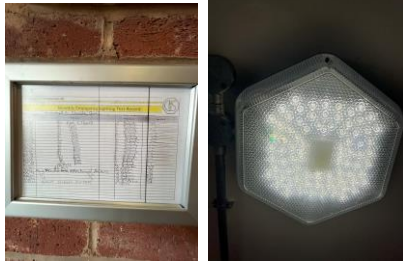
- 10) Emergency lighting is provided to communal landings and stairs. Checks are done on a monthly basis by Sandwell MBC in house electrical team or approved contractor. ([Refer to section 9](#))

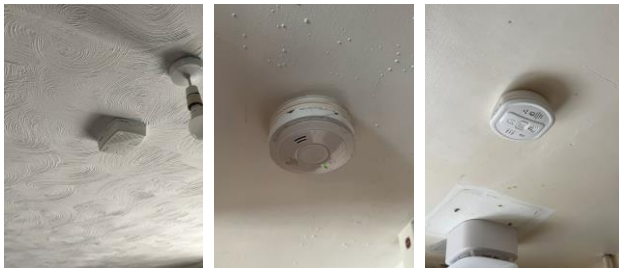
- 1) Early warning is limited to hard wire or battery smoke alarms within each of the resident's flats the equipment is subjected to a cyclical test.
- 2) Based on the sample of properties accessed during the fire risk assessment the smoke alarms within resident's flats are installed to an LD3 Standard. Flat 29 was checked at the time of the assessment.

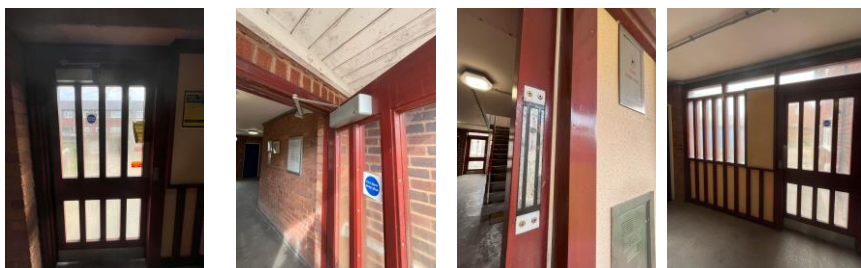
- 7) The front and rear exit doors are fitted with automatic closing devices. These are checked on a regular basis by Caretaking Teams as part of their checks. Defective closing devices are replaced either by the Caretaking Team(s) or the in-house repairs team(s).

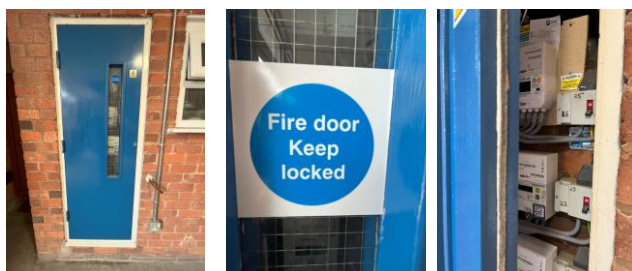
- 8) All service cupboards to communal landings are FD30s rated and lockable with budget locks and include a “Fire door Keep locked” signage.

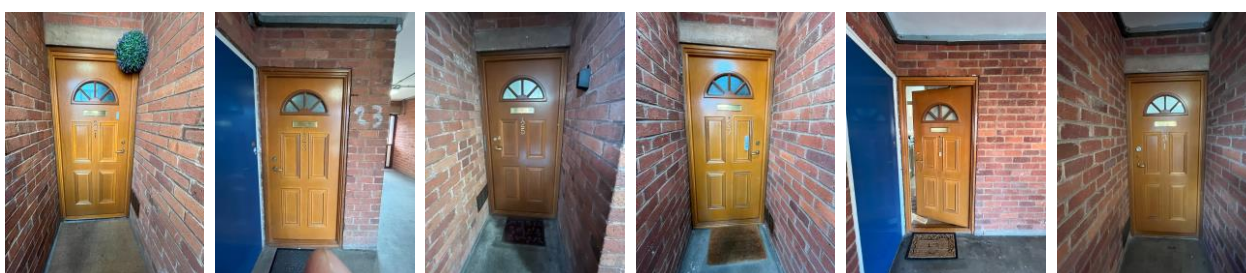
- 10) Individual flat doors are FD30s rated composite fire door construction. Flats 21 – 31 pictured

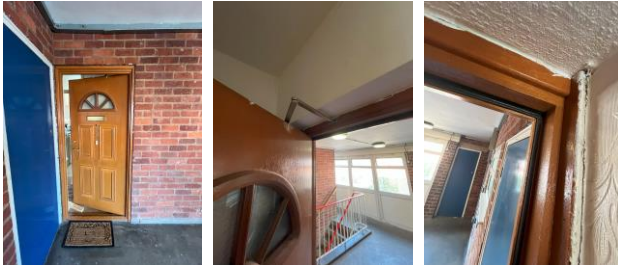
- 11) All doors would have been fitted with self-closers at the time of installation. Flat 29 was inspected and self-closers and cold smoke seals were in place and working correctly. Unable to inspect all flats at the time of the Fire Risk Assessment, so cannot say if they are all working correctly and still in place.

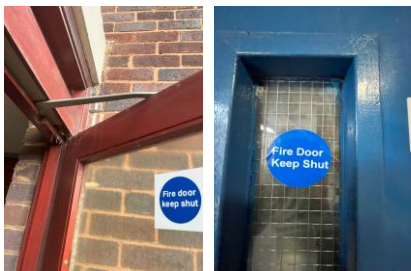
- 1) Fire door keep shut signs are displayed where appropriate. All resident meter cupboards also the front and rear exits display "Fire Door Keep Shut" sign.

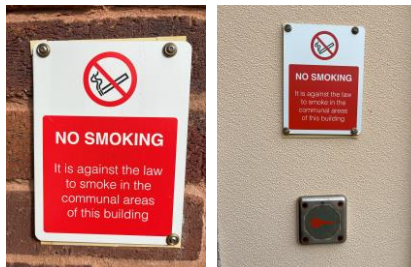
- 2) Smoking is prohibited within any communal parts of the building in line with Smoke Free England legislation.

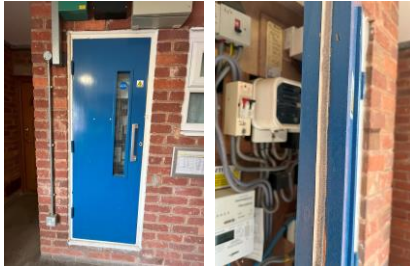
- 7) All Residents service cupboards on each floor are housed behind a FD30s fire rated doors. All cupboards are free from any combustibles.

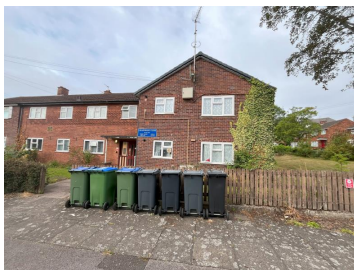
- 1) There is a regular Cleaning Service to the premises.
- 2) Refuse bins are stored at the front of the property on the pavement. Bins Are regularly emptied by weekly refuse collections.

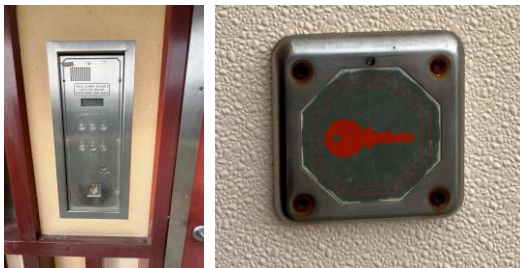
- 1) Regular checks are undertaken by Caretakers / Cleaning Team(s) 365 days per year which helps reduce the risk of arson.
- 2) Restricted access to the premises by means of a door entry system to the front and the rear.

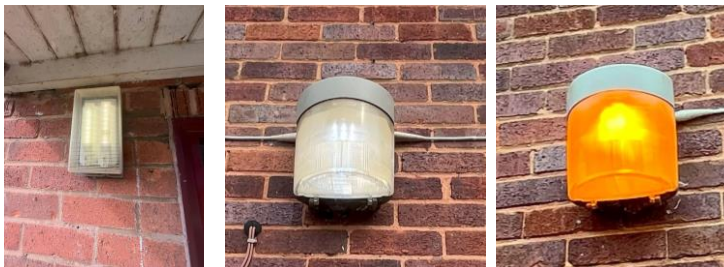
- 3) There is no current evidence of arson.
- 4) The perimeter of the premises is well illuminated.
