Fire Risk Assessment

Chandler House

**Shelsley Avenue, Oldbury,
B69 1BW**

Date Completed: 1st July 2025

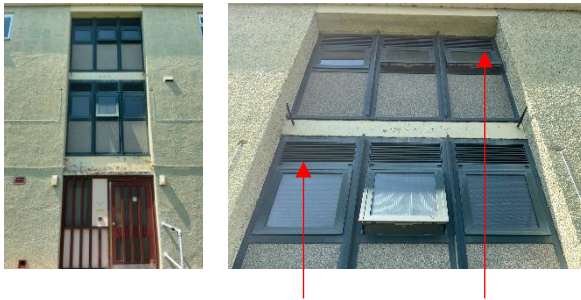
Louvered Venting above each window on the rear

- 5) Louvered vents above the communal windows to provide natural ventilation to the means of escape.

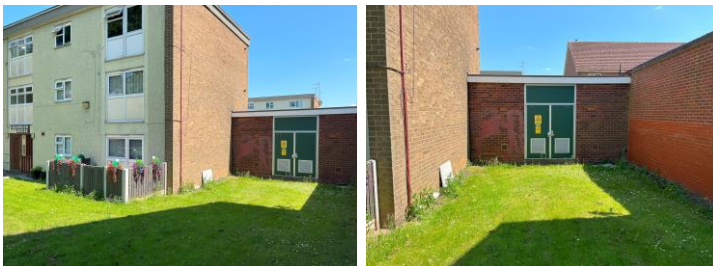
- 6) A electrical substation in attatched to the right hand side of the building.

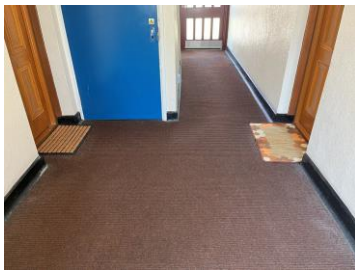
- 3) Ground floor flats 1, 2 entrances are located in between the front and rear exits, both have door mats placed outside the doors, the fire rating of these are unknown.

All floors have S.M.B.C. fitted carpet. Due to the fact SMBC specified and managed the installation of the carpets, they are in accordance with BS EN 13501-1

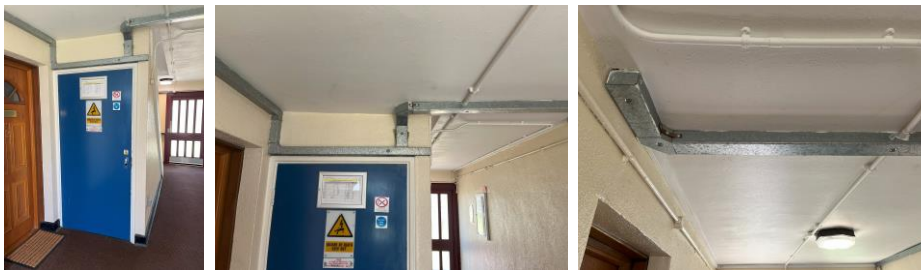
- 4) The ground floor also has an electrical cupboard near to flat 2, this is a notional upgraded FD30s and secured by a type 54 key type mortice lock. There is electrical cupboard and box trunking installed across the upper walls and ceiling.

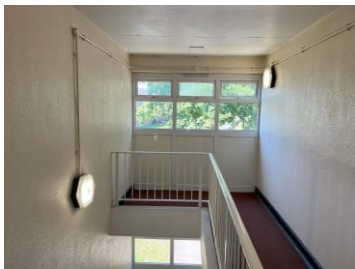
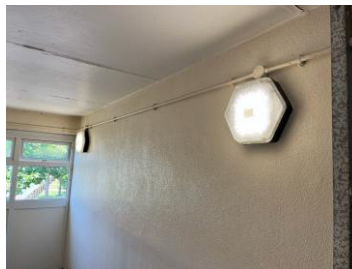
- 8) There is dead end corridor on the 2nd floor, but this is acceptable due to the length and being equipped with emergency lighting and natural ventilation, it is therefore acceptable.

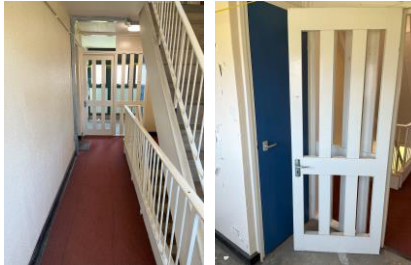
- 10) On the 1st and 2nd floor there are two sets former drying area which are separate from the 1st and 2nd floor flat entrance hallways. The partitions to these sections are of timber construction.

It is recommended that the former drying area that are on the 1st and 2nd floor landing be removed of the timber partition as this is creates a impression that this is a separate area from the communal landing and encourages residents to use this as a area to store items.

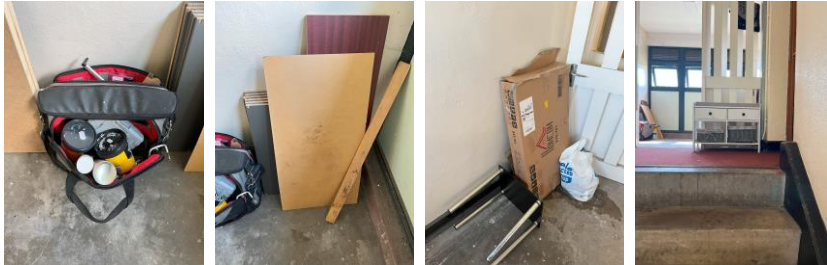
- 14) 2nd floor former drying area has several items of combustion that have been stored within and outside the area, they will need removing. Consists of pieces of wood, cardboard, table, tool bag and a small wooden cabinet.

7, 14	2 nd floor former drying area has several items of combustion that need removing

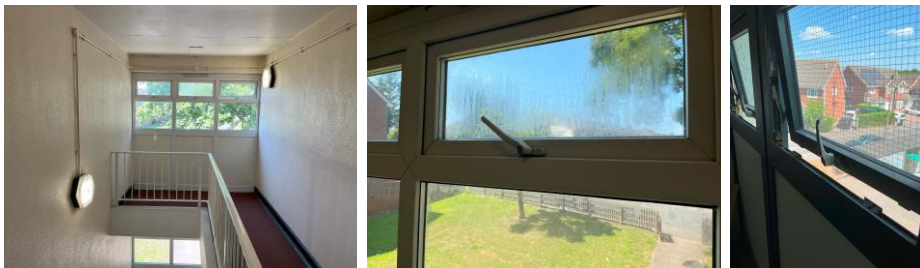
- 16) On both ends of the corridors there are a set of UPVC/Aluminium windows that open without the use of a key. These windows allow natural ventilation across the floor. The aluminium set of windows are installed with Georgian glass.

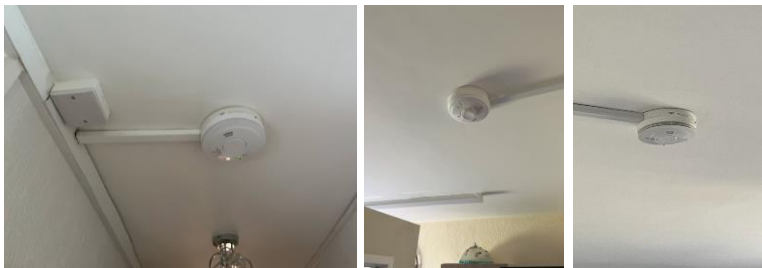
Flat 2 smoke detectors

Flat 2 LD2 - 1x smoke detector in hallway, bedrooms and lounge

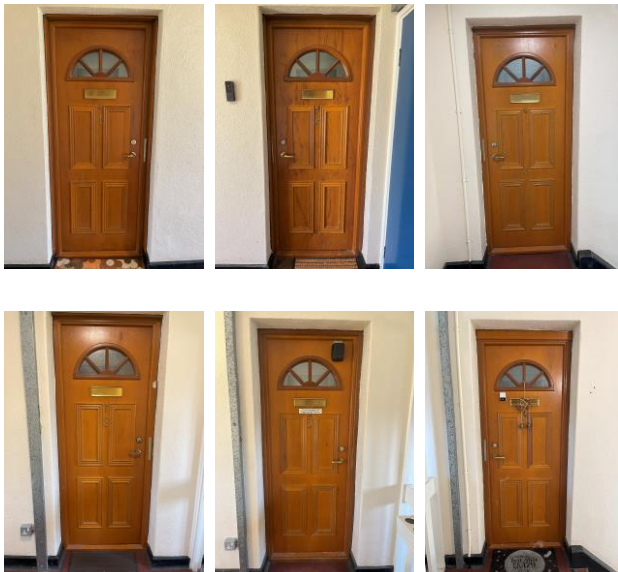
- 6) Flats 2 was sampled for the condition and function of the front entrance door, from inspection, the door closure has been removed by the resident, this has been referenced in **section 7 point 20**. An email has been sent to the Housing Manager regarding the removal of self-closures by residents.
- 7) No breach of compartmentation found within building.

P2	1 – 3 months Caretaking Team	
7, 20	Flat 2 resident has removed door closure, needs reinstalling.

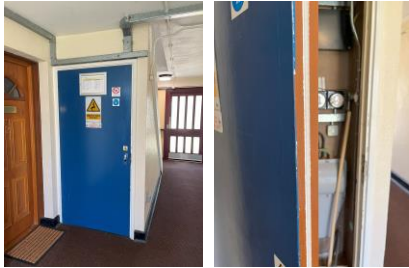
- 6) The electrical installation i.e. risers are contained within a dedicated service cupboard that is secure and protected by means of an FD60s door.
