Fire Risk Assessment

1 – 6 Cleton Street

**Cleton St, Tipton,
DY4 7TR**

Date Completed: 15/11/22

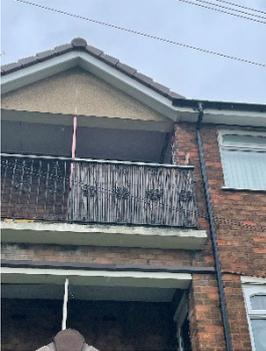
The addition of wicker screening to one balcony could potentially support the surface spread of flame in that area which is an unnecessary risk. Once this is removed the level of risk presented by materials present to the external envelope of this building would become acceptable.

- 5) Flat 6 has installed wicker screening to the balcony.

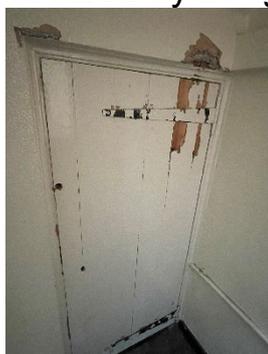
- 10) The electrical service cupboard is located on the ground floor beneath the stairs and contains resident's meters. The door is secured by budget lock and is none fire rated.

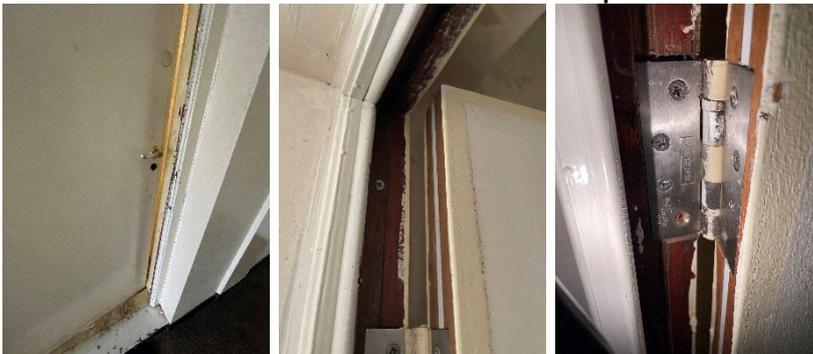
At the time of the visit access could only be gained to flat 6. This door is a timber flush FD30s with no evidence of tampering, **however the door did fail to reliably self-close fully into frame, and screw was missing from the centre hinge.** A combined intumescent strip & cold smoke seal was installed to the frame **with a section missing from above the upper hinge**, in addition there was a second intumescent strip installed to the door edge.

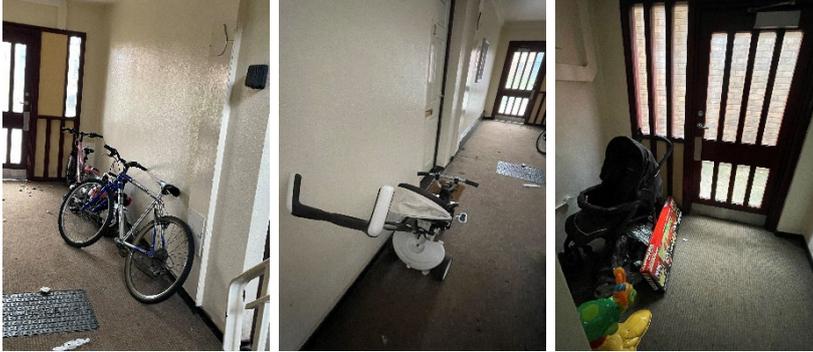
- 16) Ground floor outside flats 1 & 2 there were several items being stored within the means of escape. This included bikes, pushchairs & children's toys.

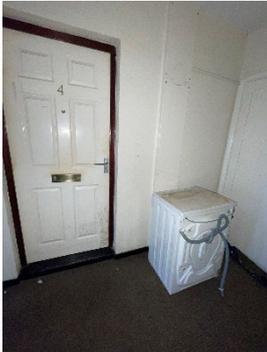
- 17) Washing machine outside flat 4 in 1st floor communal corridor. 23/11/22 It was noted that this item had been removed.

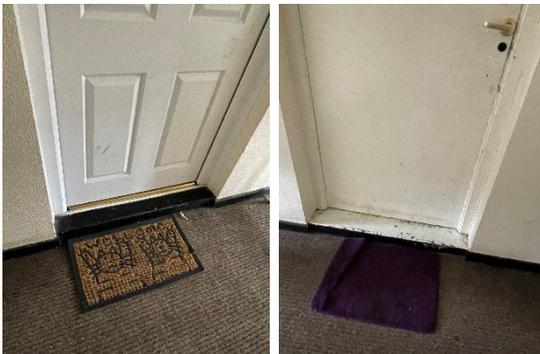
20) The fire rating of the individual floor mats to the communal areas is unknown. The resident of flat 6 was requested to remove the bathroom mat that was present outside their door at the time of the visit.

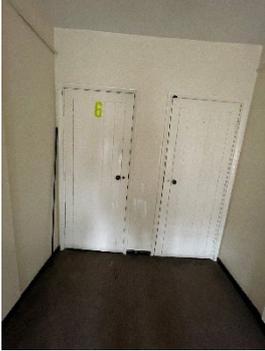
- 7) Resident storage cupboards to the 1st & 2nd floors have none fire rated doors.**

(Email received from contracts manager for housing informing upgrade works scheduled 2027/28)

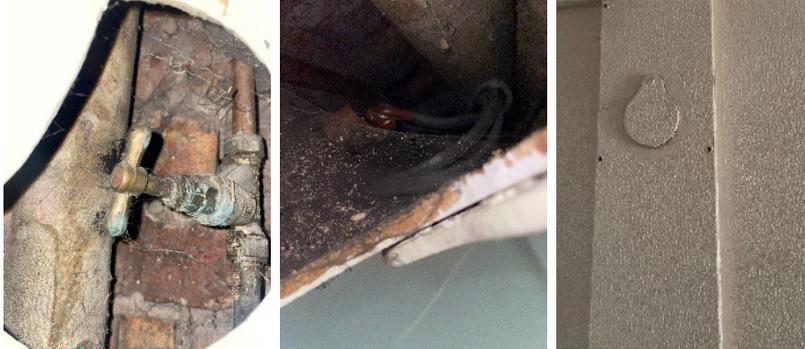
- 8) Access panels to stop taps are constructed of timber ply.**

(Confirmation of appropriate fire stopping received from Fire Rapid Response Team)

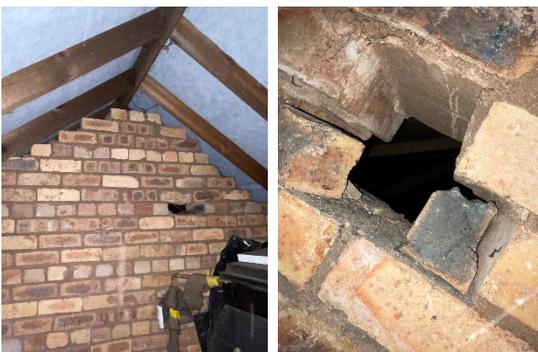
- 9) Inspection of the common roof space above the communal landing revealed gaps along the party walls. Installation of a firestopping material is necessary to prevent the travel of any potential products of combustion.**

Due to the presence of water tanks it was not possible to access the entirety of this area.

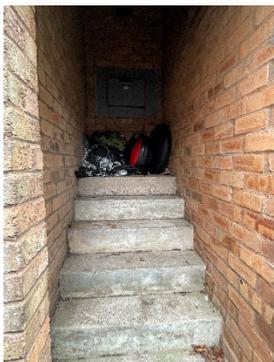
- 5) **Rubbish has been discarded on the steps to the bin chute.**
-

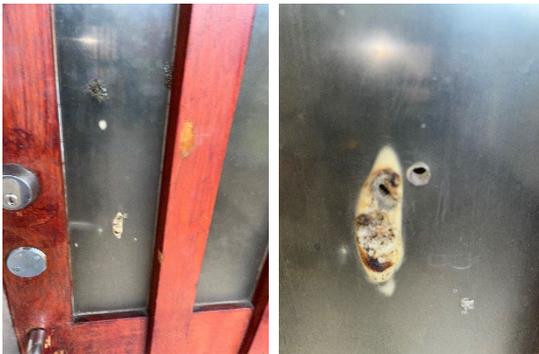
- 1) Regular checks are undertaken by Caretakers / Cleaning Team(s) 365 days per year which helps reduce the risk of arson.
- 2) Restricted access to the premises by means of a door entry system.
- 3) There is evidence of scorch marks to the front entrance door.

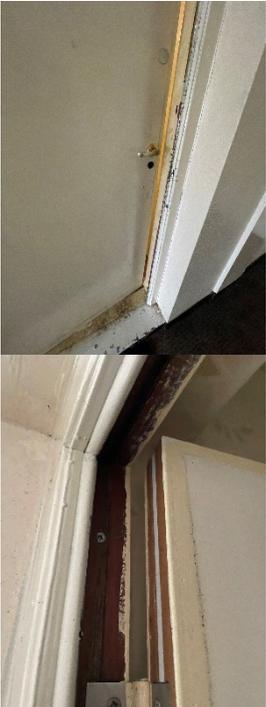
P2	Within 1 - 3 months of action plan date. Housing Manager	20/07/2023
07/15	Flat 6 entrance door - doesn't reliably self-close into frame. - requires smoke seal above top hinge. - replace missing screw to centre hinge.

P2	Within 1 - 3 months of action plan date. Fire Rapid Response JM:10053991	04/01/2023

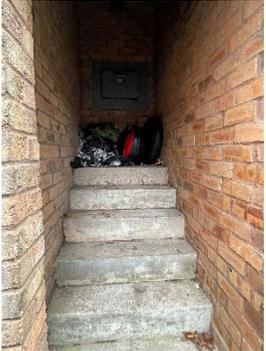
<p>P2</p>	<p>Within 1 - 3 months of action plan date. Fire Rapid Response JM10070687</p>	<p>11/01/2023</p>
<p>15/05</p>	<p>Rubbish has been discarded on the steps to the bin chute.</p>

<p>P2</p>	<p>Within 1 -3 months of action plan date. Caretakers</p>	<p>06/02/2023</p>
