# Fire Risk Assessment

**1-6 Cleton Street  
Lodge Street,  
Oldbury,  
B69 4JE.**

**Date Completed: 03/09/2025**

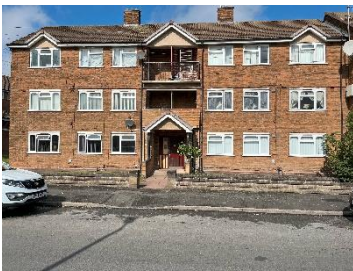
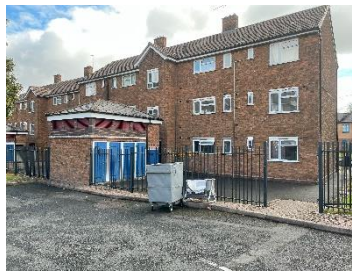
- 1) The external surface of the building is predominantly traditional brick construction.

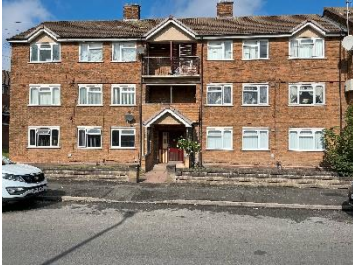
- 4) Flats to the 1<sup>st</sup> and 2<sup>nd</sup> floors have access to a balcony.

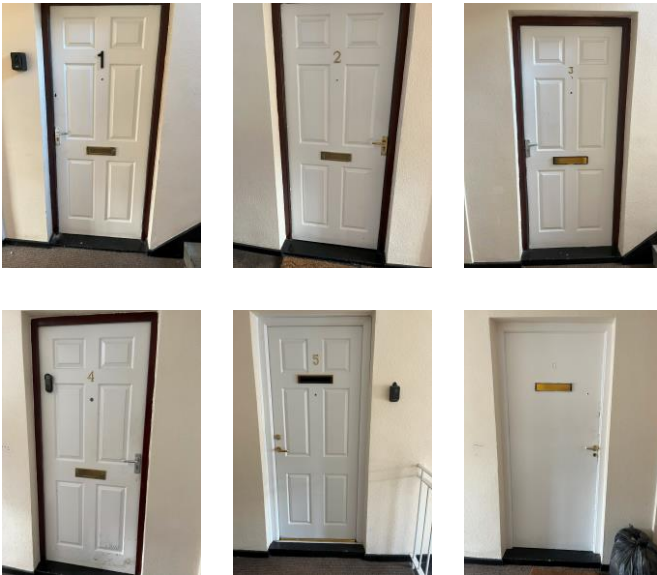
- 1) Individual flat doors appear to be FD30s rated composite fire doors, and original notional timber doors. Original timber doors should be considered for replacement in the future.

- 2) **Flat no 5 is missing an external letter box plate off the front of the flat door, this needs replacing. See action 7/2.**

| Question/<br>Ref No | Required Action | Supporting<br>photograph | Priority | Timescale<br>and Person<br>Responsible | Date<br>Completed |
|---|---|---|---|---|---|
| 7/2 | Replace missing letterbox<br>outer plate in Flat 5. | | P2 | 1-3 Months<br>Fire Rapid<br>Response. | |

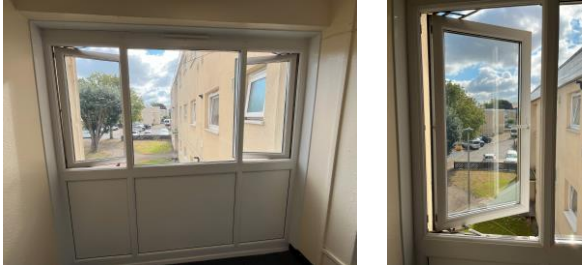
- 14) Ventilation of the common area is facilitated by openable windows in the stairwell. There is no automatic smoke ventilation system installed in this premises.

- 15) No emergency lighting is fitted in the common areas of the building.(see observations).
- 16) The front final exit door has a door entry system installed. These systems are designed to fail safe i.e., door unlocked in the event of a power failure. This prevents residents being locked in or out of the building.

Emergency lighting is recommended to be fitted at next refurbishment; this is due to the building being three stories.

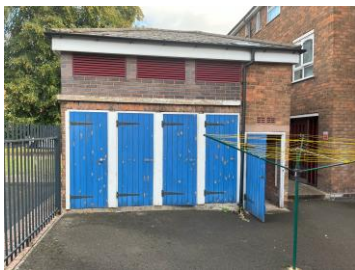
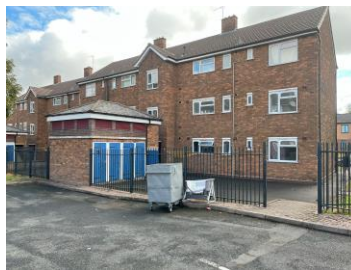
- 1) There is a regular Cleaning Service to the premises.
- 2) Refuse bins are stored to the front and rear of the building in a purpose-built store away from the main building. Bins Are regularly emptied.
