Fire Risk Assessment

**7-12 Cleton Street
Lodge Street,
Oldbury,
B69 4JE.**

Date Completed: 08/09/2025

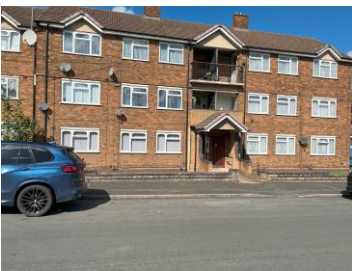
- 6) **Flat 10 has plastic netting hanging on the balcony, this must be removed see action 6/6.**
- 7) **Flat 12 has plastic netting hanging on the balcony, this must be removed see action 6/6.**

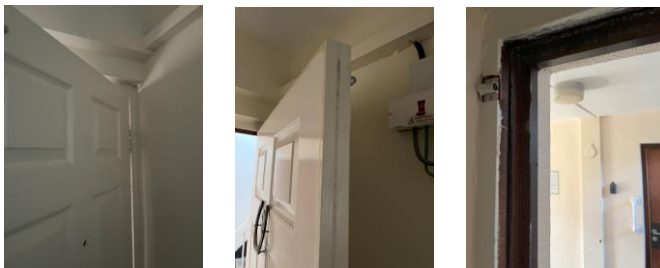
- 2) Access was attempted to a sample some of the properties as part of the risk assessment. This was to ensure the doors have not been tampered with by residents.
- 3) **Flat no 8 was accessed and had no self-closer no smoke seals and no intumescent strip fitted.**

P3	3-6 Months Housing manager	
7/3	Flat no 8 was accessed and had no self-closer no smoke seals and no intumescent strip fitted.

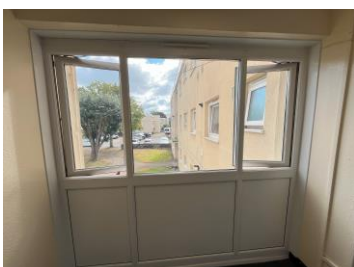
- 12) Ventilation of the common area is facilitated by openable windows in the stairwell. There is no automatic smoke ventilation system installed in this premises.

- 13) No emergency lighting is fitted in the common areas of the building.(see observations).
- 14) The front final exit door has a door entry system installed and is unlocked using a key. These systems are designed to fail safe i.e., door unlocked in the event of a power failure. This prevents residents being locked in or out of the building.

Emergency lighting is recommended to be fitted at next refurbishment; this is due to the building being three stories.
