# Fire Risk Assessment 13 - 18 Cleton Street

Cleton St, Tipton, DY4 7TR

Date Completed: 17/11/22

Sandwell
Metropolitan Borough Council

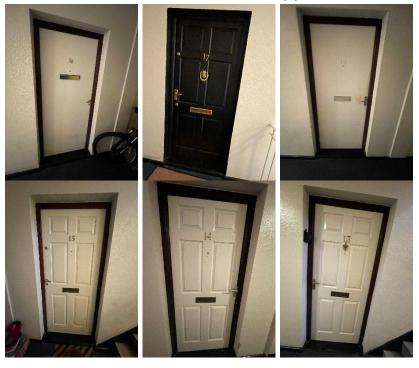
6) Individual flat doors are timber FD30s fire rated door sets.
