# Fire Risk Assessment

**13-18 Cleton Street  
Lodge Street,  
Oldbury,  
B69 4JE.**

**Date Completed:** 10/09/2025

**Officer:** C. Hudson **Fire Risk Assessor**

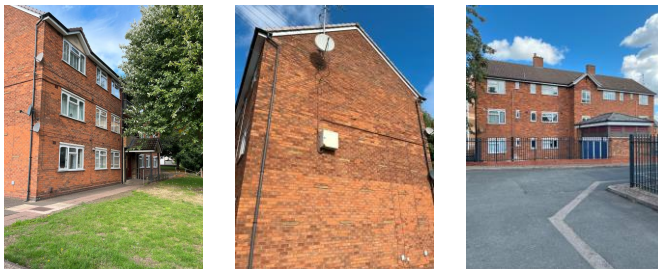
- 1) The external surface of the building is predominantly traditional brick construction.

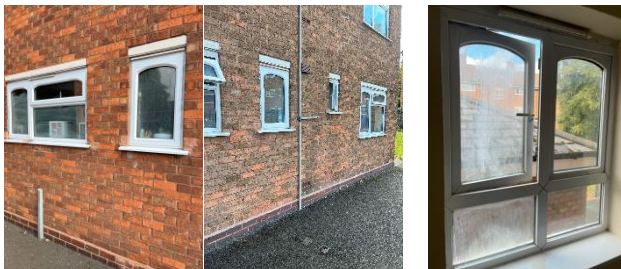
- 3) UPVC double glazed units have been installed to each flat. The windows in the communal staircases are UPVC window frames with openable vents.

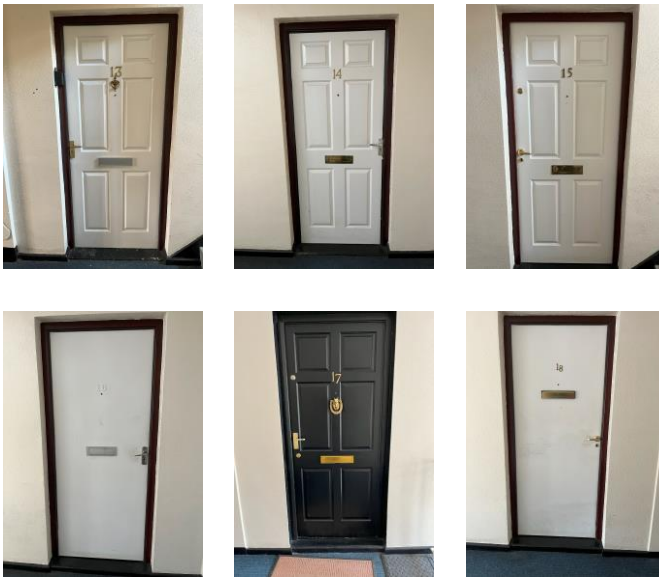
- 1) Individual flat doors appear to be FD30s rated composite fire doors, and original notional timber doors. Original timber doors should be considered for replacement in the future.

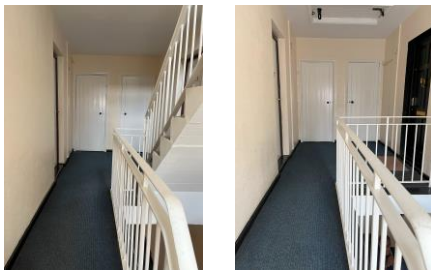
- 7) The means of escape is an open plan landing and stairs construction over three floors. The landings are kept clear to maintain safe means of escape.

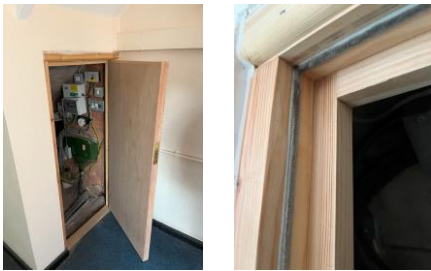
- 8) There are no communal doors other than the final exit doors which are fitted with automatic closing devices. These are checked on a regular basis by Caretaking Teams as part of their checks. Defective closing devices are replaced either by the Caretaking Team(s) or the in-house repairs team(s).
- 9) Service cupboards on ground floor containing residents' meters are timber fire doors with upgraded smoke seals and intumescent strips and lockable with a 138 mortice lock.

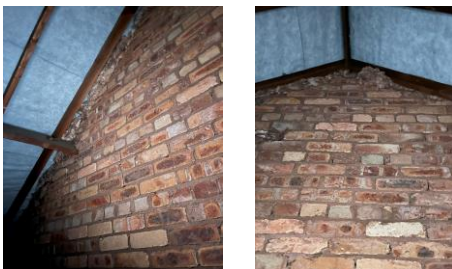
- 12) The loft was accessed to confirm the fire stopping that was required after the last Fire Risk Assessment was completed. This was correct.

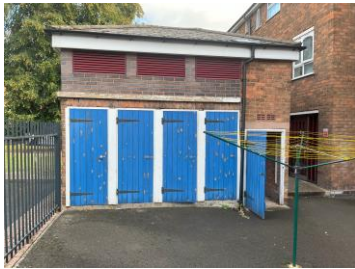
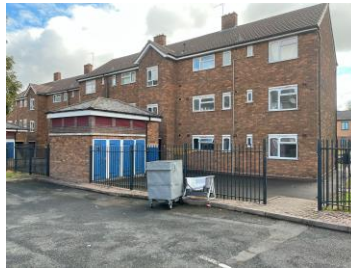
- 1) There is a regular Cleaning Service to the premises.
- 2) Refuse bins are stored to the front and rear of the building in a purpose-built store away from the main building. Bins Are regularly emptied.
