# Fire Risk Assessment

## Holly Grange

Mallin Street, Smethwick,  
B66 1QY

**Date Completed:** 5<sup>th</sup> August 2025

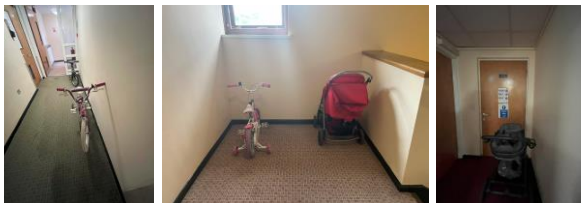
- 3) **Bicycles and a pushchair were noted within the communal areas outside flats 22-26 and a recess on a first floor landing. The premise manager should ensure these items don't compromise the means of escape and seek to identify an alternative suitable storage solution.**

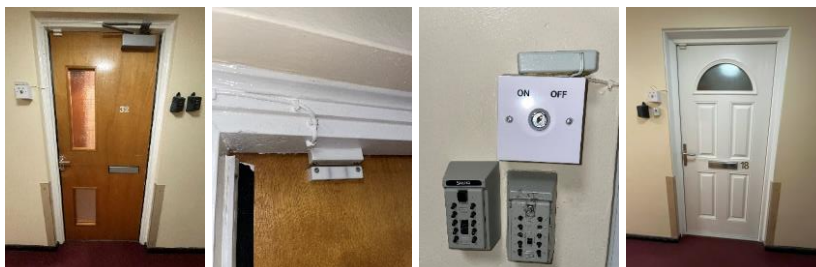
20) Individual flat doors are nominal FD30s timber doors with overhead self-closing devices (externally mounted) apart from flat 18 that has been fitted with a composite FD30 rated door (no answer at time of assessment, previous assessment 2024 mentions overhead closer fitted inside property), intumescent lined letterboxes and two Georgian wired glazed panels. There is an alarm system connected to each door which has been disabled since the building has been repurposed.

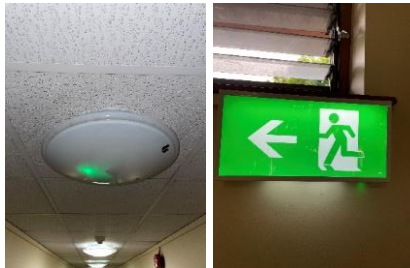
- 1) The premises have a sufficient emergency / escape lighting system in accordance with BS 5266 and has test points strategically located. A number of the illuminated directional fire exit signs were not working, email sent 06/08/25 to the electrical compliance manager to rectify.

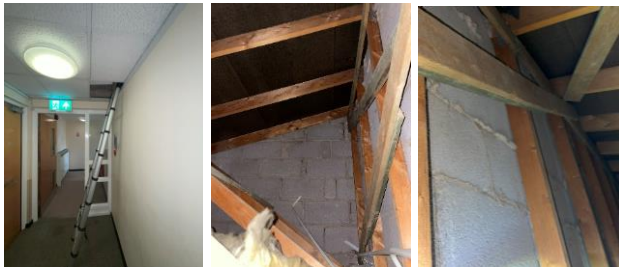
- 1) The building is designed to provide as a minimum 1-hour vertical fire resistance and 1-hour horizontal fire resistance around flats stairwells and lift shafts. All doors are minimum 30-minute fire resistant with cold smoke seals, including those in 1-hour rated walls.
- 2) The premise has sufficient compartmentation to limit the travel and effect of smoke and flame in event of a fire. Whilst the existing fire stopping is fit for purpose, there is a cyclical programme to ensure fire stopping has not been compromised by third parties and where applicable enhance the fire stopping.
- 3) Compartmentation walls extend to the roof line as confirmed by sampling roof voids above flats and corridors.

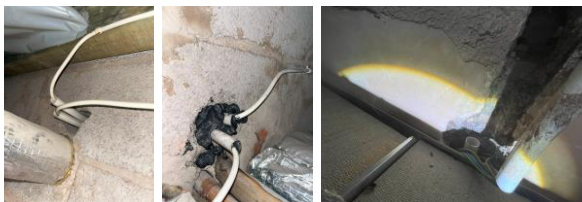
- 4) **Fire stopping required (x 2) above the corridor door in ceiling void by flat 24. Torch light could be seen pass through the penetrations.**

| 10/4 | Fire stop (x 2) where cables penetrate wall in ceiling void above landing door by flat 24 | | P2 | Within 1-3 months<br>Fire Rapid Response | |

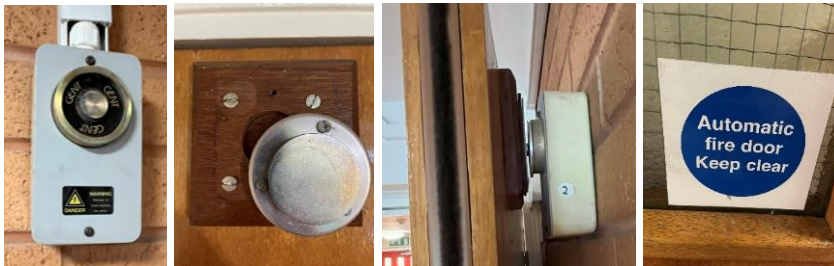
- 6) All communal doors are fitted with automatic closing devices. These doors are held open by magnetic devices that are activated by the fire alarm panel. Automatic fire door stickers are displayed on each door. A number of the electro-magnet devices are defective, but this does not cause any concern with the integrity of the fire doors. This has been reported to the electrical compliance manager.

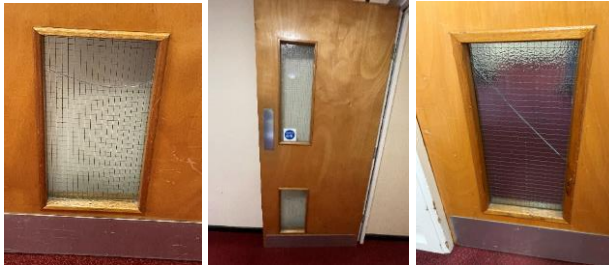
- 7) All communal fire doors are subject to a 12-week check by the Fire Safety Rapid Response Team.
- 8) Lower vision panel is cracked in communal corridor door by flat 20 and by flat 16. Repair has been organised job number 17554239.
-

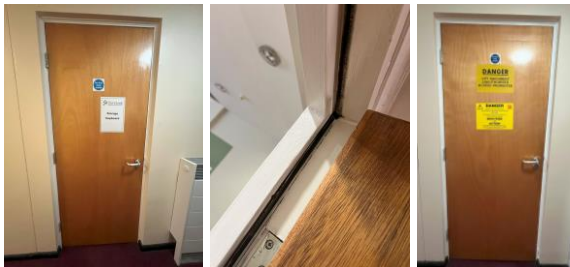
- 9) **Smoke seal come away from frame of corridor fire door by flat 20.**

| 10/9 | Replace smoke seal that has come away from frame of corridor fire door by flat 20 | | P2 | Within 1-3 months<br>Fire Rapid Response | |

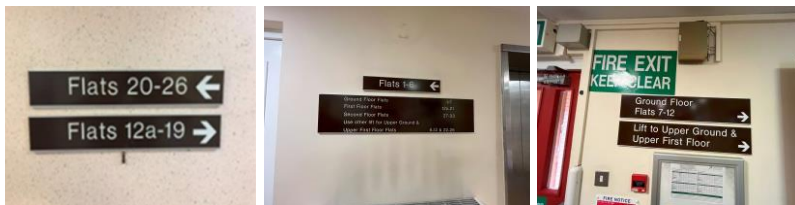
It was noted that signage depicting the location of flats 12a – 21 was missing from the 1<sup>st</sup> floor lift lobby landing nearest to flat 21. The premise manager has been advised to reinstate the missing signage.

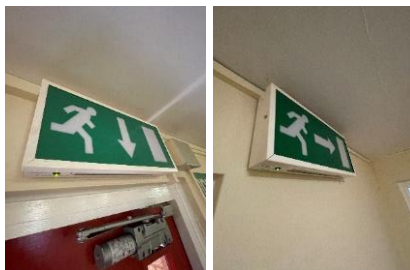
- 6) A number of the illuminated directional fire exit signs were not illuminated, email sent 06/08/25 to electrical repairs to inspect .

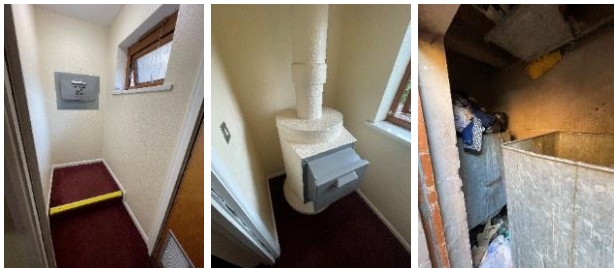
- 2) There are two internal refuse chutes serving bin stores.

- 3) A number of white goods and refuse situated outside the premise, close to the property. Premise manager has now removed all items 29/8/25.

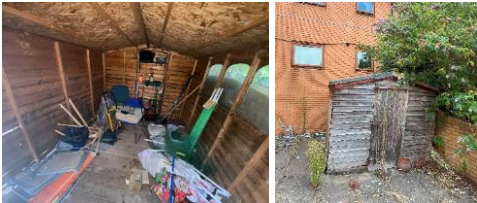
- 1) Residents instructed not to bring L.P.G cylinders into block.
- 2) No Flammable liquids stored on site by Caretakers / cleaners.
- 3) All store cupboards are kept locked.
- 4) There are no flammable liquids or gas cylinders stored on site.
- 5) Shed located in the courtyard outside of offices. This is in a poor state of disrepair and close to the building. There are no ignition sources within however, the premise manager should consider removal.
