# **Fire Risk Assessment**

## **Compton Grange**

**Whitehall Road,  
Cradley Heath, B64 5BG**

**Date Completed: 13<sup>th</sup> June 2025**

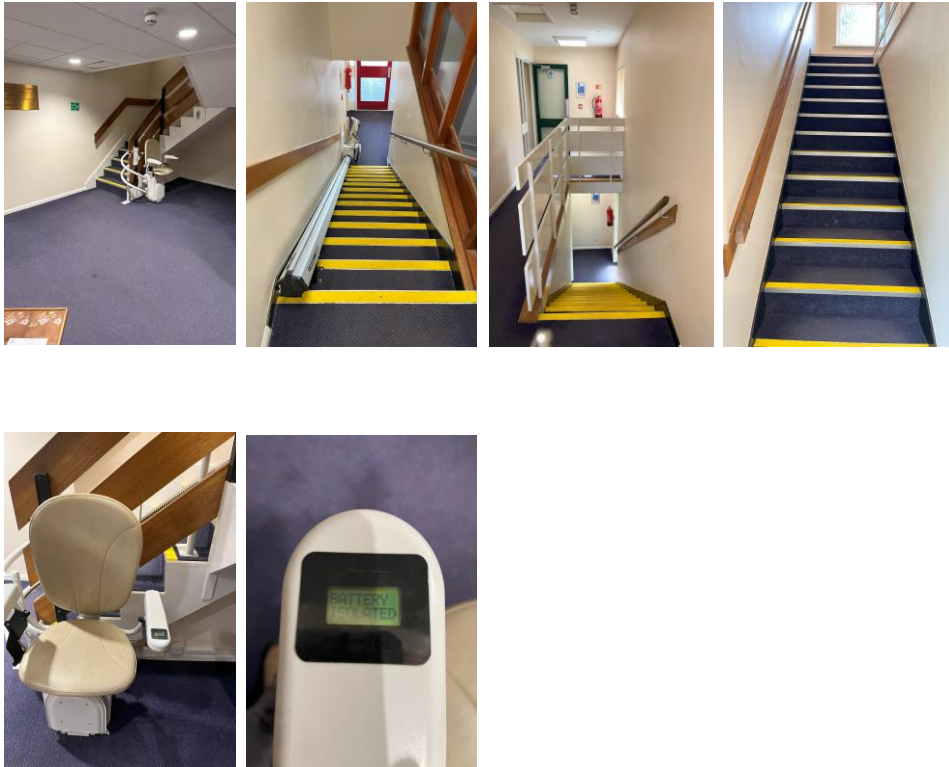
Both stairlifts on inspection appear to be decommissioned.

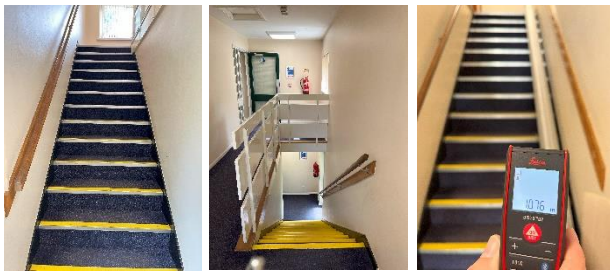
- 1) The site has four staircase's that provide a means of escape, all are 1.076m in width.

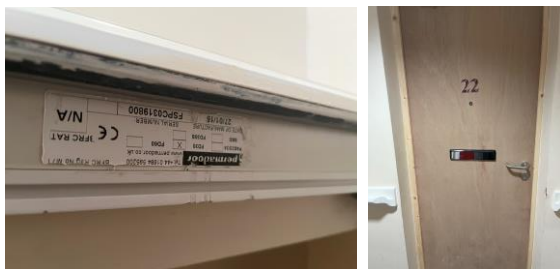
Flat 22 door.

- 14) The building has sufficient passive controls that provide effective compartmentation in order to support a Stay Put-Unless Policy. Therefore, residents are advised to remain in their flat unless the fire directly affects them.
- 15) Individual flat entrance doors are FD30s rated door sets manufactured by Permadoor, as confirmed by the manufacturer label. Only flat 22, currently at the time of conducting FRA, has a temporary 30 wooden fire door.

- 19) Flat 22 was fitted with a temporary fire door and new frame after a forced entry by the Ambulance service, the frame has intumescent strips installed. When testing the closure of the door, the door did not self-close into the latch, this test was done from an angle 15 degrees on opening of the door.

| Flat 22 – Resident currently has a Temporary timber Nominal FD30 door installed following a forced entry recommendations for this door to be upgraded to a fully certified FD30s Door set. Currently the door is acceptable as a temporary replacement. | |

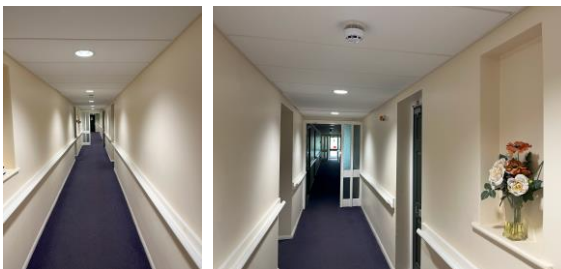
- 22) Decorative artificial flowers have been placed in some alcoves within some communal corridors. There is a building entry system in place and all corridors have smoke detectors therefor the risk is considered minimum.

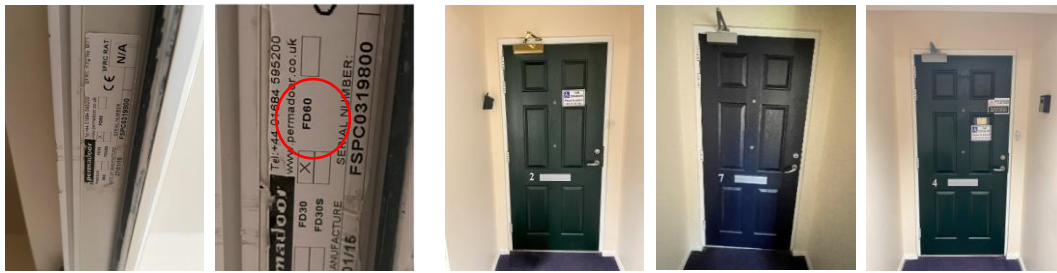
- 5) Individual flat doors were originally specified to be FD30s rated fire door construction, manufactured by Permadoor. However, some doors have labels that would suggest the doors are FD30 rated. This was clarified within the previous FRA dated February 2023. The assessor had contacted the manufacturer who confirmed that

the doors are in fact FD30s rated after detailing the affected serial numbers.

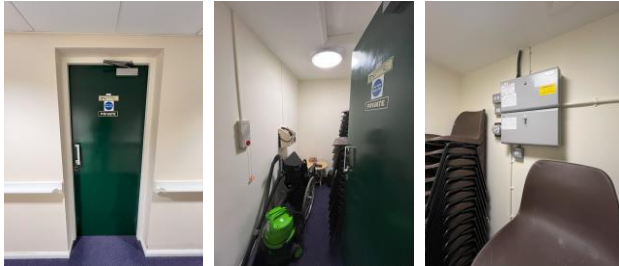
- 7) On the first floor in the telephone room, on inspection it was found that combustibles are being stored, 2 stacks of plastic chairs, wooden table, wheelchair and a Hoover, the room houses a distribution board alongside emergency lighting switches, there is no detection in this room
