# Fire Risk Assessment

## Compton Grange

**Whitehall Road,  
Cradley Heath, B64 5BG**

**Date Completed: 04/06/2026**

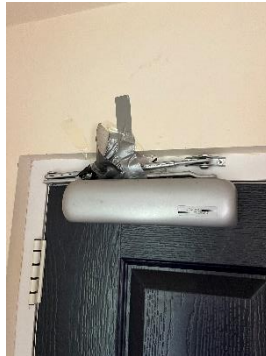
**a) Flat 9 – Flat front entrance door appears to have a damaged self-closer. See action 7/12a.**

| Question/<br>Ref No | Required Action | Supporting<br>photograph | Priority | Timescale and<br>Person<br>Responsible | Date<br>Completed |
|---|---|---|---|---|---|
| 7/12a | Flat 9 – Flat front entrance door appears to have a damaged self-closer. Rectification required. | | P2 | Fire Rapid Response<br>1 – 3 months. | |

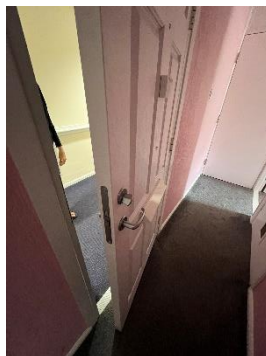
**b) Flat 26 – Flat front entrance door will not close into frame, adjustment required. See action 7/12b.**

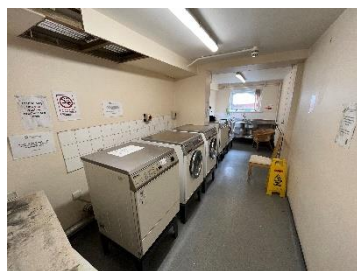
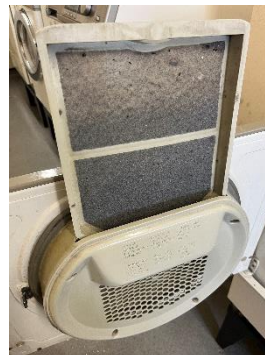
- 14) The laundry is located on the ground floor, adjacent a final exit door. This has a nominal FD30s rated door secured by suited 138 mortice lock. It was noted that a dryer filter had not been cleaned post use. See action 7/14.

| 7/14 | It was noted that a dryer filter had not been cleaned post use. It is required that residents are reminded of the necessity to clean dryer filters after each use. | | P2 | Housing Officer<br>1 – 3 months. | |

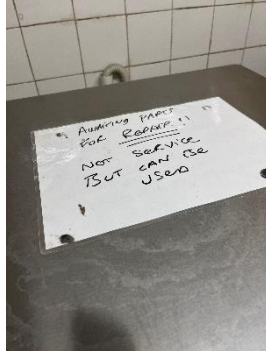
- 15) It was noted that contradictory information is signed on the first dryer. This dryer should be removed from service until it is repaired. See action 7/15.

| 7/15 | It was noted that contradictory information is signed on the first dryer. The dryer should be taken out of use until repaired. | | P2 | Housing Officer<br>1 – 3 months. | |

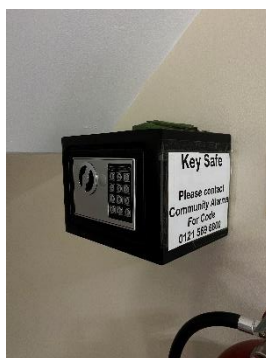
- 2) The assessor called SMBC community alarms service and was given information stating that the common alarm system was not monitored and therefore it is unclear how this AFA system would be re-set in the event of actuation. Management of the common area automatic fire alarm system should be reviewed. See action 8/2

| 8/2 | The common alarm system was not monitored and therefore it is unclear how this AFA system would be re-set in the event of actuation. Management of the common area automatic fire alarm system should be reviewed. | | P3 | Asset Management.<br>3 – 6 months. | |

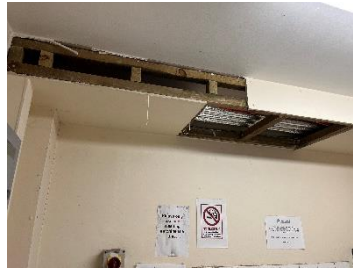
- 4) **The laundry has damaged duct work, requiring repair. See action 10/4.**

| 10/4 | The laundry has damaged duct work, requiring repair. | | P2 | Fire Rapid Response<br>1 – 3 months. | |

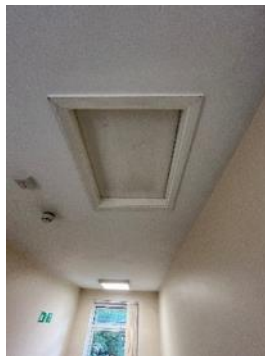
- 9) Loft hatches (not accessed due to health & safety reasons) do not appear to be fire resistant. See observations.

It is recommended that in any future planned upgrade of Compton Grange that the loft hatches are upgraded to a minimum FD30s level, if not already done.

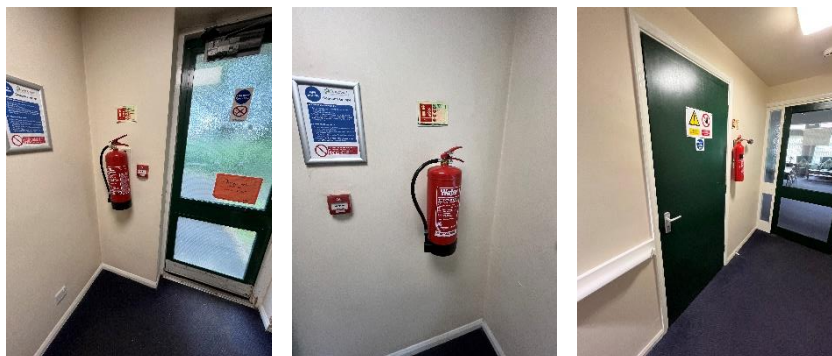
- 1) Portable fire extinguishers are sited in common areas throughout the block. Fire extinguishers are not recommended in the common escape routes of unstaffed residential housing, including specialised age accommodations where care is not provided.

Untrained residents should be discouraged from attempting to fight fires and should, instead follow the blocks evacuation strategy. Therefore, all fire extinguishers in the common escape routes should be removed. Those sited outside of hazard rooms, such as the main electrical service room, laundry and lift motor room should be re-sited within these hazard rooms for the potential use by trained contractors and SMBC staff. See action 11/1.

| 11/1 | All fire extinguishers in the common escape routes should be removed. Those sited outside of hazard rooms, such as the main electrical service room, laundry and lift motor room should be re-sited within these hazard rooms. | | P3 | Asset Management.<br>3 – 6 months. | |

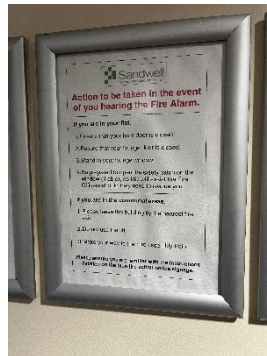
- 2) **Fire Action Notices** are displayed throughout the building. However, the specific fire action notice shown below, gives confusing information and should be removed. See action 12/2.

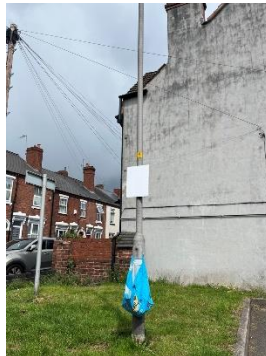
- 5) No visible signage is in place to identify the fire assembly point if it is required. A 'Fire assembly point' sign is required for the main car park. See action 12/5.

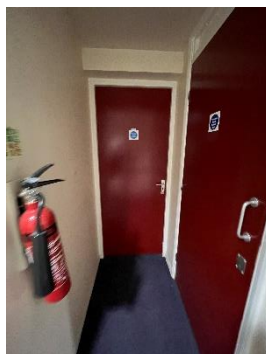
- 6) An electrical hazard sign is missing from the main electrical room on the ground floor. An electrical hazard sign is required to be fitted. See action 12/6.

| 12/6 | An electrical hazard sign is required to be fitted on the outside of the main ground floor internal electrical plant room. | | P3 | Fire Rapid Response<br>3 – 6 months. | |
