Fire Risk Assessment

James Clift House

**Martley Road,
Oldbury,
B69 1EH**

Date Completed: 6th August 2025

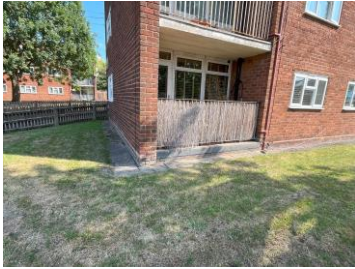
6) Flat 3 has wicker type screening attached to the balcony railings.

| Question/ Ref No | Required Action | Supporting photograph | Pr ior ity | Timescale and Person Responsibl e | Date Completed |
|---|--|--|---|--|---|
| 6/6 | Flat 3 remove wicker screening attached to the front of balcony | A photograph showing the exterior of a brick building. A balcony on the ground floor is covered with a light-colored wicker screening. The area is surrounded by grass and a low fence. | P2 | 1-3 Months Leaseholder Management | |

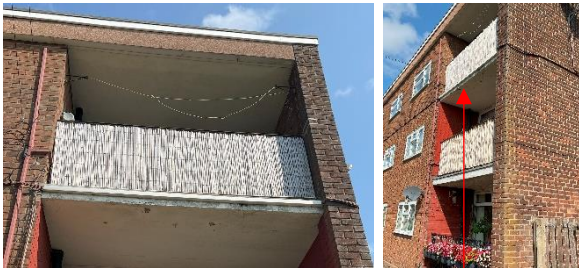
8) Flat 8 has wicker screening attached to the balcony railings

| 6/8 | Flat 8 remove wicker screening attached to the front of balcony. | | P2 | 1-3 Months Housing Team | |

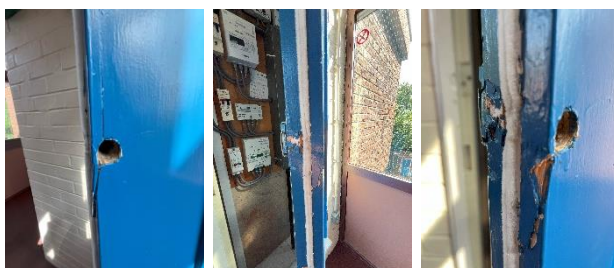
- 4) **1st floor electrical cupboard has damage around the locking area, slight snagging of the smoke seal was evident**

| 10/4 | Repair 1 st floor electrical cupboard due to damage around the locking area. | | P2 | 1-3 Months Fire Rapid Response | |

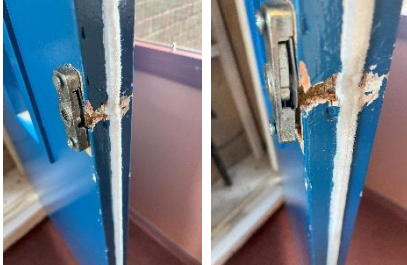
- 5) 2nd floor electrical cupboard, there is damage around the budget lock area, smoke seal slightly snagged and difficult to lock.**

| 10/5 | Repair 2 nd floor electrical cupboard, due to damage around the locking area. | | P2 | 1 -3 Months Fire Rapid Response | |

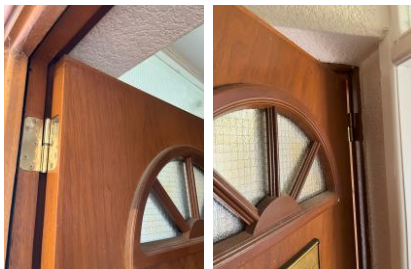
- 9) Flat 1 has removed door closure due to difficulty in accessing doorway with wheelchair.**

| 10/9 | Flat 1 re-instate door closer. | | P2 | 1-3 Months Fire Rapid Response | |

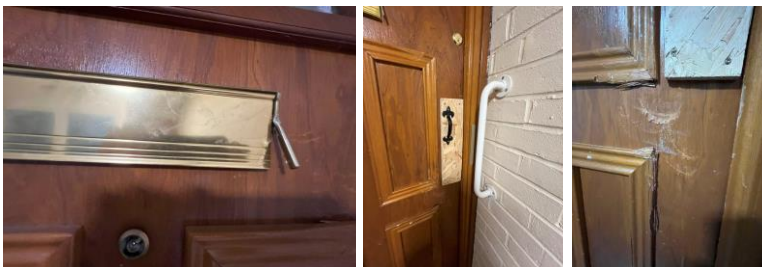
- 10) Flat 2 front door is damaged, there is a piece of plyboard fixed to the door allowing an additional door handle to be installed, there is damage around letter box and on the mid part of the door there is surface damage to the face, by look of it most likely from impact, could not access the flat to check the door entirely.**

| 10/10 | Flat 2 has plyboard attached to door allowing for an extra door handle to be installed, letter box has been damaged, surface damage to mid part of the door. Needs repairing if acceptable. This will require a new door check JM to see if there is an order | | P2 | 1-3 Months Fire Rapid Response | |
