# Fire Risk Assessment

**10-20 Martley Road**  
**Martley Road,**  
**Oldbury,**  
**B69 1DZ**

**Date Completed:** 04/08/2025

**Current Risk Rating = Tolerable**

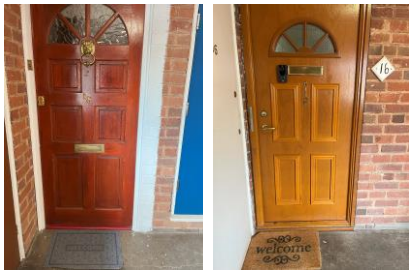
Two properties in the block have door mats which can be a trip hazard the fire rating of these is unknown

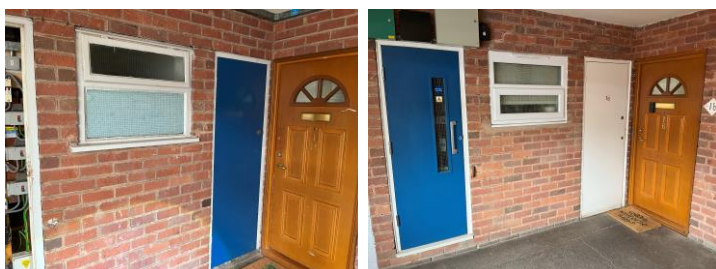
- 3) On the ground floor and first floor a window installed in the common area. The window on the first floor is a timber framed window with Georgian wired glass installed, on the ground floor the window is of UPVC construction with a double-glazed unit, both windows open into the common area, it looks like the window opens from the bathroom of the flat which is a low-risk room. This is noted in 10, (compartmentation) Email has been sent to capital investment 12/08/2025.

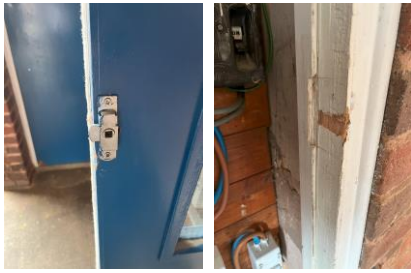
**5) The electrical service cupboard on the first and ground floor does not lock**

10/5	Ground floor service cupboard budget lock defective – repair or replace.

P2	1-3 months Fire Rapid Response	
10/6	1 <sup>st</sup> floor service cupboard budget lock defective – repair or replace.

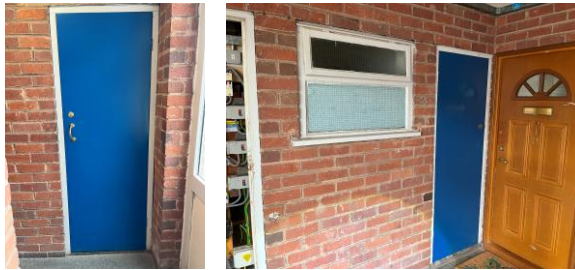
**6) Each flat has access to a storage cupboard situated on the properties landing. Cupboards do not have fire rated doors but are kept locked**

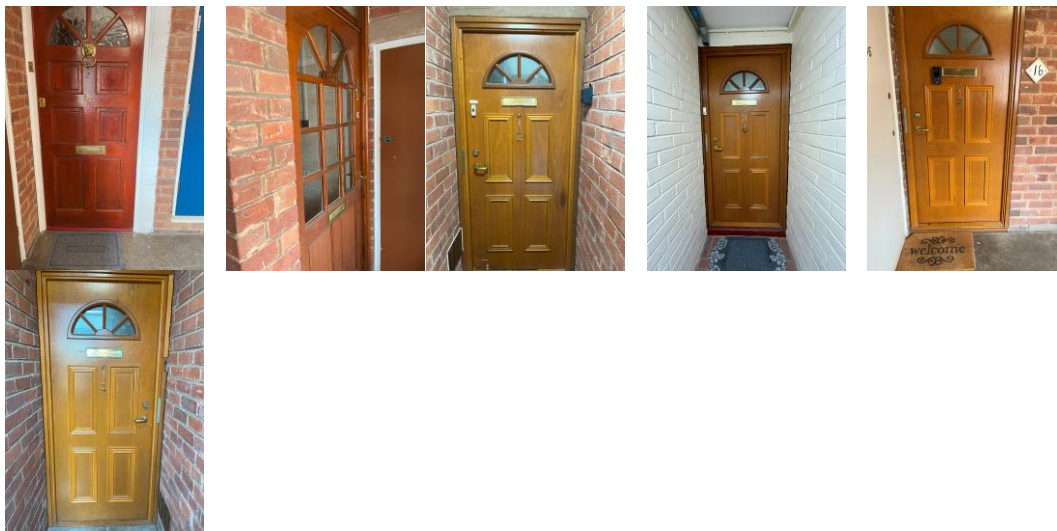
**7) Individual flat doors are FD30s rated composite fire door construction. Flats 18 and 20 have installed an additional front door creating a small lobby area, these additional doors are not fire rated. See observations in section 19.**

Flats 18 and 20 have non-fire rated timber doors installed on the front of the alcoves. The doors are secured by a mixture of Mortice and Yale type key locks. These doors should be removed or considered for replacement, to certified self-closing FD30s door sets, on the next refurbishment of the block.

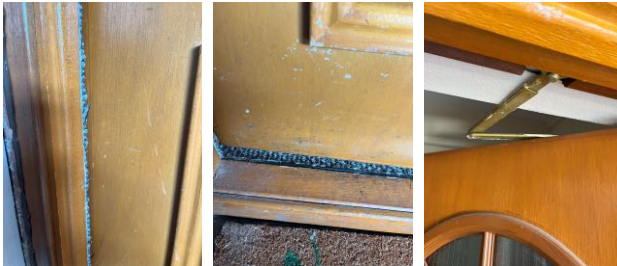
**9) Flat 10 entrance door is failing to reliably self-close due to carpet that has been fitted over the threshold and within the frame. The tenant should remove the carpet that is affecting the door.**

P2	1-3 Months Fire Rapid Response	
10/9	Flat 10 Remove carpet from step / threshold and frame to enable fire door to self-close fully.

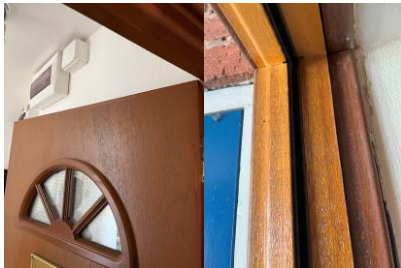
**10) Flat 18 entrance door is failing to self-close because the overhead self-closer has been removed. This is a leaseholder property. Leaseholder has stated they will remove any replacement self-closer.**

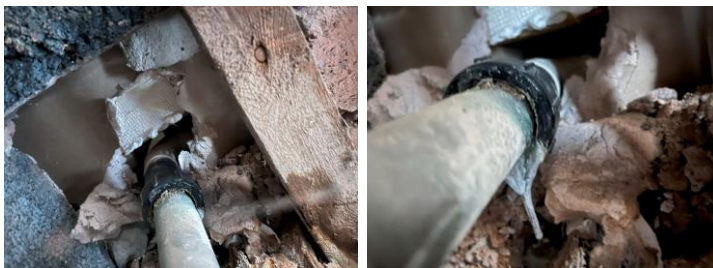
**11) Ground floor electrical cupboard has a small hole in the ceiling leading to the first floor and a small hole at floor level that the waste pipe comes through from the flat next to the cupboard. These holes require firestopping.**

P3	3-6 Months Leasehold Manager	
10/11	Fire stop Ground floor electrical cupboard small hole in the ceiling leading to the first floor and a small hole at floor level that the waste pipe comes through from the flat next to the cupboard.

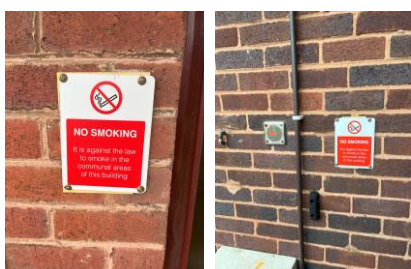
- 2) Fire Action Notices are not displayed throughout the building. The signs are not necessarily due to the building not having a complex layout.
- 3) Smoking is prohibited within any communal parts of the building in line with Smoke Free England legislation.

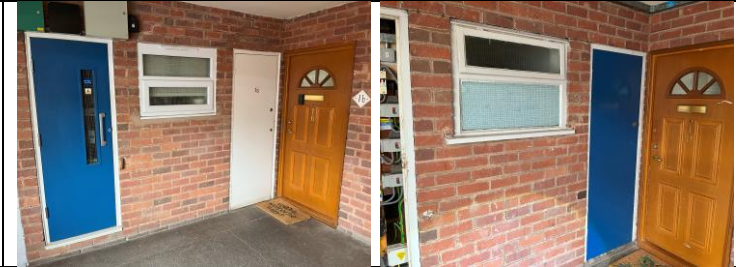
Flats 10 & 16 have windows that open into the common area, it is assumed that these windows are from the bathrooms of the flats, for future renovation works integrity of the compartmentation between flats and the common area needs to be considered e.g. fire-resistant glazing could be installed.
