Fire Risk Assessment

Martley Road 36-46

**Martley Road, Oldbury,
B69 1DZ**

Date Completed: 4th August 2025

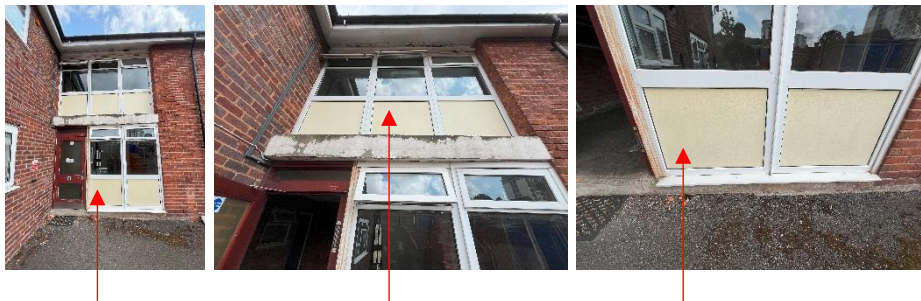
Rear Spandrel panelling under the window units

- 3) On the front and rear elevation of the building, there are Spandrel panels installed under the rear entrance and stairwell window units.

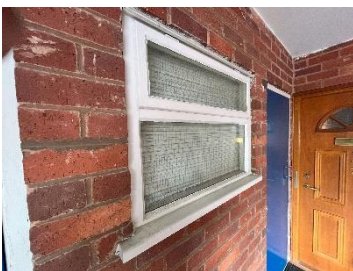
- 3) There is a timber framed window with Georgian Wired glass installed in flat 42. It is not known whether the window can be opened, it seems that this window opens from a bathroom which is considered a low-risk room. This is noted in 10,13 (Compartmentation)

Flats 36 & 42 have timber framed windows that open into the common area, it is assumed that these windows are from the bathrooms of the flats, for future renovation works integrity of the compartmentation between flats and the common area needs to be considered e.g. fire-resistant glazing could be installed.

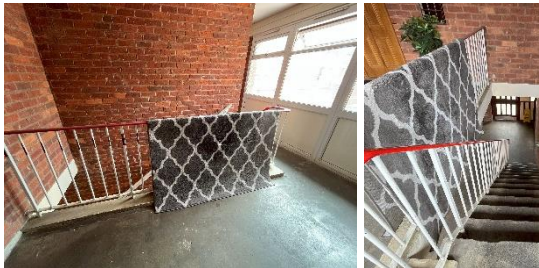
- 6) A large rug has been placed over the rails of the first-floor landing area, it drapes over towards the stairwell, there is a risk of it slipping over on to the stairs or onto the route of means of escape. This was however removed by tenant.

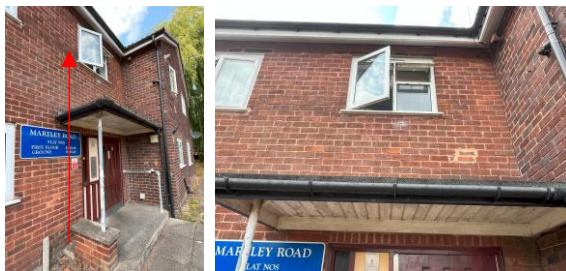
- 11) Flat 46 on the 1st floor has a window that exits out on to the front entrance canopy. The building is within the 4.5m threshold in height which is measured from the ground to the floor of the 1st floor flat.

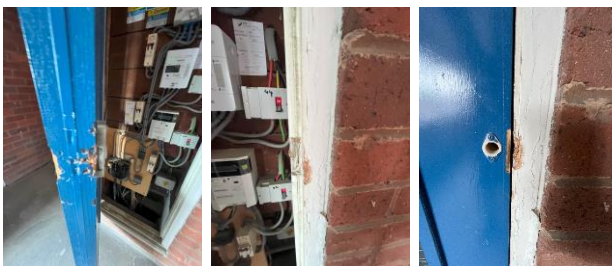
1st floor Riser

- 4) **The 1st floor electrical cupboard door and frame is damaged around the locking mechanism area.**

10/4	First floor electrical cupboard, damage around the lock area on the door and frame. Will need repairing

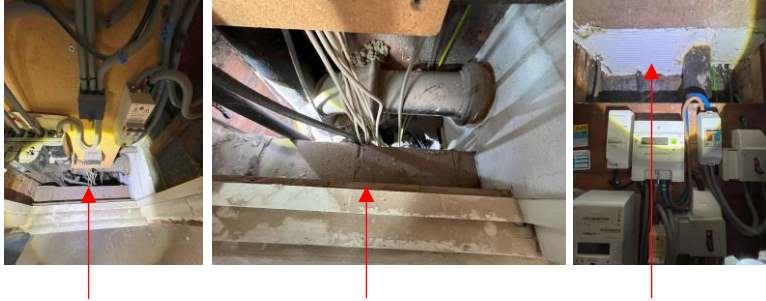
Electrical cupboard from 1st floor & ground floor electrical cupboard

- 8) First floor resident's electrical cupboard has a cavity within it that leads towards the ground floor cupboard, have investigated ground floor cupboard to see if any breach in compartmentation, there is no evidence of any breach within the ground floor electrical cupboard.

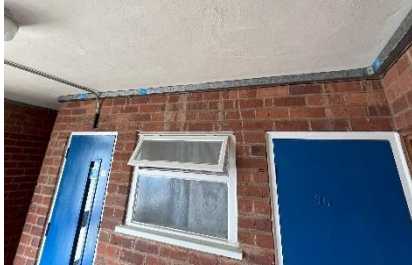
- 11) On the first floor, there is a window with Georgian wired glass, this is part of flat 36. This has been noted in section 10, Compartmentation.

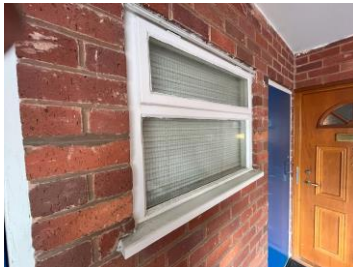
- 12) There is a timber framed window with Georgian wired glass installed in flat 42. This has been noted in section 10, Compartmentation.

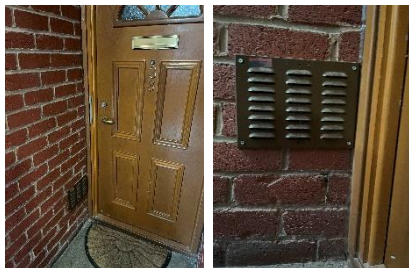
- 14) Outside flat 38 there is an air brick, it is covered with an Intumescent cover.
