Fire Risk Assessment

1-6

**Applewood Grove,
Cradley Heath,
B64 6EG.**

Date Completed: 01/11/2025

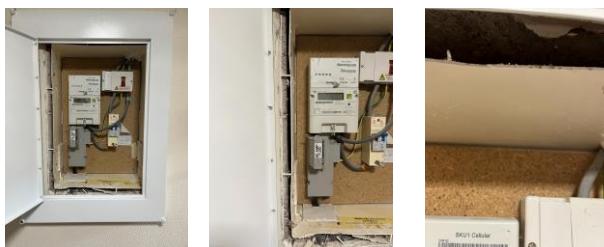
8) **The Electrical cupboards outside No 1 Requires firestopping see Action 7.7.**

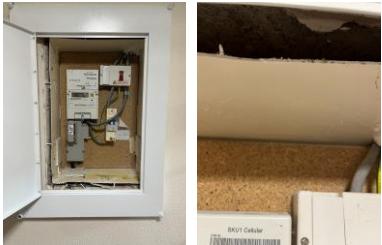
7/8	The Electrical cupboards outside flat No 1 Requires firestopping.

P3	1-3 Months Fire Rapid Response	
7/9	The Electrical cupboards outside flat No 2 Requires firestopping.
