Fire Risk Assessment

1-12

**Blue Rock Place,
Tividale,
B69 1PB**

Date Completed: 05/05/2026

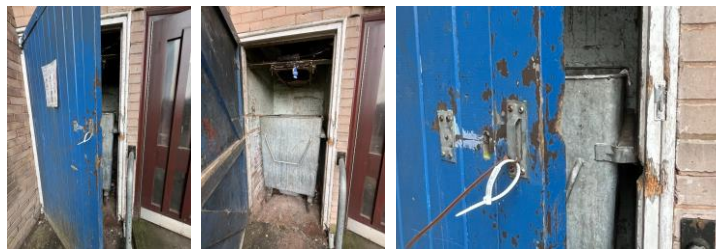
Next to the one exit/entrance door is situated a bin storage room secured behind a timber door, within this room is a large waste bin serving the blocks bin chute. This room is not secured by a lock; the latch to keep it closed is missing, new one required to keep the room closed. See section 15

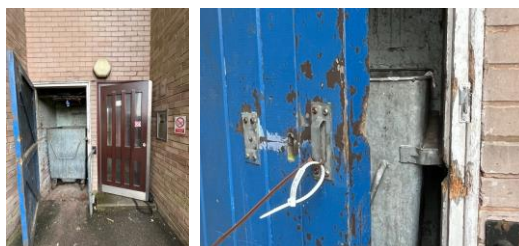
- 6) The bin room is accessible from outside through a timber door. This door is to be kept shut when not in use, see section 15.

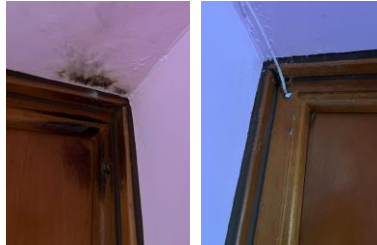
a) Flat 1: Scorch marks to the door and frame externally. Door catch needs cleaning and oiling as not engaging. Cable also running through the frame.

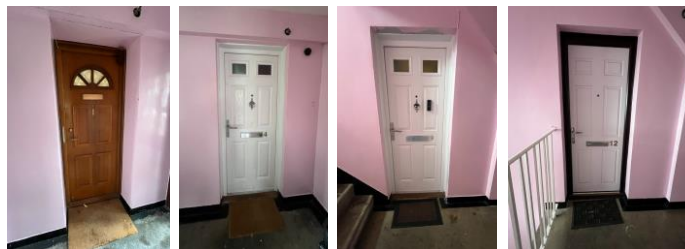
4) At a number of flat entrances door mats are present; the fire rating is not known on these door mats and are deemed to be low risk.

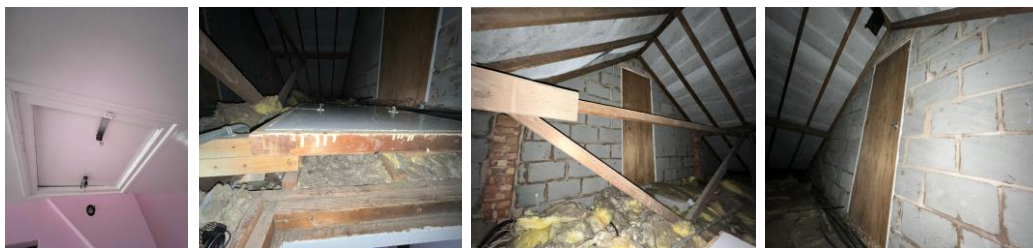
b) Third Floor: Access to the roof void is located on the third floor and is provided via a solid timber loft hatch secured with two padlocks. This area was inspected during the Fire Risk Assessment and was found to be fully fire-stopped, incorporating dividing block walls and timber fire doors installed within those partitions. The compartmentation appeared consistent with the requirements for maintaining the integrity of the protected escape route.

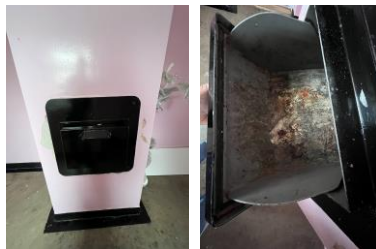
- d) Third Floor: The bin chute hopper located adjacent to Flat 10 was inspected and found to be operating correctly at the time of the assessment. All seals were intact, and no defects were observed. Ongoing maintenance and regular checks are essential to ensure the hopper continues to function effectively and does not compromise fire safety within the protected escape route.**

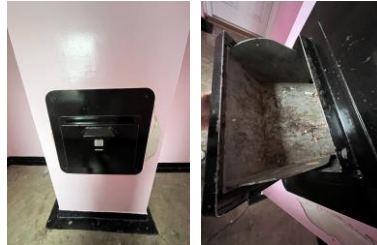
- g) Second Floor:** The bin chute hopper located adjacent to Flat 10 was inspected and found to be operating correctly at the time of the assessment. All seals were intact, and no defects were observed. Ongoing maintenance and regular checks are essential to ensure the hopper continues to function effectively and does not compromise fire safety within the protected escape route.

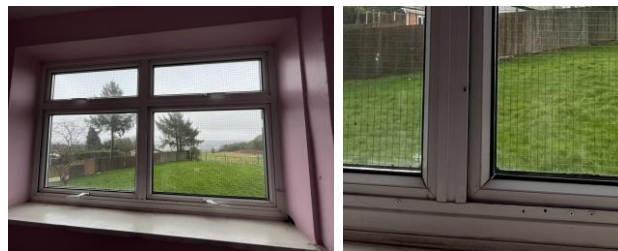
- h) First Floor:** The double window unit on the first floor has been screwed shut. It is recommended that this unit is repaired or replaced in future refurbishment.

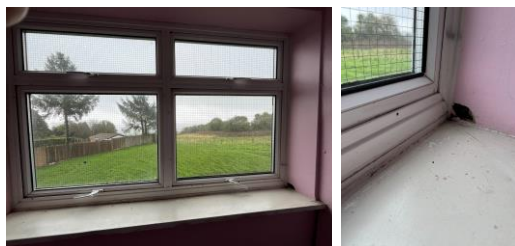
- i) First Floor:** A hole is present on the right-hand side of the windowsill, extending through to the wall cavity. This area requires appropriate fire-stopping measures.

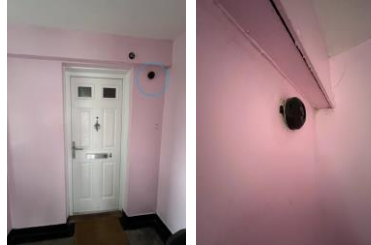
- j) First Floor: Adjacent to Flat 4, there is an old bell box with an opening behind it. This area requires appropriate fire-stopping to restore the integrity of the compartmentation and prevent the potential spread of fire and smoke.**

<p>7/8j</p>	<p>First Floor: Adjacent to Flat 4, there is an old bell box with an opening behind it. This area requires appropriate fire-stopping</p>

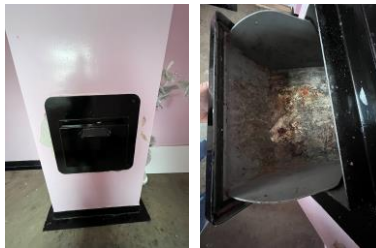
- k) First Floor: The bin chute hopper located adjacent to Flat 10 was inspected and found to be operating correctly at the time of the assessment. All seals were intact, and no defects were observed. Ongoing maintenance and regular checks are essential to ensure the hopper continues to function effectively and does not compromise fire safety within the protected escape route.**

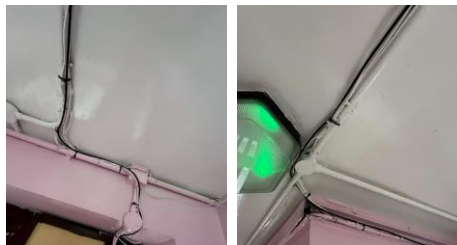
- l) Ground Floor: At ground-floor level, cabling has been fixed to the metal trunking using plastic zip ties. These should be replaced with suitable metal fixings to ensure the cables remain adequately supported in the event of a fire.**

<p>P2</p>	<p>Within 1-3 months Fire Rapid Response</p>	<p>Completed 11/05/2026</p>
<p>7/8l</p>	<p>Ground Floor: Refix cabling with metal ties on the ground floor.</p>

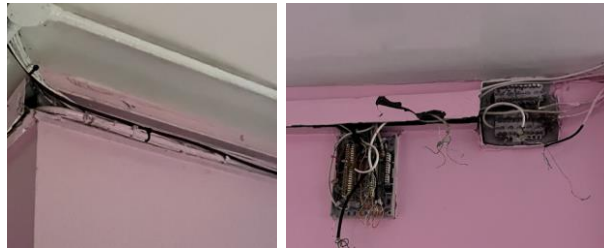
m) Ground Floor: Plastic trunking along the wall is in a poor state and requires repairing. Metal trunking would be a recommended replacement.

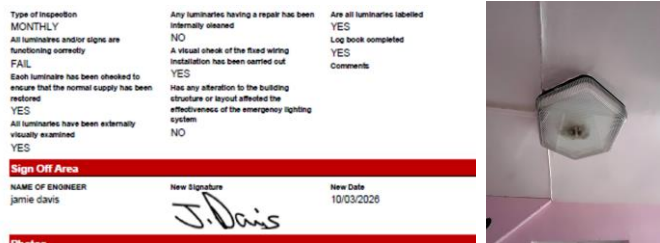
a) One emergency light unit on the ground floor was not working at the time of the Fire Risk Assessment, this had been picked up by CityFire check on the 10th March 2026. Email has been sent to electrical team to follow up on the repair (29/04/2026).

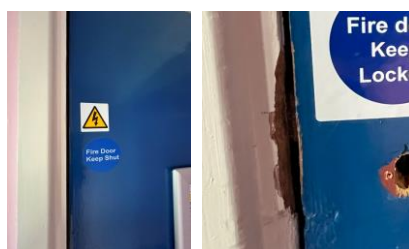
- a) **The service door frame requires a timber splice to address the gap at the point where the deadbolt engages.**

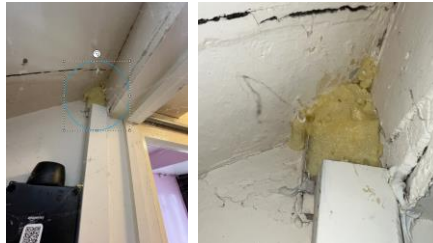
- b) Within the service cupboard that is situated on the ground floor, in the upper right-hand side of the second room, expanding foam has been used as fire-stopping. This material is not suitable for this purpose and must be removed and replaced with appropriate, compliant fire-stopping measures.**

<p>P2</p>	<p>Within 1-3 months Fire Rapid Response</p>	<p>Completed with intu filler 11/05/2026</p>
<p>10/6b</p>	<p>Ground Floor service cupboard: remove the expanding foam within the service cupboard and add appropriate fire stopping</p>

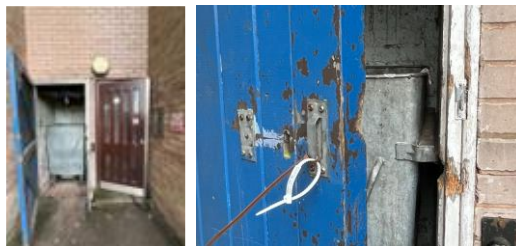
- 3) **The bin room is accessible from outside through a timber door. This door requires a new latch and lock to secure the room.**

<p>P2</p>	<p>Within 1-3 months Fire Rapid Response</p>	<p>Completed and fire stopped 11/05/2026</p>
<p>15/3</p>	<p>Fit new latch and lock to secure the room</p>
