Fire Risk Assessment

13-24

**Blue Rock Place,
Tividale,
B69 1PB**

Date Completed: 15/05/2026

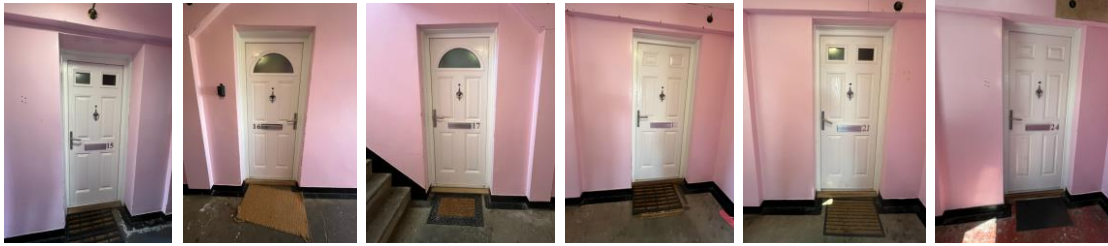
- 4) At a number of flat entrances door mats are present; the fire rating is not known on these door mats and are deemed to be low risk.

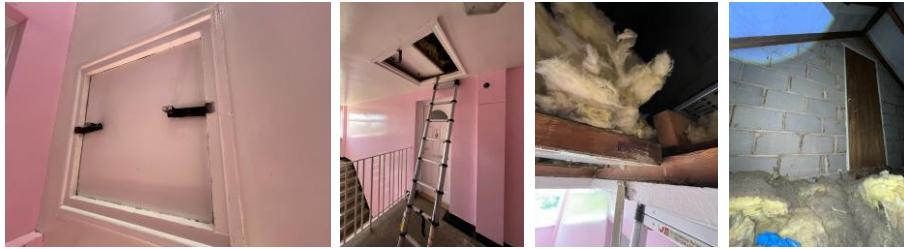
- b) Third Floor:** Access to the roof void is located on the third floor and is provided via a solid timber loft hatch secured with two padlocks. This area was inspected during the Fire Risk Assessment and was found to be fully fire-stopped, incorporating dividing block walls and timber fire doors installed within those partitions. The compartmentation appeared consistent with the requirements for maintaining the integrity of the protected escape route.

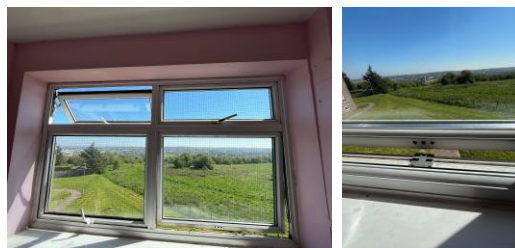
- d) Second Floor:** On the second floor, the double unit was inspected, and all sections were operable except for the bottom right-hand unit, which is missing its handle. As a result, this unit cannot be closed. A replacement handle is required to ensure the ventilation can be properly secured when necessary. *Email sent to asset management and maintenance 29/04/2026*

7/8d	Second floor: Replace missing handle from bottom right hand unit, of the double window unit

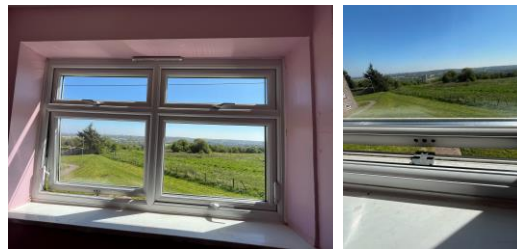
- f) **First Floor: On the second floor, the double unit was inspected, and all sections were operable except for the bottom left-hand unit, which is missing its handle. As a result, this unit cannot be closed. A replacement handle is required to ensure the ventilation can be properly secured when necessary. Email sent to asset management and maintenance 29/04/2026**

P3	Within 3-6 months Repairs	
7/8f	First floor: Replace missing handle from bottom left hand unit, of the double window unit

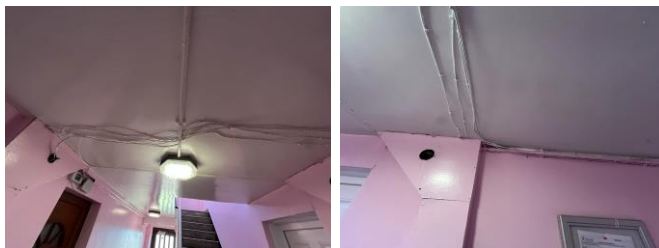
- h)** Ground Floor: At ground-floor level, cabling has been routed above the metal pipework and is currently secured to the ceiling using plastic cable clips. It is recommended that this cabling be enclosed within metal trunking during future refurbishment works to ensure it remains adequately supported and compliant in the event of a fire.

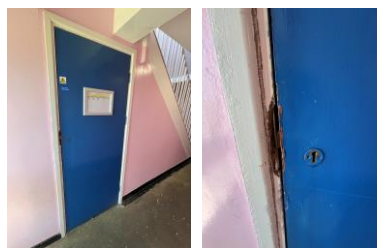
- a) **The service door frame requires a timber splice to address the gap at the point where the deadbolt engages.**

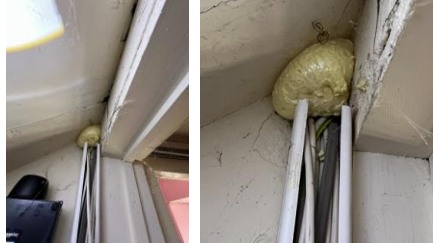
- b) Within the service cupboard that is situated on the ground floor, in the upper right-hand side of the second room, expanding foam has been used as fire-stopping. This material is not suitable for this purpose and must be removed and replaced with appropriate, compliant fire-stopping measures.**

<p>P2</p>	<p>Within 1-3 months Fire Rapid Response</p>	<p>Completed</p>
<p>10/6b</p>	<p>Ground Floor service cupboard: Foam been used within the service cupboard for fire stopping, remove and replace compliant fire stopping</p>

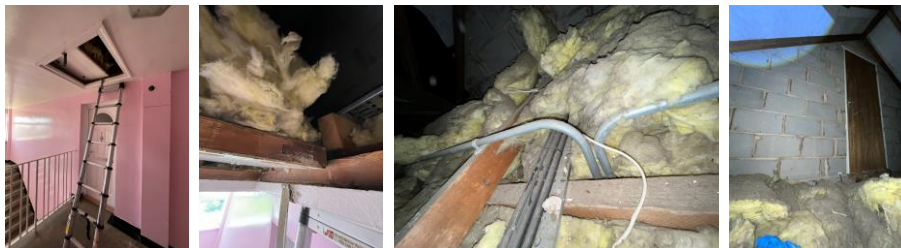
- 7) Individual flat doors appear to be FD30 doors sets. See section 7/2
- 8) On the top floor, access to the loft space is provided via a solid timber loft hatch. The fire rating of this hatch is unknown, and it is recommended that it be upgraded during future refurbishment works. Given that the communal area is maintained as a sterile zone, the current arrangement presents a low level of risk. The loft hatch must remain padlocked at all times. During the Fire Risk Assessment, the loft areas were inspected and found to have appropriate fire-stopping in place throughout the space.

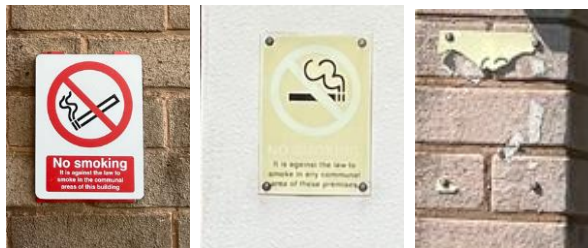
- a) **Couple of No Smoking signs require replacement due to fading and damage. The two locations needing new signage are positioned outside the double entrance doors.**

<p>P2</p>	<p>Within 1-3 months Fire Rapid Response</p>	<p>Completed</p>
<p>12/2a</p>	<p>Entrance doors (external area): Replace 2 No Smoking signs, one has faded and the other damaged. At 2 separate doors</p>
