# Fire Risk Assessment

**1 - 23**

**Monk Close,  
Tipton,  
DY4 7TP**

**Date Completed: 13/10/2025**

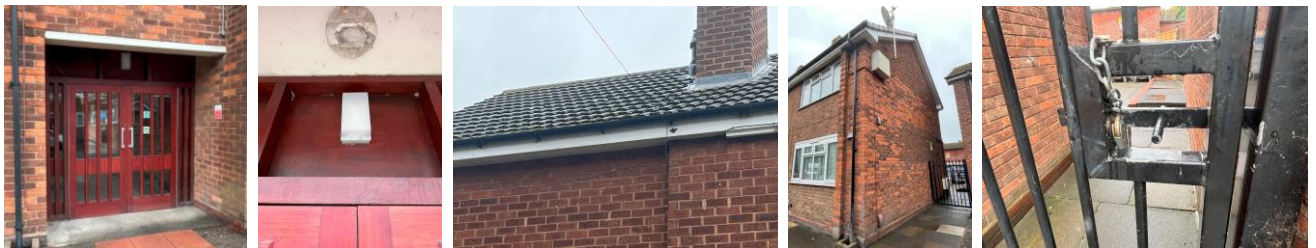
At the front of the premises, the main entrance features double wooden doors with glazed panels. Above the door, there is a security light. This door is not fitted with any locks and is accessible 24/7. Additionally, access to the premises is available via two side gates, which are secured with padlocks to prevent unauthorised entry.

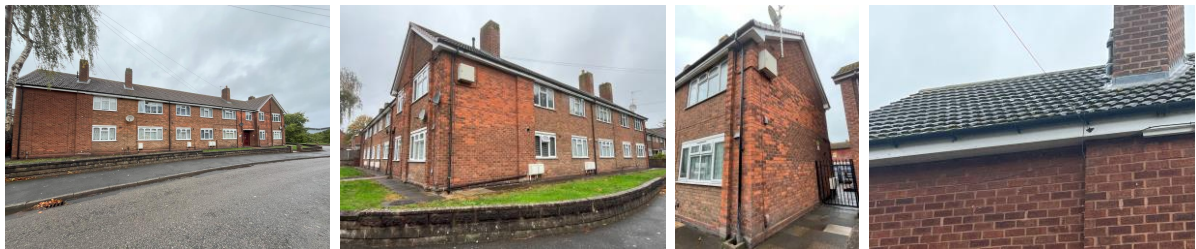
- 1) The external surface of the building is predominantly brick structure with uPVC soffits and fascia. The roof is pitched and fitted with Marley concrete interlocking roof tiles are fitted on the roof.

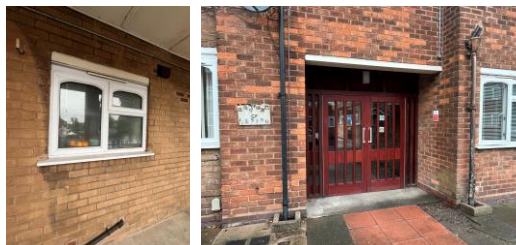
- 2) uPVC double glazed units have been installed to each flat. The main entrance is a timber and glass panelled door and frame, which is set back slightly from the building line. There is a light installed above the door to add safety/security. This door is not locked and accessible 24/7

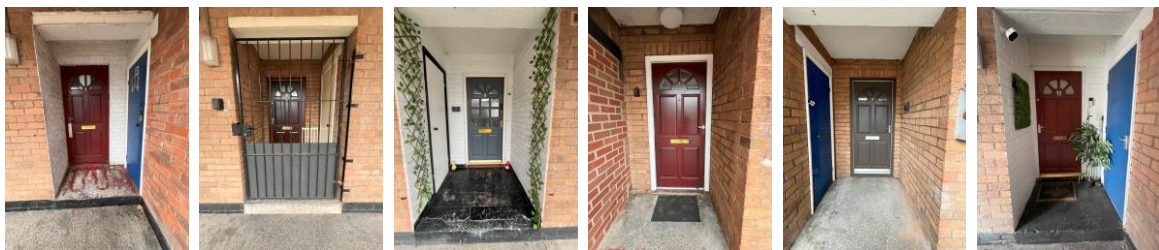
#### Ground floor 1-11

- 1) Each flat should be fitted with a minimum of an LD3 system to allow early warning from fire. See Section 8
- 2) 1<sup>st</sup> floor flats should be fitted with a minimum of a notional FD30 rated door. No access was gained at the time of the fire risk assessment, so cannot conclude if all doors meet the current standards and that any fire safety door furniture is fitted or been tampered with. Ground floor flats lead out into a courtyard so do not have to be fitted with FD30s rated doors.

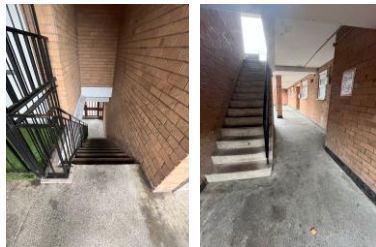
- 10) There is a concrete single stairway leading from the first floor to the final exit. Due to this area being left in darkness during dusk, **fit a light on the stairway route to assist.**

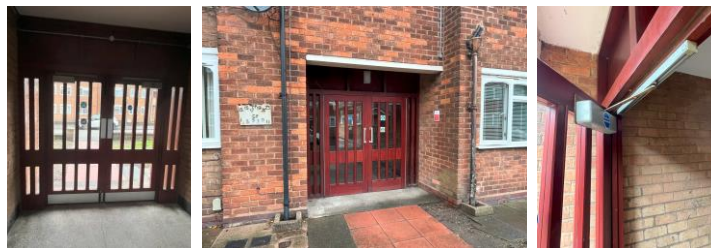
- 11) Final exit doors do not have any locking mechanisms fitted, so are opened by pushing them. They lead directly out on to Monk Close. The doors and frame are timber construction with glass panels and are fitted with self-closers. Above the roadside of the door a light is fitted to assist with safety/security.

The final exit door is not lockable. Lock system to be fitted to this door to prevent unauthorised access.

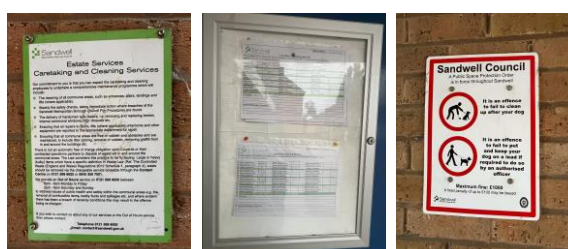
- 12) Communal areas are kept free of flammable items. The communal areas are checked on a regular basis by Caretaking / Cleaning teams 365 days per year and all items of rubbish are immediately removed. There is also an out of hour's service that allows combustible items of furniture / rubbish to be removed.

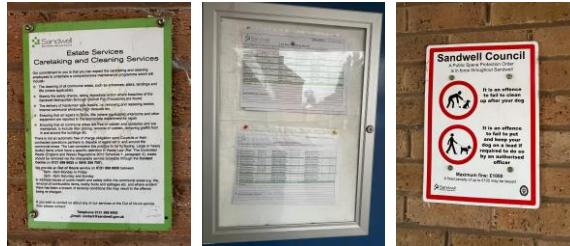
- 1) There is a regular Cleaning Service to the premises carried out by caretakers to minimise risk of waste accumulation.

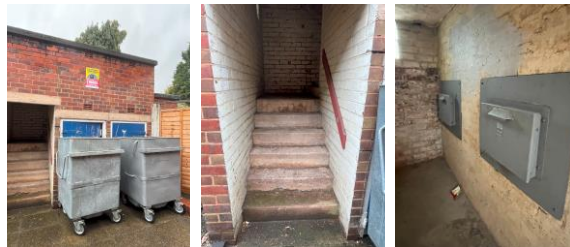
- 2) The refuse bins are located to the rear of the main building, next to a purpose-built bin room. The bins are kept outside due to being too big for the room.

The bin room also has a chute system but is not used due to the bins being located outside.

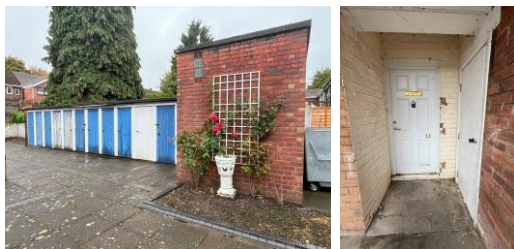
- 1) Residents instructed not to bring L.P.G cylinders into block.
- 2) The tenancy conditions, Section 7 – Condition 5.6 stipulates “If you live in a flat or maisonette, you, people living with you and any visitors to your property must not keep or use paraffin oil, petrol, bottled gas appliances or any other explosive, FLAMMABLE or dangerous material in the property. This restriction also applies to any storage facility situated in or attached to the block, which has been provided for your use.”
- 3) Residents should not store flammable liquids or gas cylinders on site.
- 4) No Flammable liquids stored on site by Caretakers / Cleaners.
- 5) Residents have individual storage cupboard internally and externally which they keep secured by means of own keys.
