Fire Risk Assessment

Macauley House

**Glover Street,
West Bromwich, B70 6DY**

Date Completed: 05th December 2025

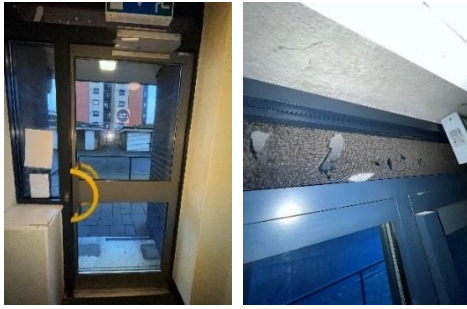
- 10) There's a ventilation grill installed above the rear exit door.

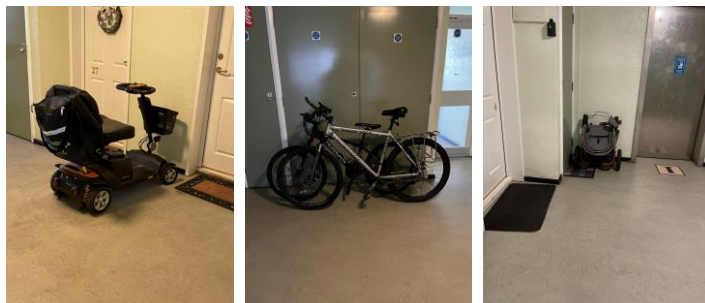
- 14) Items of personal storage were noted on means of escape in several locations. These were 7th floor, 5th floor and 1st floor. These items should be removed; the means of escape should be a sterile area.**

Question/ Ref No	Required Action	Supporting photograph	Priority	Timescale and Person Responsible	Date Completed
07/14	Items of personal storage were noted on means of escape in several locations. These were 7 th floor, 5 th floor and 1 st floor. These items should be removed; the means of	   	P2	Housing Manager 1-3 Months

escape should be a sterile area.				
07/18	It was noted on the ground floor that paint had started to peel in several areas. These should be scraped and repainted with appropriately rated materials.

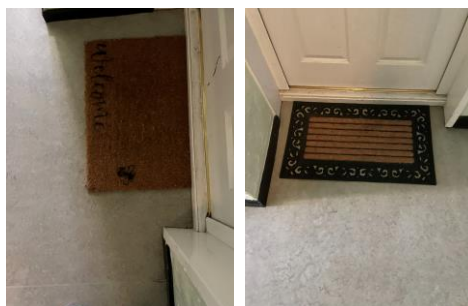
- 15) Individual floor mats were noted outside some flats. Fire rating of the mats is unknown but deemed to be of low risk.**

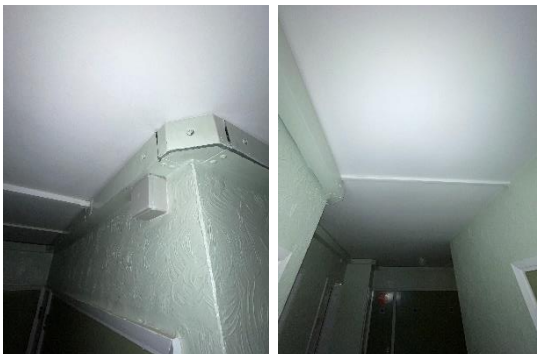
- 22) Ideally, plastic trunking should not be used in common areas and means of escape. As per the 18th edition electrical regulations confirmation is required that secure metal clips/fixings have been used to ensure cables are not released in a fire situation.

P3	Repairs 3-6 Months	
07/22	Ideally, plastic trunking should not be used in common areas and means of escape. Confirmation is required that secure metal clips/fixings have been used to ensure cables in plastic trunking are not released in a fire situation.

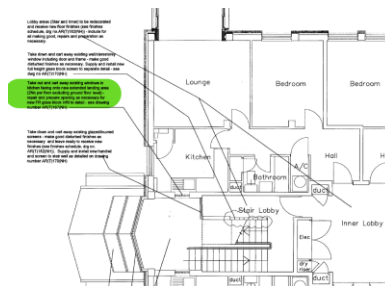
- 13) The seal on the chute hopper in the 8th floor chute room needs to be replaced as this has perished and ineffective.

P2	Electrical 1-3 Months	
10/13	The seal on the chute hopper in the 8 th floor chute room needs to be replaced as this has perished and ineffective.

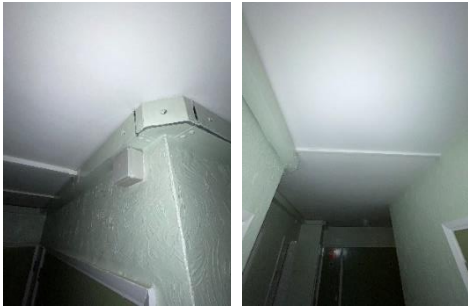
- 19) Cabling is generally housed in metal trunking however, small amounts of plastic trunking noted in the building's stairwell and corridors near lift motor room.
