Fire Risk Assessment

Holly Court

**Acacia Avenue, Yew Tree Estate,
WS5 4BN**

Date Completed: 05/03/2026.

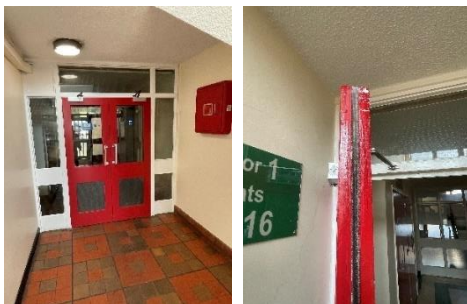
- 2) All corridors are of adequate width (at least 1050mm) and will be maintained clear to that width as a minimum.
- 3) There are no single travel condition corridors or dead end situations in the building.
- 4) The means of escape are protected to prevent the spread of fire and smoke by means of notional fire doors.
- 5) The communal landing / staircases are protected by use of self-closing 44mm notional 30-minute timber fire doors with vision panels. All doors have been upgraded with intumescent strips / cold smoke seals.

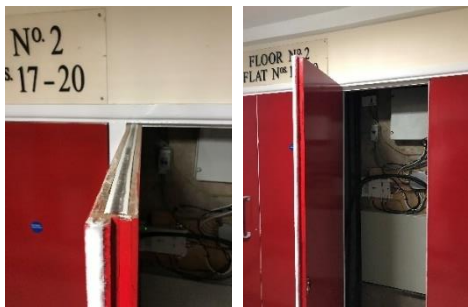
Also, all service cupboards in lift lobbies are secured with budget style locks which are failing to secure the fire doors correctly therefore these locks should be replaced with suited mortice locks.

- 21) Service/electrical cupboards with lobby areas are notional 44mm 30-minute fire doors, secured with plastic budget locks through the majority of the block.

P2	Fire Rapid Response 1-3 Months	
07/10	Remove & replace old plastic locks on electrical cupboards & dry riser doors, these should be fitted with suited mortice (138 key) & (054 key) locks to prevent unauthorised access. The old plastic meter type lock are not fit for purpose and should be removed. All residents to be provided with a 138 key to access individual meters.

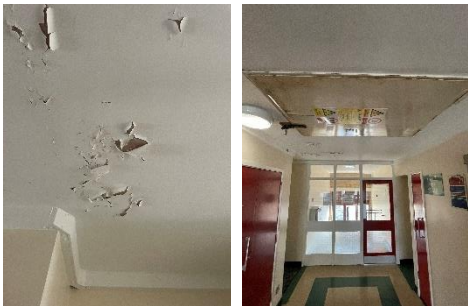
- 31) It was noted on the top floor that paint had started to peel in several areas. This area should be scraped and repainted with appropriately FR rated materials.

07/31	It was noted on the top floor that paint had started to peel in several areas. This area should be scraped and repainted with appropriately FR rated materials.

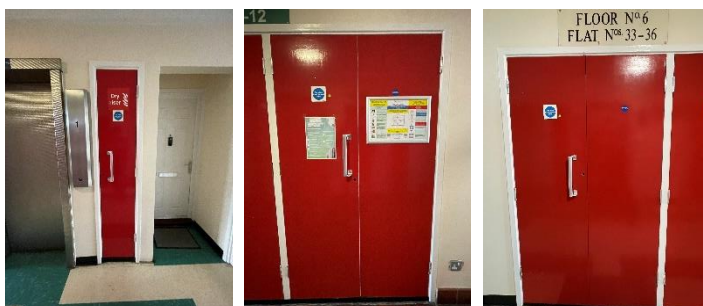
- 4) All communal fire doors are subject to a 12-week check by the Fire Safety Rapid Response Team.
- 5) All service cupboards to communal landings are notional fire doors with a minimum of 30 minutes fire resistance, secured with budget locks.

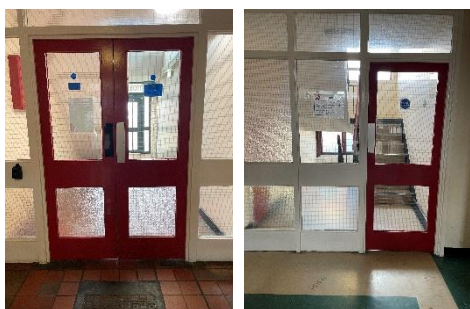
- 6) It was noted that the majority of staircase doors complete with side panels and service doors are at the end of life. These were found to be poorly fitted, warped & twisted. When any future refurbishment of the building takes place, all doorsets should be replaced. See section 7/7.

- 7) The communal landing & staircases are protected by use of notional self-closing 44mm 30-minute timber fire doors with vision panels & 25mm stops. (see point above).

- 7) **Therefore, as an interim measure and to improve the function of staircase doors, these will be upgraded to include re lipping, re aligning, removing old bat wings and oversized strips. Replace with new combined strips, new hinges and self-closers where necessary.**
- 8) **Replace missing beading on the staircase door outside flat 24. (Lower vision panel).**

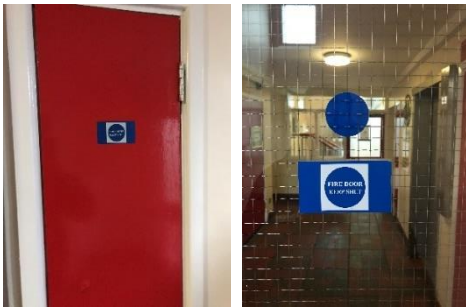
- 1) All fire doors display “Fire Door Keep Shut” & “Fire Door Keep Locked” where appropriate, communal cupboard doors display fire door keep shut signs rather than fire door keep locked signage however this is considered a trivia risk.

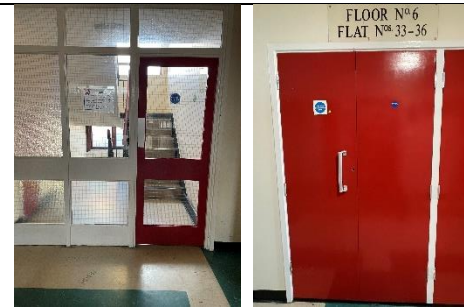
It was noted that the majority of staircase doors complete with side panels and service doors are at the end of life. These were found to be poorly fitted, warped & twisted. When any future refurbishment of the building takes place, all doorsets should be replaced.

As an interim measure all staircase doors will be upgraded by the Fire Rapid Response Team.
