Fire Risk Assessment

Alfred Gunn House

**Thompson Road,
Oldbury, B68 8RW**

Date Completed: 23rd April 2026

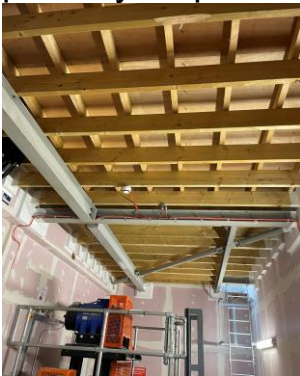
- 1) The timber flat roof covering the lift motor room and timber floor covering to the plant room should be considered, as part of a future works programme, for having the combustibility rating of these elements improved by the application of an intumescent paint by a specialist contractor. See observations section 19.

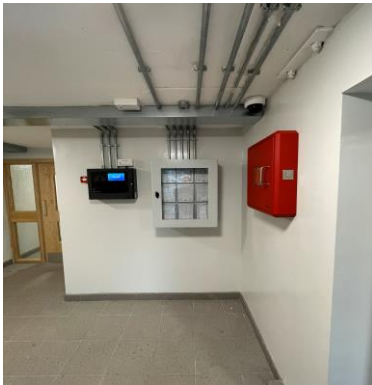
Both lifts come to ground on activation of this alarm. The alarm panel is presently only indicating an ignition on floor 10 and requires re programming. Fire Alarm Engineer currently rectifying situation.

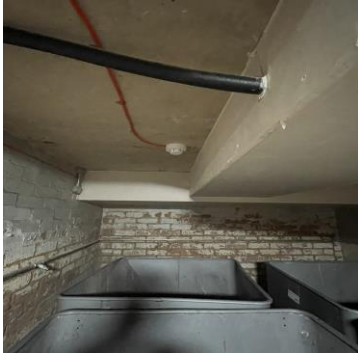
- 5) A deluge system is provided to the refuse chute bin store. An approved contractor maintains the system. The frequency for the maintenance checks is twice per year (April and October) of each calendar year. The newly installed fire stopping (boarded construction creating a down stand) has resulted in the smoke detection, which operates the deluge system, being within 300mm of the down stand. **Smoke detection to be re positioned (relates to both bin rooms).**

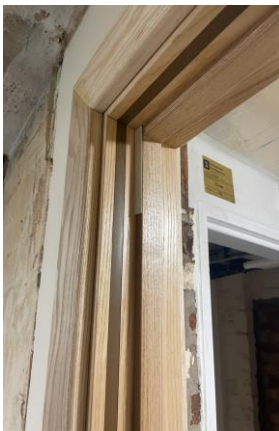
11) Smoke seals are required to lift lobbies at Lower Ground Floor Level.

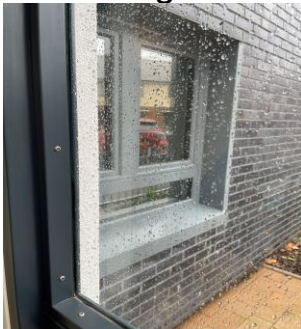
15) Glazing between the flatted accommodation/ lower ground floor and the staircase is in proximity. The fire engineer has verbally confirmed this situation is acceptable. Fire strategy awaited confirming this.

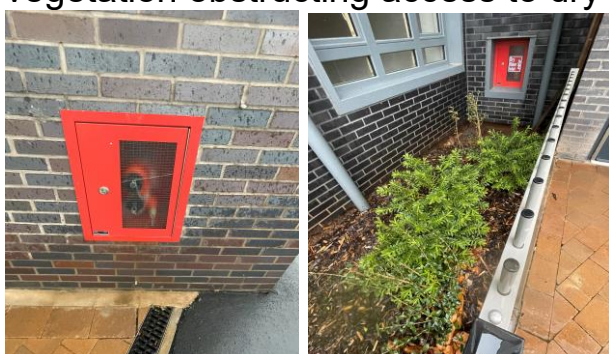
- 1) The building has two dry risers located at the front of the building. Identified as A and B internally to aid firefighting operations. Keys for the dry riser inlet are located within the secure premise information box. Estate services have agreed to remove the vegetation obstructing access to dry riser A.

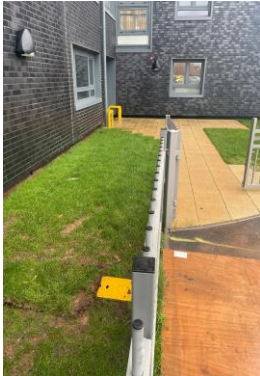
- 8) Rear hydrant is now redundant and therefore should be removed/covered to avoid confusion of firefighters. WMFS have been notified.

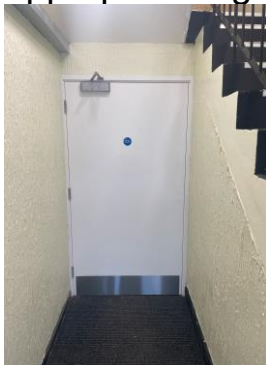
- 10) The door into the lower ground floor from staircase B cannot be opened staircase side. Building Safety Manager has confirmed appropriate signage is to be installed.

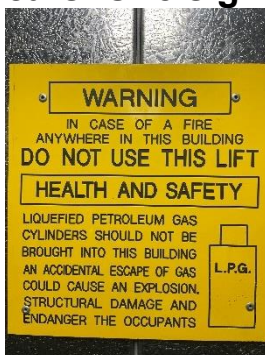
- 3) Yellow LPG warning signs are not displayed within the lift cars. One sign required in each lift.

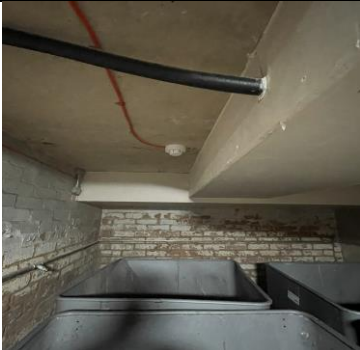
Question/ Ref No	Required Action	Supporting photograph	Priority	Timescale and Person Responsible	Date Completed
8/5	Smoke detection within both bin rooms to be repositioned as within 300mm of down stand.

P2	Urban Design 1-3 Months

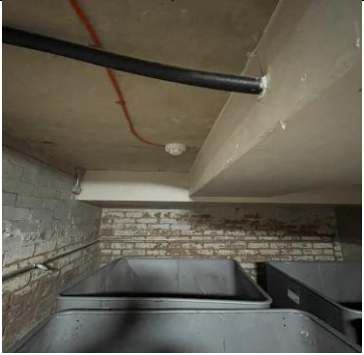
10/2	Confirmation required of fire resistance of fire stopping within Bin rooms (Boarded Construction with fixings exposed)
