Fire Risk Assessment

Mountford House

**1-66, Glover Street,
West Bromwich, B70 6DS**

Date Completed: 01/12/2025

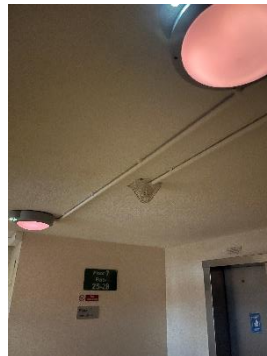
- 2) The self-contained units are provided to the communal landings, stairs, and lift motor room.
- 3) **The lighting in the lift lobby on the 7th floor was not fully operational and requires rectification. See action 9/3.**

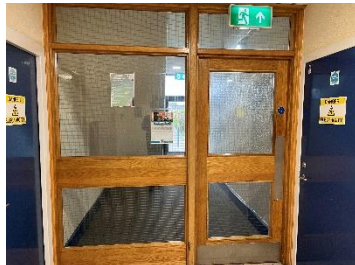
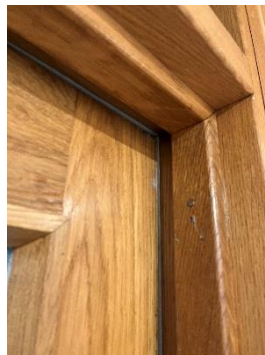
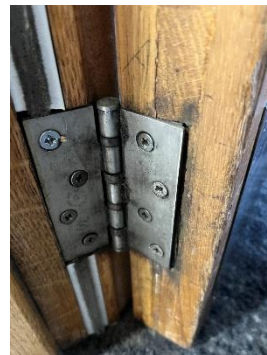
- 6) Service cupboards to the ground floor containing the gas and water risers are nominal 54mm timber FD60 doors secured with a suited 54 key mortice lock. The ground floor lobby fire door leaf separating the lift lobby from the stairwell fails to close into its frame correctly. This door leaf has loose fixing screws at the middle and lower hinge sets and requires adjustment for the leaf to close into the frame correctly. See action 10/6

P2	Electrical. 1 – 3 months.	
10/6	The ground floor lobby fire door leaf separating the lift lobby from the stairwell, fails to close into its frame correctly. This door leaf has loose fixing screws at the middle and lower hinge sets and requires adjustment for the leaf to close into the frame correctly.

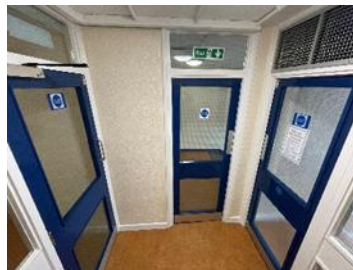
- 9) The communal corridors, landings & staircases from the first floor up, are protected by use of notional self-closing 44mm 30-minute timber fire doors with vision panels and 25mm rebates. It is recognised that these doors do not meet today's benchmark of a certified FD30s fire door install.

However, because they were installed at the time of the building's construction and to the standard of that time, they are deemed as acceptable so long as the doors are free of damage and function as they were intended to do so. It has been recognised that all the corridor, landing / staircase notional doors in this block have been upgraded with combined intumescent strips & cold smoke seals to enhance their original design and minimise departures from today's standards.

Some communal notional fire doors show signs of wear and tear due to age. Consideration should be given to upgrade with certified FD30s door sets & combination frames as part of a future programme.
