# Fire Risk Assessment

## Braybrook House 356-422

**Moor street, West Bromwich,  
B70 7AU.**

**Date Completed:** 6th January 2026

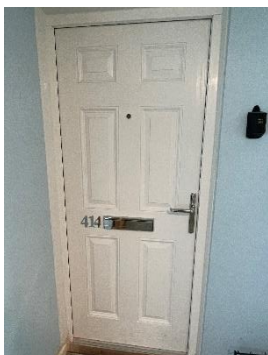
- 1) Individual flat entrance doors are predominately nominal FD30S timber fire doors. Door 414 is a composite door.

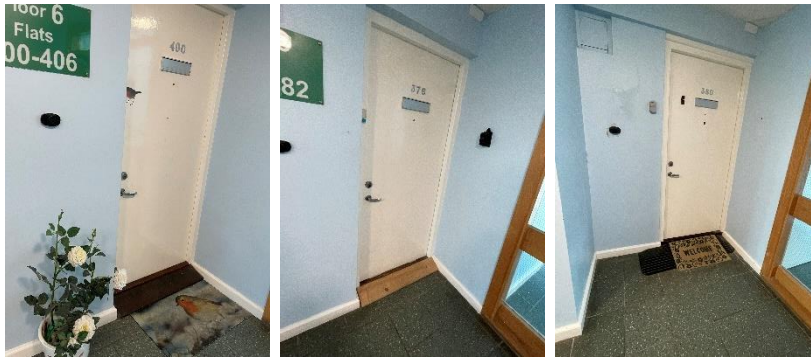
- 4) Ramps were noted outside flats 400, 376, 364. The ramps have been installed by the tenants who rely on mobility aids to assist passage over the threshold. It is deemed the ramps represent a sufficient low risk.

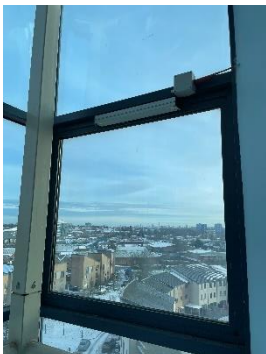
- 16) Glazing noted within 1.8m of staircase. Sprinkler roll out programme should therefore be considered as part of future refurbishments. (Recommended in section 19 Observations)

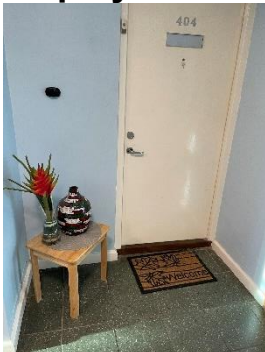
- 22) 6<sup>th</sup> floor lift lobby – Table with vase and artificial plant displayed outside flat 404 in lift lobby.**

| 7/22 | Remove table, vase & artificial plant from outside flat 404 communal area | | P3 | Within 3-6 Months<br>Housing Manager | |

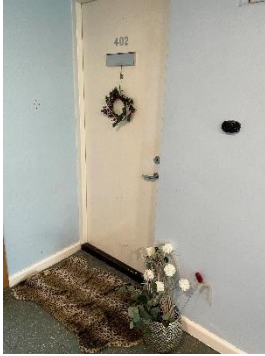
- 23) 6<sup>th</sup> floor lift lobby – Artificial plants in pot displayed outside flat 402. Also, there's a small rug which potentially could cause a trip hazard during evacuation or firefighting procedures. It is recommended that the rug should be replaced with a suitable door mat. A small Christmas wreath was also noted attached to the flat door; it presumed this item will be removed by the tenant following the festive period.**

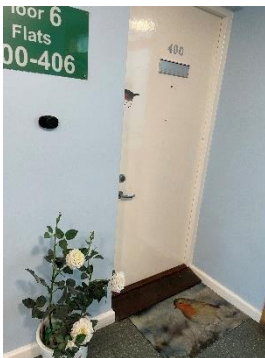
- 24) 6<sup>th</sup> floor lift lobby - Artificial plant in pot displayed outside flat 400.**

| 7/24 | Remove artificial plant from outside flat 400 communal area. | | P3 | Within 3-6 Months<br>Housing<br>Manager | |

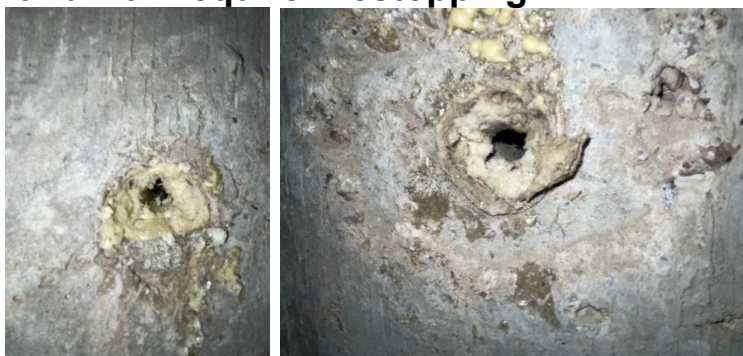
- 5) **Two small holes in the ground floor service cupboard left hand wall require firestopping.**

| 10/5 | Ground floor service cupboard – fire stop 2 small holes in left hand wall. | | P2 | Within 1-3 months<br>Rapid Fire Team | |

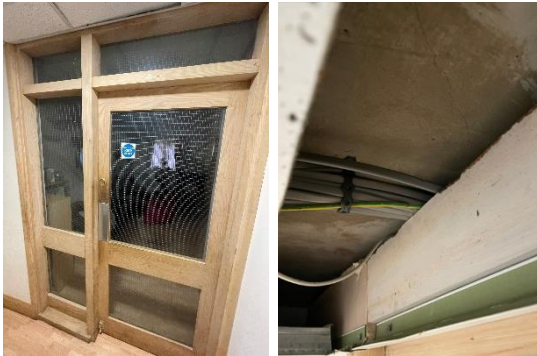
- 6) Fire stopping is required above the community room fire doors.

| 10/6 | Firestop above fire door in community room using suitable products and method. | | P2 | Within 1-3 months<br>Rapid Fire Team | |

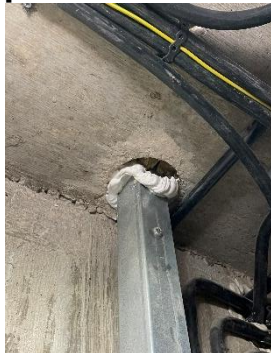
- 7) Intumescent mastic applied to a 3rd floor service cupboard penetration has moved and will need to be reapplied.

| 10/7 | 3 <sup>rd</sup> floor service cupboard. Remove and replace intumescent mastic which has moved. | | P2 | Within 1-3 months<br>Rapid Fire Team | |

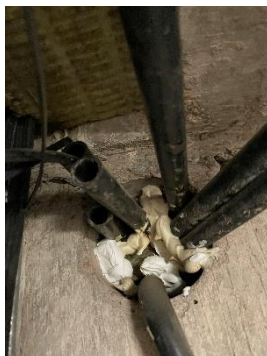
- 8) A variety of methods / materials have been used to achieve fire-stopping including intumescent mastic, intumescent sponge and mineral wool. **It is recommended that all fire stopped penetrations in service cupboards on all floors are, where possible, enhanced further with ablative batt, installed as per the manufacturer's application instructions.**

| 10/8 | Where possible enhance all fire stopped penetrations in all service cupboards with ablative batt or other suitable product. | | P2 | Within 1-3 months<br>Rapid Fire Team | |

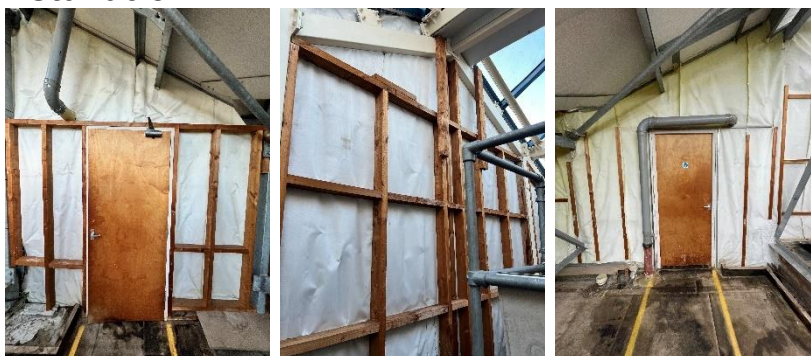
- 20) A steel frame pitched roof was added to the building during extensive refurbishment works in 2000. The steel frame is fixed to perimeter blockwork and steels. Compartment lines continue up into the roof void in the form of fire curtains fixed to timber studwork. The fire curtains are not fixed to both sides of the studwork leaving exposed timber. **It is has been discussed with the Team Lead for Building Safety that a qualified fire engineer should be appointed to assess the suitability of the installation.**

| 10/20 | Appoint a suitable contractor / fire engineer to assess the fire curtains and exposed studwork forming compartment lines in roof void. | | P4 | Programmed Work<br>Head of Building Safety & Compliance | |

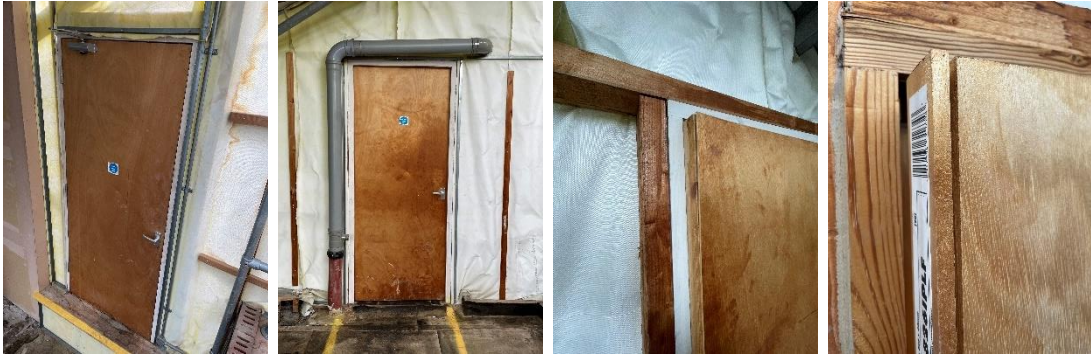
- 21) Nominal fire doors have been installed within the fire curtain walls to the roof void. All 6 doors fit poorly; lipping's have come away and appear to have swollen. It is likely they have been affected by fluctuations in temperature and moisture due to exposure to direct sunlight and heat from the installed solar thermal system. **Therefore, all 6 doors should be replaced with external grade FD30s timber fire doors with self-closing devices and mandatory signage. Door stops should be considered when openings foul pipework**

| 10/21 | Replace all 6 fire doors installed in roof void fire curtain wall with external grade self-closing FD30s (Where necessary install door stops) | | P4 | Programmed Work<br>Asset Management | |

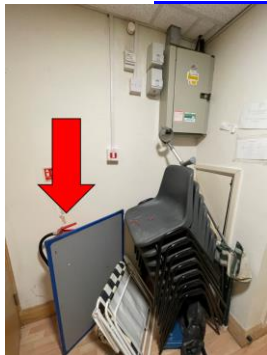
- 6) The fire extinguisher in the community room entrance is not easily accessible due to the storage of chairs. This has been raised as an action in [section 18](#).

| 18/6 | All items to be cleared from community room entrance hall which form the means of escape. | | P2 | Within 1-3 Months<br>Housing Manager | |

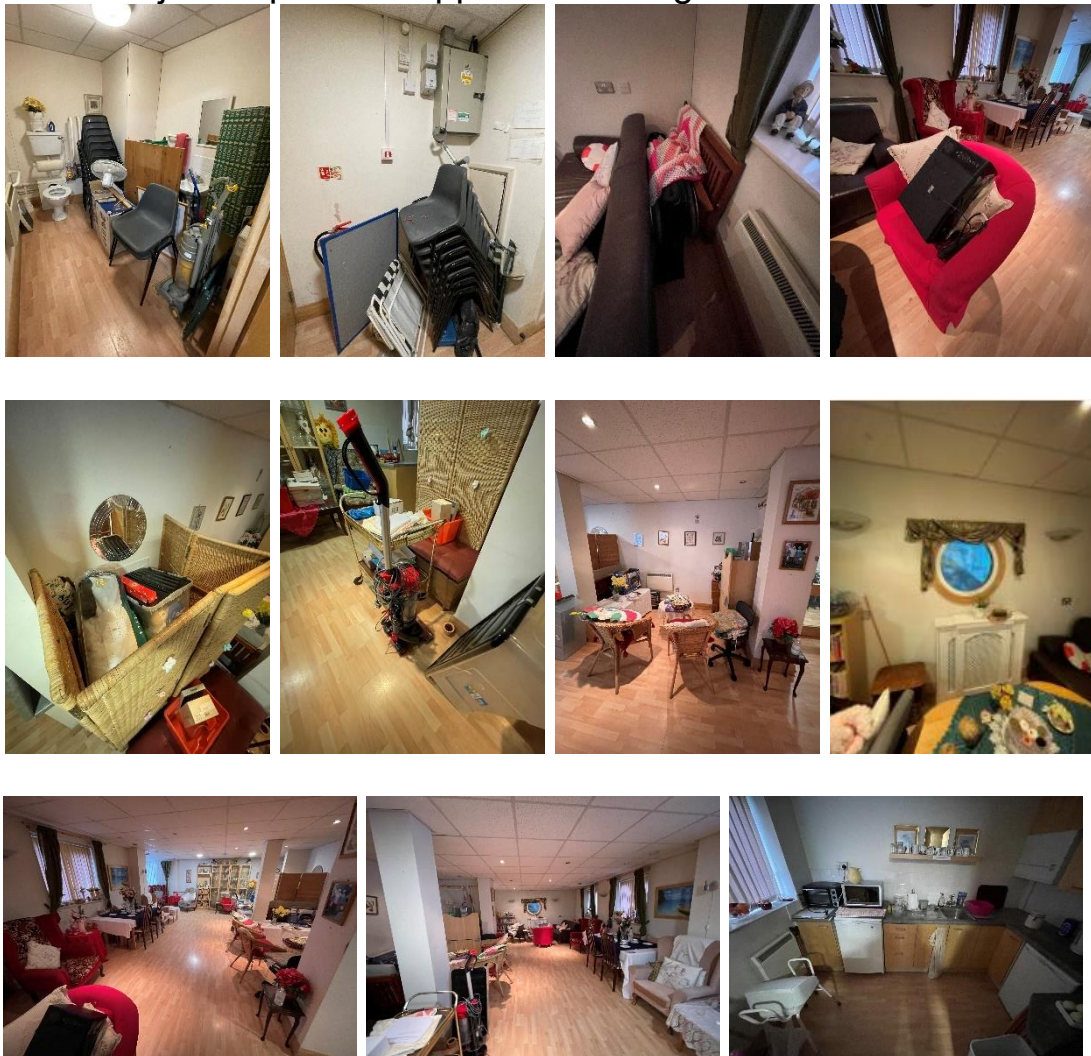
- 7) It appears a large number of personal items to include furniture; fabrics & home appliances have been introduced to the community room. Because the safety, ignitability and combustibility of such items is unknown, there's the potential for excessive fire loading.

It is recommended that the Housing Officer, Resident Engagement Officer (fire) and Building Safety Manager, consult with residents to reduce & remove the storage of unnecessary items specifically any soft furnishings that do not conform to the relevant British Standards (BS7176). This recommendation has been recorded in observations and brought to the attention of key stakeholders.

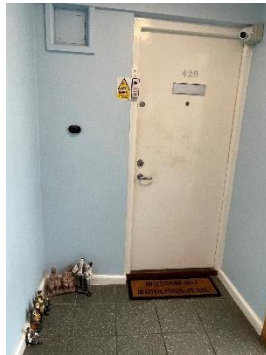
| Question/<br>Ref No | Required Action | Supporting photograph | Priority | Timescale and<br>Person<br>Responsible | Date<br>Completed |
|---|--|---|---|--|---|
| 7/19 | Flat 420, remove<br>ornaments from<br>communal area. | | P3 | Within 3-6<br>Months<br>Housing<br>Manager | |

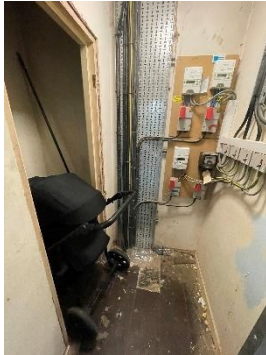
| 7/20 | Remove pushchair from 7 <sup>th</sup> floor service cupboard adjacent flats 408, 410, 412, 414. | | P3 | Within 3-6 Months<br>Housing Manager | |

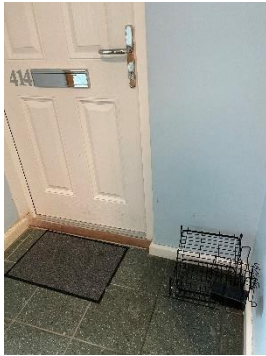
| 7/21 | Remove metal rack from outside flat 414 communal area. | | P3 | Within 3-6 Months<br>Housing Manager | |

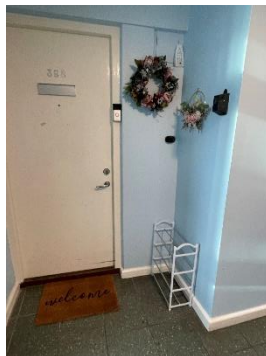
| 7/25 | Remove wreaths and shoe rack from outside flat 398 communal area. | | P3 | Within 3-6 Months<br>Housing<br>Manager | |

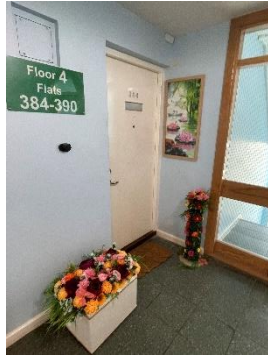
| 7/26 | Remove 2 x artificial flower arrangements and artwork displayed outside flat 384 communal area. | | P3 | Within 3-6 Months<br>Housing Manager | |

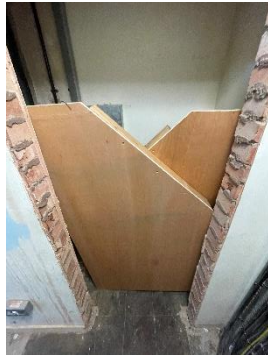
| 7/27 | 4 <sup>th</sup> floor service cupboard – remove plywood boards | | P2 | Within 1-3 months<br>Caretakers | |

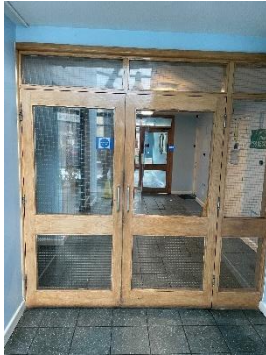
| 10/14 | Ground floor doors / front staircase – reduce gap between doors. | | P2 | Within 1-3 months<br>Rapid Fire Team | |

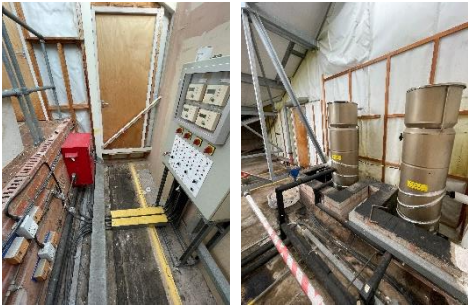
| 14/7 | There are no service records available for the servicing and maintenance of Solar Equipment provided for this building. A robust servicing and maintenance programme should be implemented for this equipment. | | P4 | Programmed Work<br>Electrical Compliance Manager. | |
