# Fire Risk Assessment

## Braybrook House 356-422

**Moor street, West Bromwich,  
B70 7AU.**

**Date Completed:** 6th January 2026

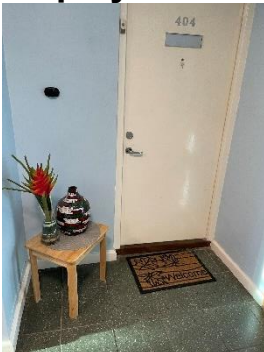
- 22) 6<sup>th</sup> floor lift lobby – Table with vase and artificial plant displayed outside flat 404 in lift lobby.**

P3	Within 3-6 Months Housing Manager	
7/22	Remove table, vase & artificial plant from outside flat 404 communal area

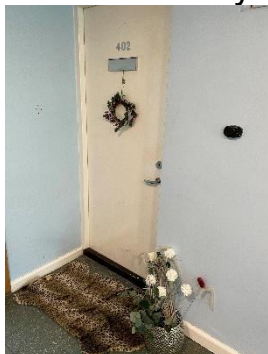
- 23) 6<sup>th</sup> floor lift lobby – Artificial plants in pot displayed outside flat 402. Also, there's a small rug which potentially could cause a trip hazard during evacuation or firefighting procedures. It is recommended that the rug should be replaced with a suitable door mat. A small Christmas wreath was also noted attached to the flat door; it presumed this item will be removed by the tenant following the festive period.**

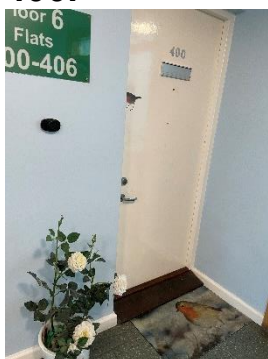
- 24) 6<sup>th</sup> floor lift lobby - Artificial plant in pot displayed outside flat 400.**

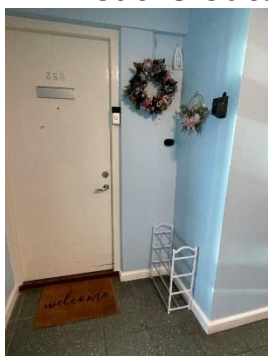
- 25) 5<sup>th</sup> floor lift lobby – A shoe rack & artificial flowers displayed in wreaths outside flat 398.**

P3	Within 3-6 Months Housing Manager	
7/25	Remove wreaths and shoe rack from outside flat 398 communal area.

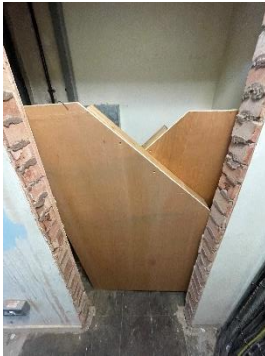
- 27) Ply wood boards stored in 4<sup>th</sup> floor service cupboard to be removed.**

P3	Within 3-6 Months Housing Manager	
7/27	4 <sup>th</sup> floor service cupboard – remove plywood boards

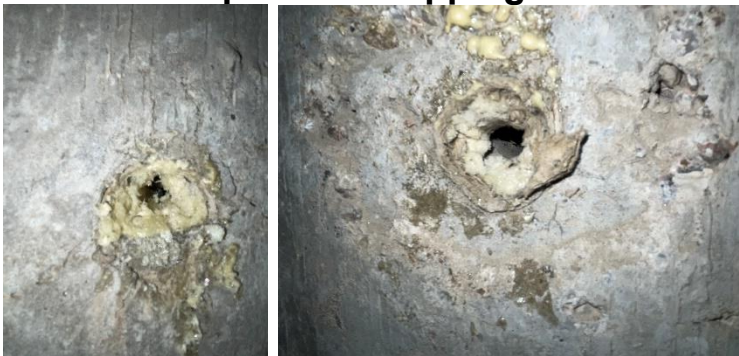
- 5) **Two small holes in the ground floor service cupboard left hand wall require firestopping.**

P2	Within 1-3 months Caretakers	
10/5	Ground floor service cupboard – fire stop 2 small holes in left hand wall.

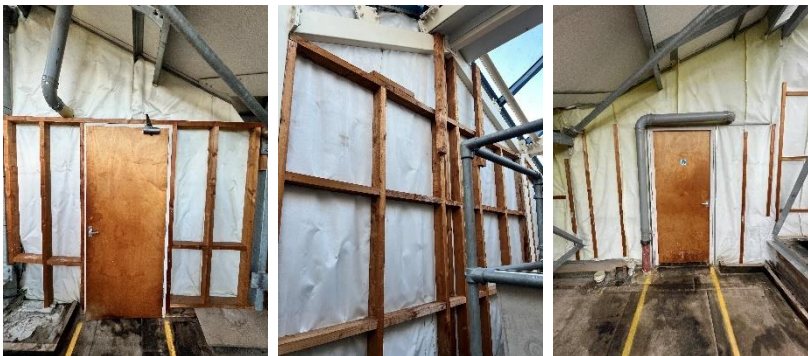
- 20) A steel frame pitched roof was added to the building during extensive refurbishment works in 2000. The steel frame is fixed to perimeter blockwork and steels. Compartment lines continue up into the roof void in the form of fire curtains fixed to timber studwork. The fire curtains are not fixed to both sides of the studwork leaving exposed timber. **It is has been discussed with the Team Lead for Building Safety that a qualified fire engineer should be appointed to assess the suitability of the installation.**

P2	Within 1-3 months Rapid Fire Team <b>JM18695201</b>	27/01/2026
10/20	Appoint a suitable contractor / fire engineer to assess the fire curtains and exposed studwork forming compartment lines in roof void.

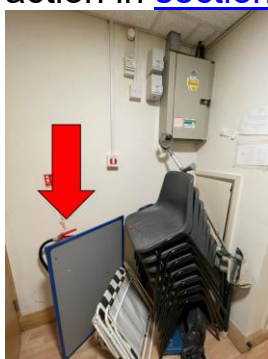
- 6) The fire extinguisher in the community room entrance is not easily accessible due to the storage of chairs. This has been raised as an action in [section 18](#).

P4	Programmed Work Electrical Compliance Manager.	
18/6	All items to be cleared from community room entrance hall which form the means of escape.

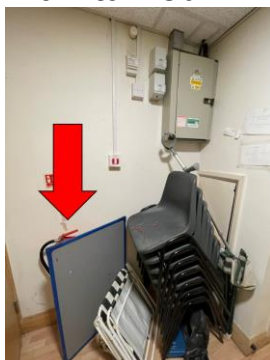
- 7) It appears a large number of personal items to include furniture; fabrics & home appliances have been introduced to the community room. Because the safety, ignitability and combustibility of such items is unknown, there's the potential for excessive fire loading.

It is recommended that the Housing Officer, Resident Engagement Officer (fire) and Building Safety Manager, consult with residents to reduce & remove the storage of unnecessary items specifically any soft furnishings that do not conform to the relevant British Standards (BS7176). This recommendation has been recorded in observations and brought to the attention of key stakeholders.
