# **Fire Risk Assessment**

## **Beaconview House**

**Beaconview Road, West Bromwich,  
B71 3PL**

**Date Completed: 13/02/2025**

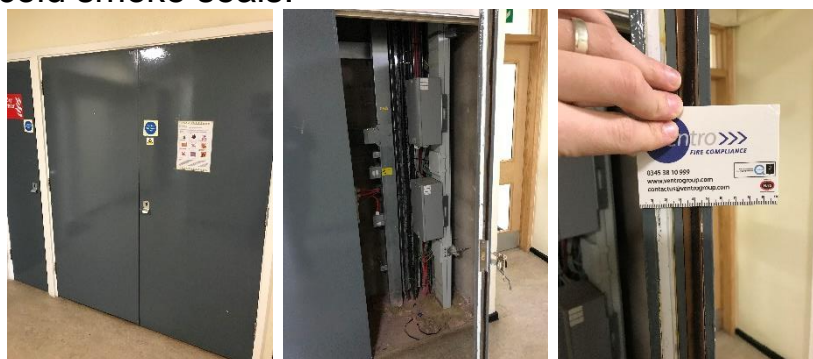
- 13) Noted the use of expanding foam was present within the communal cupboards around cabling as part of the fire stopping knowing that intumescent pads and a concrete slab is present and this foam is only used as an enhancement it is deemed acceptable. This should be enhanced as part of future works to the building and replaced with intumescent mastic to improve fire stopping.

The use of expanding foam was present within the communal cupboards around cabling as part of the fire stopping, knowing that intumecent pads and a concrete slab is present and this foam is only used as a enhancment it is deemed tolerable. This should be enhanced as part of future works to the building and replaced with intumecent mastic to imporve fire stopping. Noted that no detection was present within the main office area and the small office/ storeroom. Due to the occupancy/use, multiple escape routes and items stored within this is a tolerable risk however when upgrades take place at the block consideration should be made to introduce fire detection within these areas.

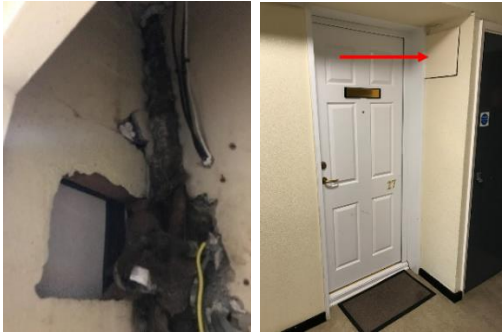
- 15) It was noted that metal trunking had been utilised to house cabling in communal areas
