Fire Risk Assessment

Beaconview House

**Beaconview Road, West Bromwich,
B71 3PL**

Date Completed: 4th February 2026

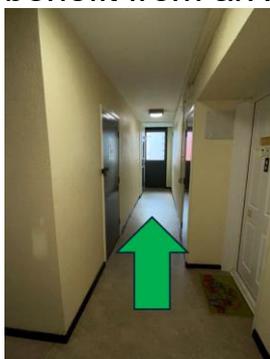
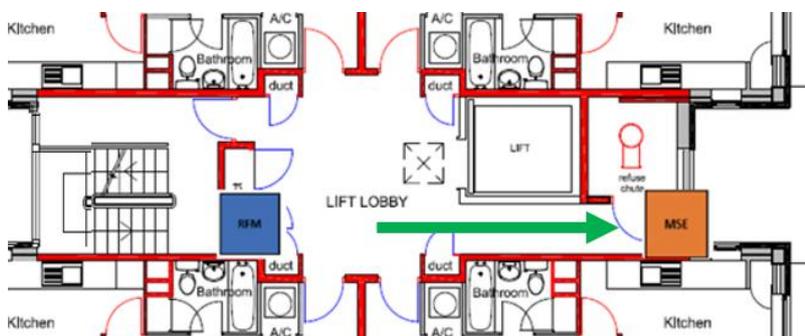
- 6) There are dead end corridors on all floors from the 1st to 8th. The dead end corridors are between the lift lobbies and the chute room. All are approximately 1050mm wide, 5.6 metres long and benefit from an Automatic Opening Vent therefore are acceptable.

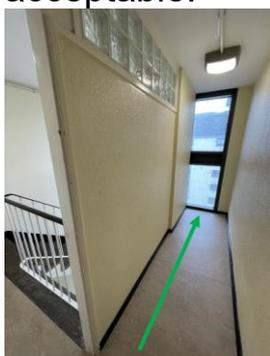
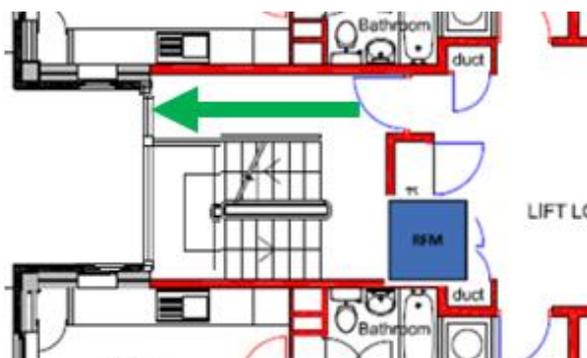
- 7) There is a further dead end corridor situation on all floors within the stairwell. The stairwell is protected with automatic opening vents, and each dead end is less than 4 metres therefore deemed acceptable.

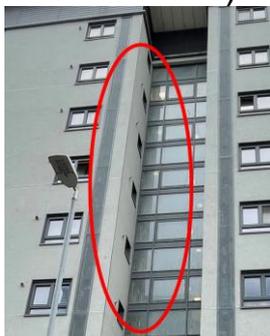
- 16) Glazing for kitchen windows in flats noted within 1.8m of staircase. Sprinkler roll out programme should therefore be considered as part of future refurbishments. (Recommended in section 19 Observations).

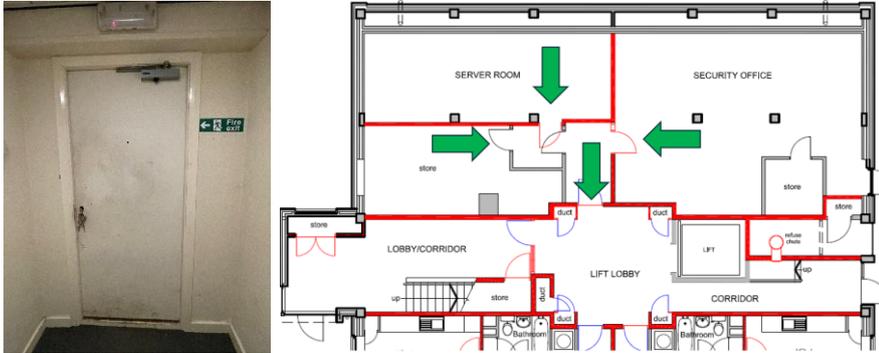
20) The entrance door serving as a fire exit door from the caretakers welfare room, store room and server room corridor is lockable. Therefore, escape via this exit may be compromised if the door was locked by someone exiting one of the rooms. A “break glass for key box” with a suited 54 key should be installed to facilitate escape.

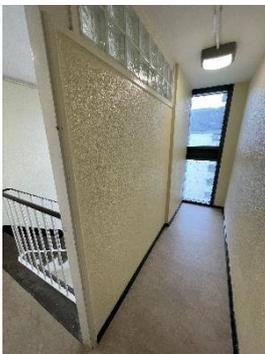
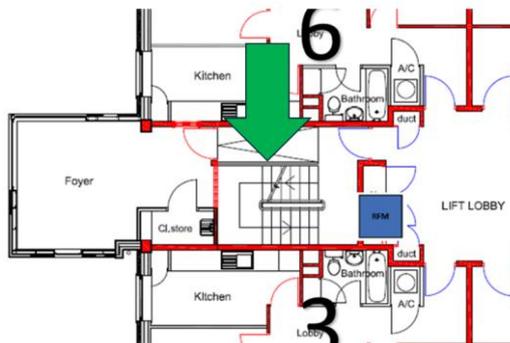
- 3) The same glass blocks were noted in other areas of the protected stairwell where 60 minute fire resistance isn't required.

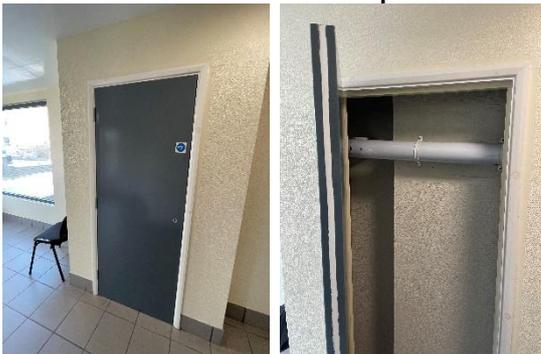
- 10) The internal linings of a cupboard within the 1st floor viewing room appear to be a non-combustible cement bonded calcium silicate based insulation board. The door to the cupboard is a locked FD30 timber door. The cupboard appears to have been built to house a steel extraction duct from the neighbouring flat. The duct doesn't terminate within the cupboard.

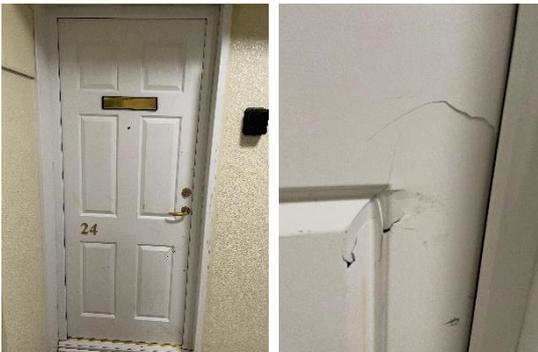
19) Superficial damage was noted to flat 24 entrance door. Access wasn't possible to inspect from both sides. Annual inspection of flat entrance doors is scheduled for February 2026.

20) Individual flat entrance doors are scheduled for annual inspection February 2026 by SMBC's Fire Rapid Response team. Repairs will be completed by the Fire Rapid Response team. An approved contractor will install any replacement FD30s doors that are required.

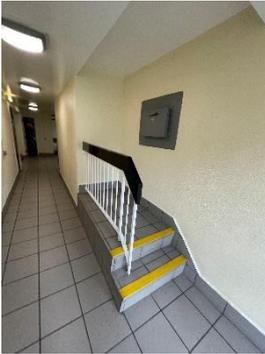
- 23) The ground floor refuse chute hopper is not enclosed in a chute room as per the original design of the building; however it does have intumescent seals.

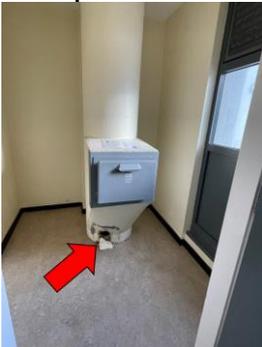
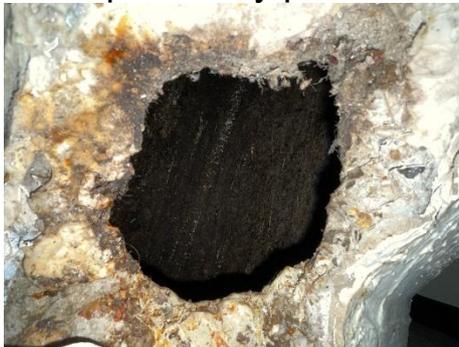
- 24) **The refuse chute system at 1st floor level has been damaged resulting in a hole approximately 100mm in diameter.** The risk is mitigated with an automatic closure plate and drencher system in the bin store, and the chute room is ventilated and has an FD30s timber door. However, the repair or replacement should be completed as soon as practically possible.

10/24	Hole in 1 st floor refuse chute to be repaired.

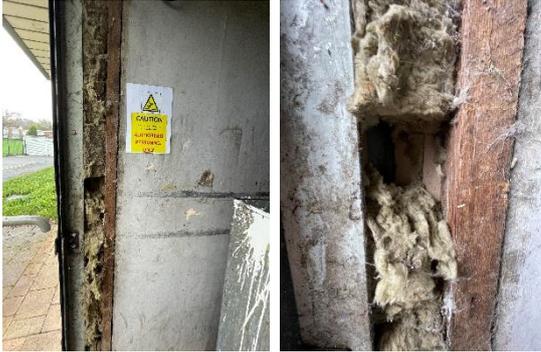
25) Reinstate mineral wool where missing where compartment wall ends in bin store.

P3	Within 3-6 Months Repairs	
10/25	Reinstate mineral wool where missing where compartment wall ends in bin store.
