Fire Risk Assessment

Broome House

**Beaconview Road, West Bromwich,
B71 3PN**

Date Completed: 13/02/2026

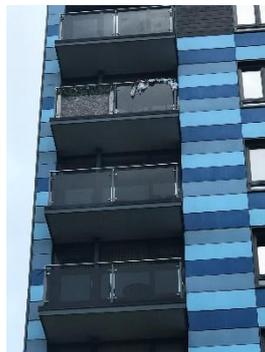
- 12) Any additional screening attached to balconies will not be tolerated on balconies as this could potentially support the surface spread of flame in those areas which is an unnecessary risk. **Damaged balcony glazing to the rear of the building on the on the 7th floor flat.**

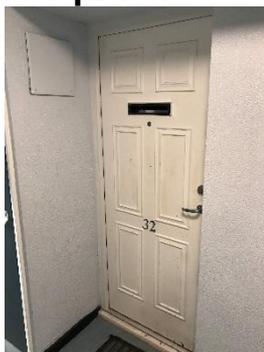
During the inspection of the external leaf of the door one door Flat 32 had a missing letter plate.

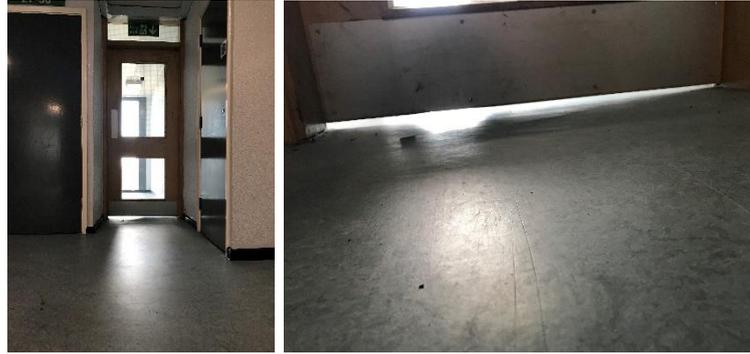
It was identified that a number of communal fire doors within the block exhibit larger than expected gaps at the threshold. It is noted that the floor finish within these areas is marginally sloped, which appears to contribute to the variation with the gaps under the door. The doors are nominal FD30s timber door sets and, aside from the increased threshold gap, no other significant deficiencies were observed at the time of inspection. The building benefits from daily presence and oversight by caretaking, cleaning, and council staff, and the communal fire doors are subject to a formal 12-weekly inspection regime.

In the context of the existing management controls, regular staff presence, and routine fire door inspections, the current level of risk is considered tolerable. It is recommended that the doors continue to be monitored as part of the established inspection programme, and when available the addition of drop seals be added.

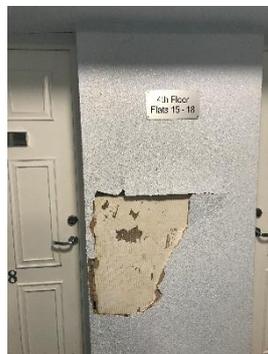
- 11) Damaged wall on the 4th floor exposing brickwork email will be sent to repairs.

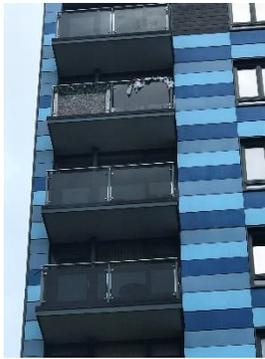
Question/ Ref No	Required Action	Supporting photograph	Priority	Timescale and Person Responsible	Date Completed
06/12	Damaged balcony glazing to the rear of the building on the on the 7 th floor flat.

P4	Programmed works Glazing Repairs

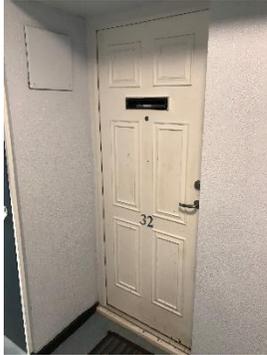
07/02	During the inspection of the external leaf of the door one door Flat 32 had a missing letter plate.

P2	1-3 months Fire Rapid Response	
-------	---	--	-----------	--------------------------------------	--
