# Fire Risk Assessment

## Bowater House

Moor Street, West Bromwich,  
B70 7AZ

**Date Completed:** 20<sup>th</sup> January 2026

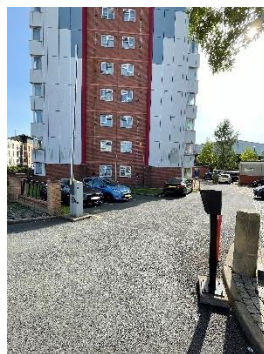
Access to the rear carpark is restricted by an automated barrier. The Access code for the barrier is recorded on the on arrival form. It was noted that during the assessment the barrier was continually in the raised position.

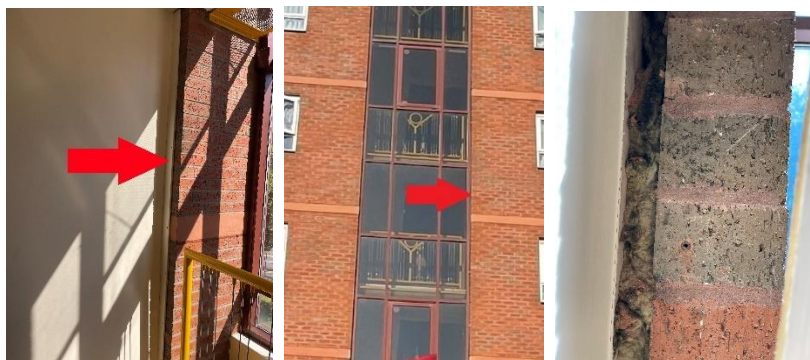
*Additional information was received after the inspection confirming that these cavities are in fact closed off by the return of the blockwork at the window positions. The MDF trim is in place for decorative purposes.*

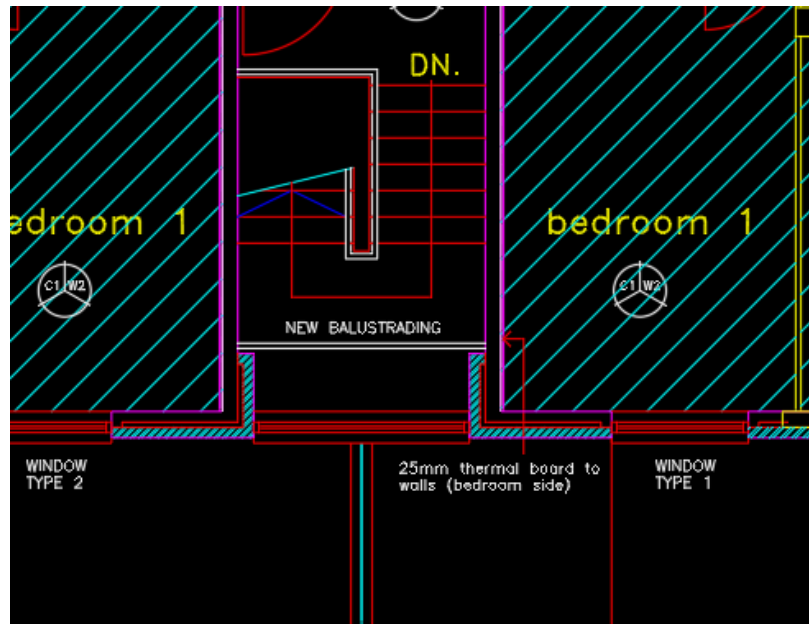
*Further inspection holes were created within the external masonry at ground floor level to the north east facing side elevation. A borescope revealed evidence of PUR insulation board and what appeared to be a vertical cavity barrier contained within a green sock to the party wall. This type of cavity barrier can provide up to 4 hours of fire integrity dependant on which version was installed. Due to the limitations of the available resources, it could not be determined if the cavity barrier was consistent throughout the vertical lines of the party walls.*

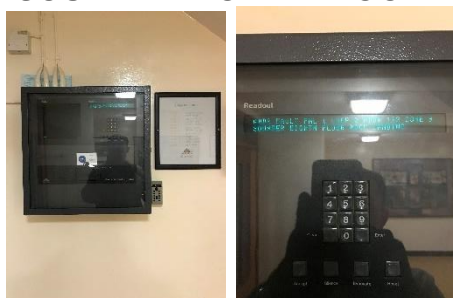
- 3) There's a communal fire alarm system installed at Bowater House. The panel and zone plan can be found within the ground floor entrance lobby. The system is checked and tested weekly and bi-annually by the in-house electrical team or procured contractor. **Fault recognised on the control panel states "ADDR FAULT PNL 1 LOOP 2 ADDR 122 ZONE SOUNDER EIGHTH FLOOR BACK LANDING".**

- 4) The communal fire alarm system shall remain as a temporary measure until the results of the FRAEW from the specialist contractor have been received, and any identified remedials have been satisfactorily completed to lower any identified risks. The system shall then be decommissioned.
- 5) The system is addressable so will identify the floor number with the relevant zone number and will state landing / stairs in text on the display.
- 6) The system provides detection to the communal areas which includes stairs, landings, mains cupboards, lift shaft, internal roof space and is also linked to heat detectors within resident's hallways.

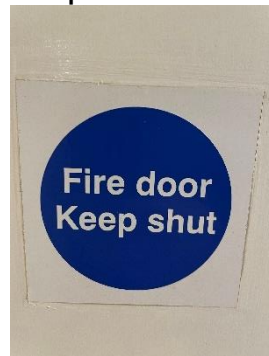
- 2) Fire Action Notices are displayed throughout the building. However, there is no instruction or reference to “on hearing the fire alarm”. During the previous FRA, a discussion with the (now former) Head of Building Safety and Compliance, RH has concluded that the Stay Put - Unless evacuation strategy shall remain in place. The communal fire alarm system shall also remain and continue to be maintained as a temporary measure until the results of the FRAEW from the specialist contractor have been received, and any identified remedials have been satisfactorily completed to lower any identified risks. The communal fire alarm will then be decommissioned to align with the stay put strategy and avoid any potential confusion for residents.
