Fire Risk Assessment

Bowater House

**Moor Street, West Bromwich,
B70 7AZ**

Date Completed: 20th January 2026

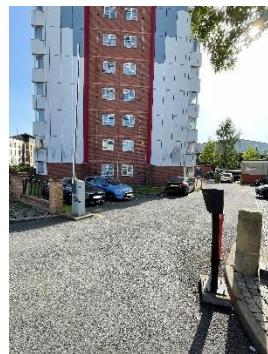
Access to the rear carpark is restricted by an automated barrier. The Access code for the barrier is recorded on the on arrival form. It was noted that during the assessment the barrier was continually in the raised position.

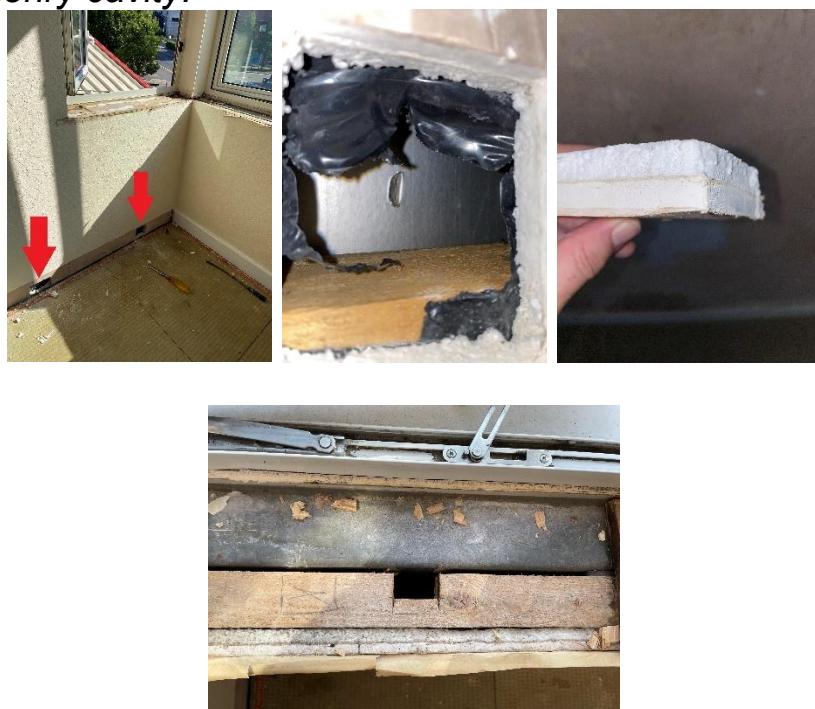
The borescope could not access beneath or behind the PUR boards or the area where the cavity within the balcony meets the masonry or masonry cavity.

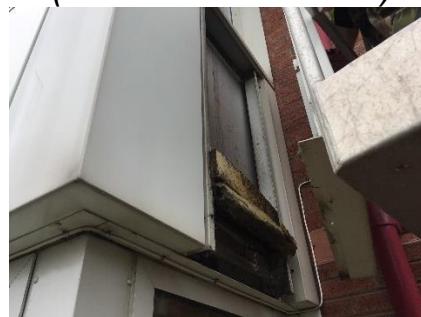
Historic images were provided inhouse which appear to show a horizontal layer of mineral wool between the cantilevered concrete base and PUR board (enclosed balconies).

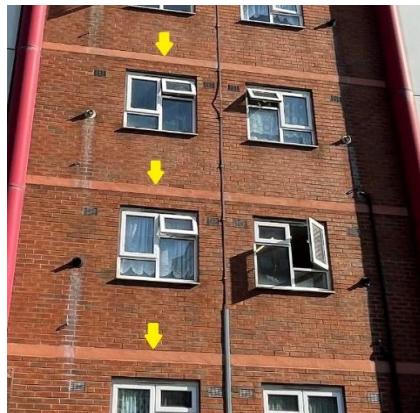
It appears that the extended concrete floor slabs could provide horizontal fire stopping between floors.

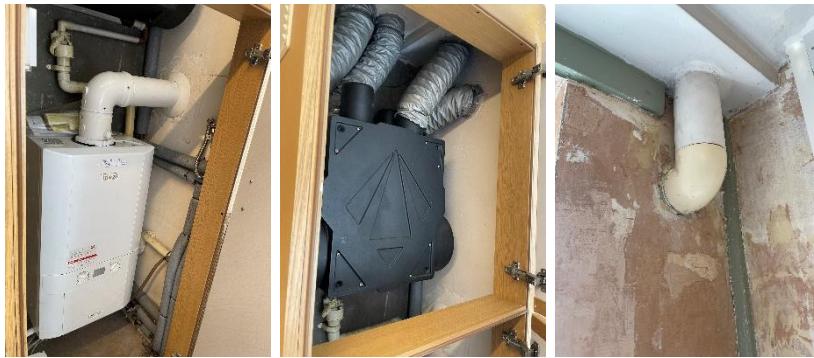
At the time of the assessment, it was not determined if cavity barriers are in place around openings for windows, ventilation pipework and flues.

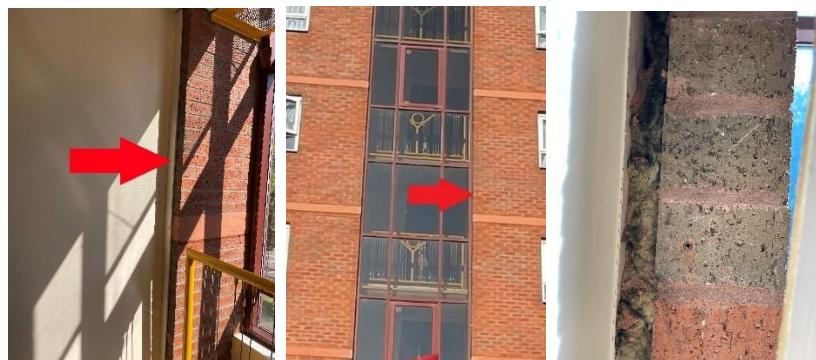
An MDF strip with unknown fire rating was removed to inspect the cavity between the 1-hour party wall between a flat and the stairwell. This is where external masonry returns into the protected front stairwell. The cavity between the two surfaces was insulated with mineral wool. At the time of the inspection, it could not be determined if this cavity extended into the cavity of the external wall system.

Additional information was received after the inspection confirming that these cavities are in fact closed off by the return of the blockwork at the window positions. The MDF trim is in place for decorative purposes.

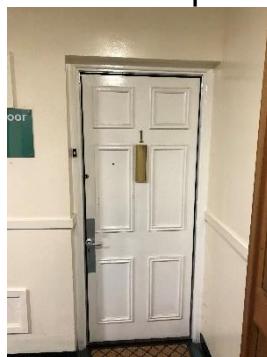
- 1) Individual flat doors are predominantly nominal self-closing 30-minute timber fire door sets with intumescent strips, cold smoke seals. Flat 18 has a replacement FD30s composite, not all doors have an intumescent lined letterbox which is acceptable because the doors were installed at a time prior to current standards.

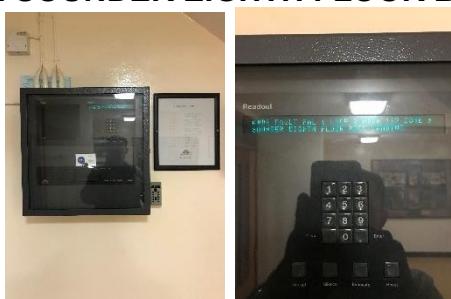
- 3) There's a communal fire alarm system installed at Bowater House. The panel and zone plan can be found within the ground floor entrance lobby. The system is checked and tested weekly and bi-annually by the in-house electrical team or procured contractor. **Fault recognised on the control panel states “ADDR FAULT PNL 1 LOOP 2 ADDR 122 ZONE SOUNDER EIGHTH FLOOR BACK LANDING”.**
