# Fire Risk Assessment

## Bowater House

Moor Street, West Bromwich,  
B70 7AZ

**Date Completed:** 20<sup>th</sup> January 2026

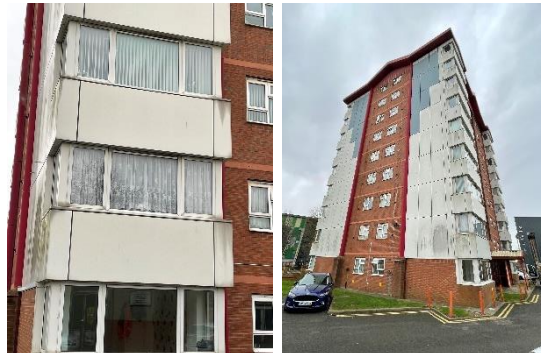
- 3) 3mm solid aluminium panels clad approximately 32% of the external walls to include the enclosure of the former balconies. Information available at the time of the risk assessment (delta submission) records fire classification as A1.

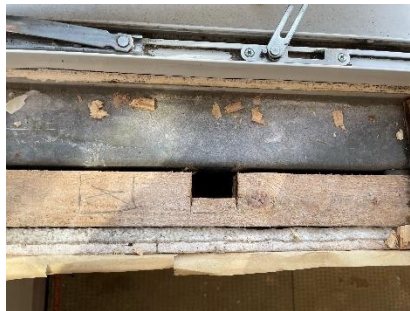
*Historic images were provided inhouse which appear to show a horizontal layer of mineral wool between the cantilevered concrete base and PUR board (enclosed balconies).*

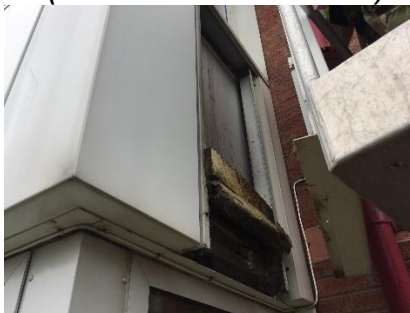
*It appears that the extended concrete floor slabs could provide horizontal fire stopping between floors.*

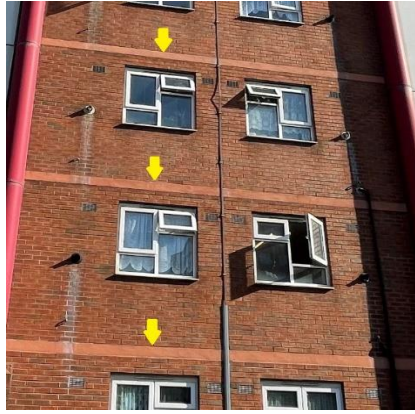
*At the time of the assessment, it was not determined if cavity barriers are in place around openings for windows, ventilation pipework and flues.*

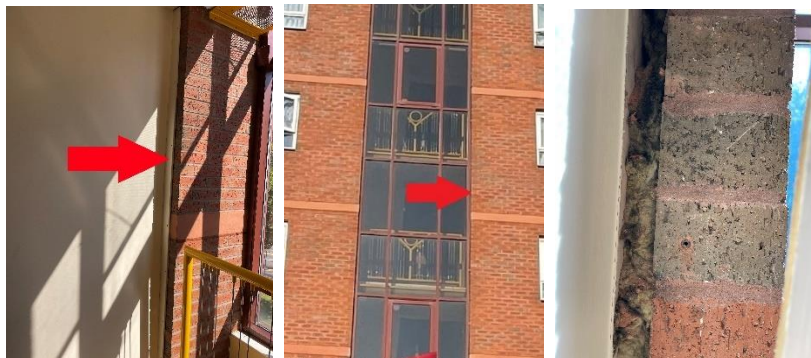
*Additional information was received after the inspection confirming that these cavities are in fact closed off by the return of the blockwork at the window positions. The MDF trim is in place for decorative purposes.*

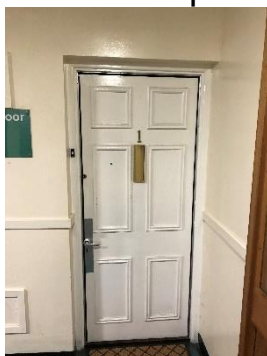
- 1) Individual flat doors are predominantly nominal self-closing 30-minute timber fire door sets with intumescent strips, cold smoke seals. Flat 18 has a replacement FD30s composite, not all doors have an intumescent lined letterbox which is acceptable because the doors were installed at a time prior to current standards.

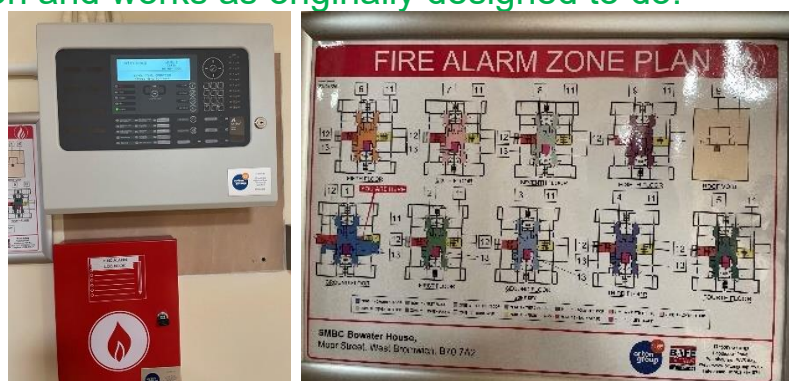
5th to 8th May 2026 the communal fire alarm was replaced with a new L1 system. Work is ongoing to connect the new fire alarm system to an alarm receiving centre at SMBC CCTV control room. The new system includes the same functions as the previous with additional smoke detectors outside the chute room door on each floor, a lift interface that will send the lift to ground floor upon alarm activation and the removal of the sounder silence function within all flats. For clarity all detector heads have been replaced including, those linked heat detector heads within the hallway of each flat, lift shaft and roof void. The AOV's in each staircase will operate upon detection of smoke in each respective stairwell. The AOV override switch in each stairwell has not been affected by the new fire alarm installation and works as originally designed to do.
