# Fire Risk Assessment

## Lissimore House

**Maria Street, West Bromwich,  
B70 6DR.**

**Date Completed: 01/12/2025**

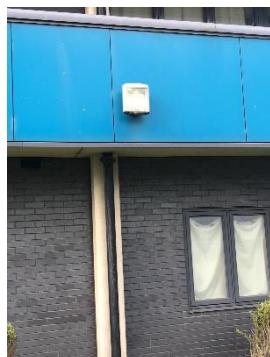
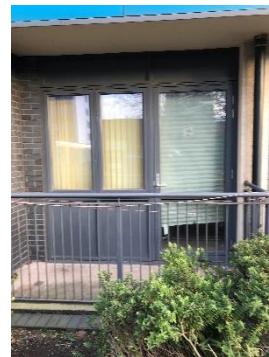
- 5) The bin store, located at the rear elevation of the block, is secured with a roller shutter door.
- 6) It was noted that some balconies had combustible materials in the form of hanging washing, this is deemed an acceptable risk due to the likelihood of a fire starting in this area being low combined with the temporary nature of the activity.
- 7) Fenestration consists of aluminium faced timber composite for resident's flat windows/balcony doors and communal windows.

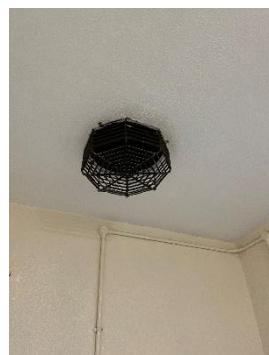
10) A ventilation grill was noted to the head of the staircase.

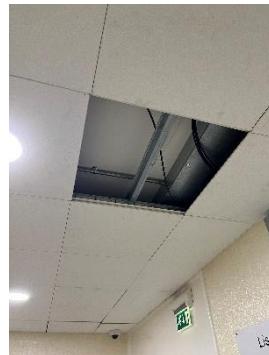
**17) A suspended ceiling tile was noted to be missing in the ground floor lift lobby. This tile is required to be replaced. Missing ceiling panels may slow down smoke getting to an AOV detector head. See action 7/17**

Question/ Ref No	Required Action	Supporting photograph	Priority	Timescale and Person Responsible	Date Completed
7/17	A suspended ceiling tile was noted to be missing in the ground floor lift lobby. This tile is required to be replaced.

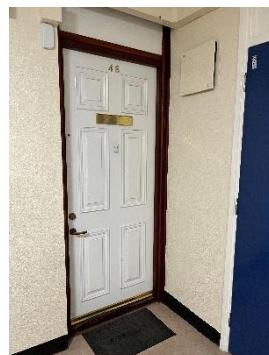
**19) Individual floor mats were noted outside some flats. Fire rating of the mats is unknown but deemed to be of low risk.**

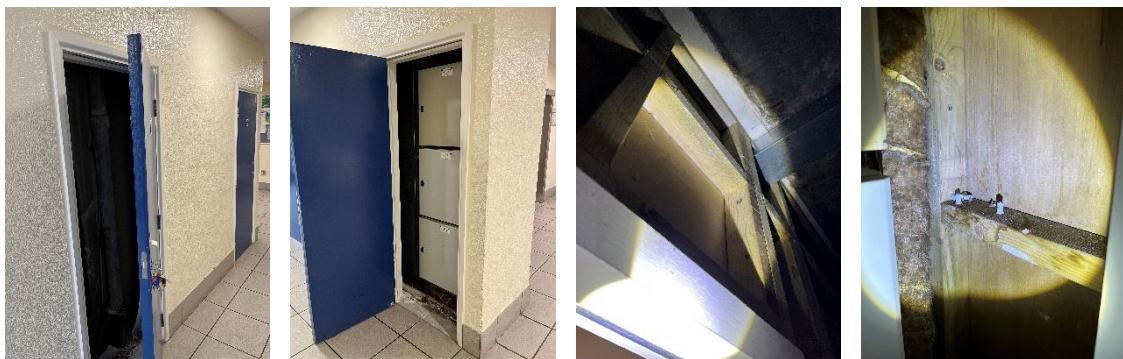
6) The electrical service cupboard on the ground floor lift lobby has two FD60 doors, secured with 54 key mortice locks. This cupboard is of timber construction. It is required that the inside of the service cupboard is lined with fire resistant plasterboard and fire rated jointing compound to improve the fire resistance of this service cupboard. See action 10/6 and note in Observations.

<p>The electrical service cupboard on the ground floor lift lobby is of timber construction. It is required that this timber service cupboard is replaced with a masonry constructed structure, offering 60 minutes of fire resistance. This work will form part of a future work programme.</p>

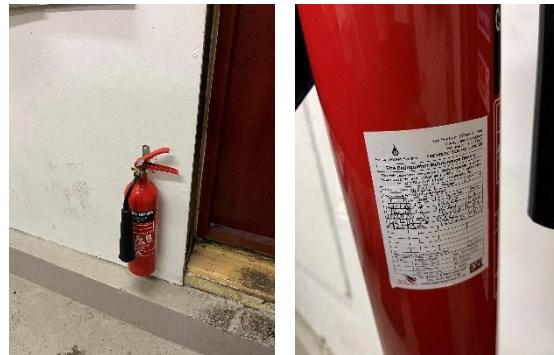
5) A portable fire extinguisher (CO2) is provided to the lift motor room. Maintenance contracts in place for maintenance of the extinguisher. The frequency for the maintenance checks is once (October) of each calendar year. The CO2 extinguisher is missing its information notice; a suitable CO2 extinguisher information notice is required to be fitted. See action 11/5.

11/5	The CO2 extinguisher in the lift motor room is missing its information notice; a suitable CO2 extinguisher information notice is required to be fitted.
