# **Fire Risk Assessment**

## **Meadow Avenue (Beech).**

**Charlemont Farm, West Bromwich,  
B71 3EJ.**

**Date Completed: 03/02/2026**

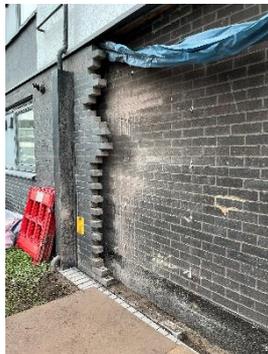
- 1) The external wall at Beech House has 3 separate areas of cladding. The external wall system was upgraded in 2017/18 and comprises of:
  - Brickwork from ground to 1ST floor. Fire classification A1.
  - At the time of the assessment repairs were ongoing to rectify damaged caused by a vehicle impact to the ground floor exterior wall.

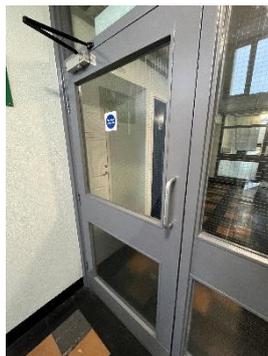
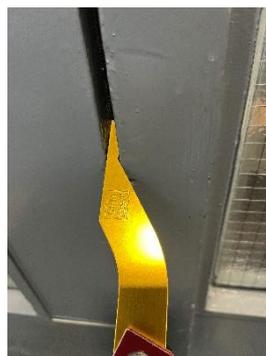
- 7) All communal doors are fitted with automatic closing devices that are checked on a regular basis by Caretaking Teams as part of their checks. Defective closing devices are replaced either by the Caretaking Team(s) or the in-house repairs team(s).
- 8) All communal fire doors are subject to a 12-week check by the Fire Safety Rapid Response Team.
- 9) **The 6<sup>th</sup> floor front stairwell fire door has a 6mm latch-side gap, requiring adjustment. See action 7/9.**

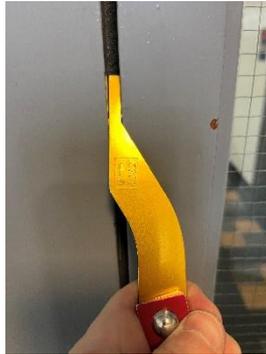
- 10) The 6<sup>th</sup> floor rear stairwell fire door has a 6mm latch-side gap, requiring adjustment. See action 7/10.

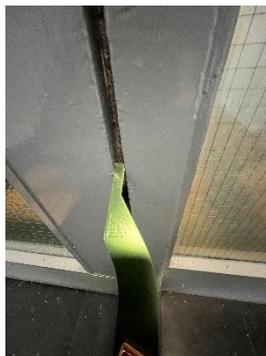
- 11) The 5<sup>th</sup> floor front stairwell fire door has an 8mm latch-side gap, requiring adjustment. See action 7/11.

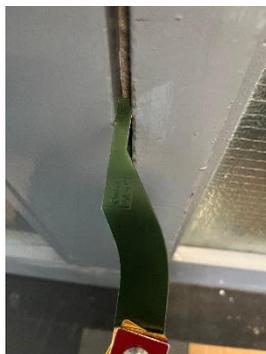
- 12) The 3<sup>rd</sup> floor front stairwell fire door has an 8mm latch-side gap, requiring adjustment. See action 7/12.

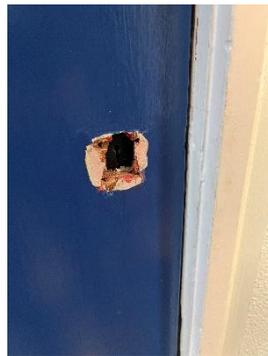
- 7) The escutcheon plate on the service cupboard door leaf near flat 127 on the 6<sup>th</sup> floor is missing, a replacement is required. See action 10/7.

P2	Fire Rapid Response 1 – 3 months.	
10/7	The escutcheon plate on the service cupboard door leaf near flat 127 on the 6 <sup>th</sup> floor is missing, a replacement is required.

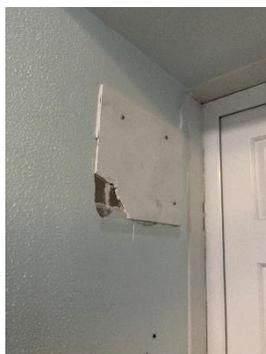
- 14) **The access panel for flat 117 is damaged, repair is required.  
See action 10/14**

P2	Fire Rapid Response 1 – 3 months.	
10/14	The tap access panel for Flat 117 is damaged. Repair required.

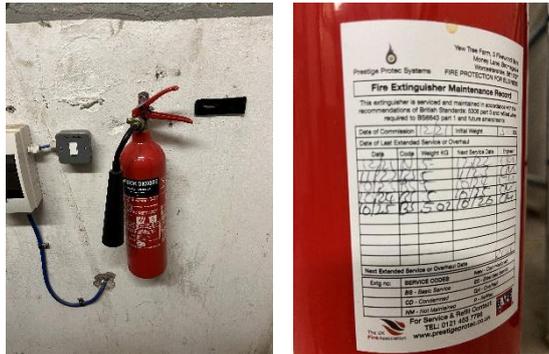
- 4) A portable fire CO2 fire extinguisher is provided in the lift motor room. A contract is in place for maintenance of the extinguisher. The frequency for the maintenance checks is once (October) each calendar year. There is no extinguisher information sign. A CO2 extinguisher information sign is required to be fitted. See action 11/4.
