Fire Risk Assessment Greenford House

**Maria Street, West Bromwich,
B70 6DX**

Date Completed: 17/01/2024

Current Risk Rating = Tolerable

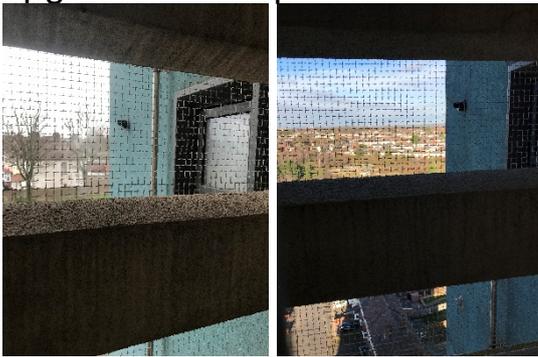
- 8) Open air natural ventilation Along the bin chute lobby area made of concrete construction at the rear of the block, it was noted that netting was present along this section of the premise the netting does not run down to the ground level and does not have easy access combined with sufficient compartmentation within the block and the stay put unless policy the council has reduces the overall risk. However an alternate option should be explored with future upgrades to the premises.

It was noted that netting was present along the rear elevation of the premise Alternate option should be explored with future upgrades to the premises.	
---	--

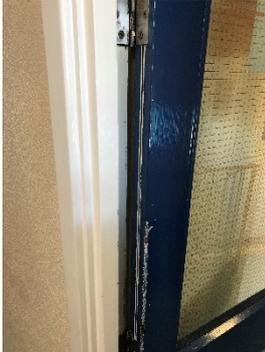
- 26) 16th floor Communal door coming from stair is missing cold smoke seal on hinge side of the door.

07/21	Flat 20 Install cold smoke seals to flat entrance door	N/A	P2	Fire Rapid Response 1-3 months	
07/26	16 th floor replace missing cold smoke seal on hinge side to door leading to the protected stair

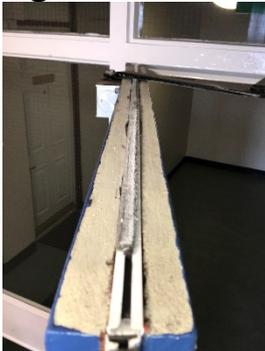
- 27) Communal door from the flat/lift lobby area into the chute landing area missing a small piece of cold smoke seal at the right hand side atop of the door on the 14th floor.

P2	Fire Rapid Response 1-3 months	
07/27	14 th floor replace missing piece of cold smoke seal to top right hand side of door entering into the lift lobby

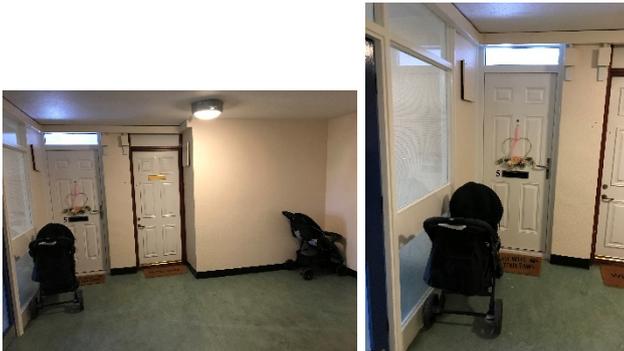
- 28) Items left within the communal areas on the 2nd floor

P2	Fire Rapid response 1-3 months	
07/28	Removal of pushchairs stored within the communal lobby area on the 2 nd floor

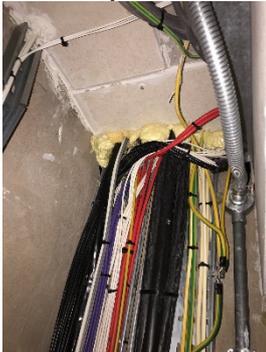
- 14) Noted the use of expanding foam was present within the communal cupboards around cabling as part of the fire stopping knowing that intumescent pads and a concrete slab is present and this foam is only used as an enhancement it is deemed tolerable. This should be enhanced as part of future works to the building and replaced with intumescent mastic to improve fire stopping.

<p>Noted the use of expanding foam was present within the communal cupboards around cabling as part of the fire stopping knowing that intumecent pads and a concrete slab is present and this foam is only used as an enhancement it is deemed tolerable. This should be enhanced as part of future works to the building and replaced with intumecent mastic to enhance fire stopping.</p>

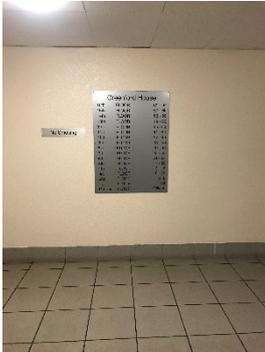
- 4) Signage depicting the floor location of each flat is fitted to the ground floor lobby wall it was noted that the sign displays the office space on the first floor as flats 1-4 the location of the flats is correct however these flats have been converted into office spaces.

- 5) A plan to install new Wayfinding Signage to the block depicting floor level and flat numbers is to be fitted to the wall adjacent to lift and within the staircase. This will meet the requirements set out in the Fire Safety (England) Regulations 2022.
- 6) Currently there is signage on each floor of the block as well as on the wall of each floor from the staircase

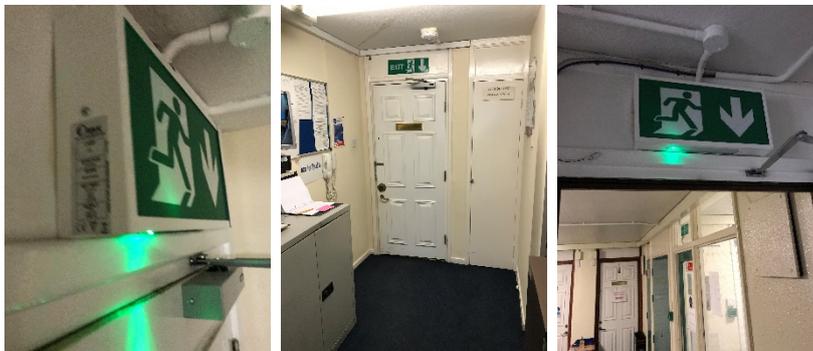
- 11) Emergency escape signage is used within the office spaces along the means of escape noted that some signage is incorrect however due to the occupancy and familiarity with the spaces with is deemed tolerable

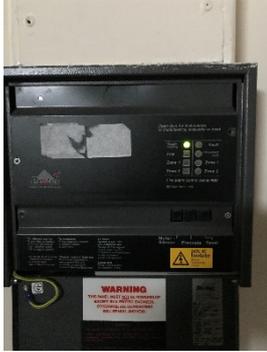
23) **it was noted that there was no evidence of weekly fire tests weekly fire alarm testing results need to be documented within the fire risk logbook.**

P2	Bryan low	
20/23	Provide evidence of weekly fire alarm testing and document within the fire log book	N/A	P2	Bryan Low	
20/27	Provide evidence of the emergency lighting test and document within the logbook	N/A	P2	Bryan Low	
20/44	Fire marshals should be nominated and	N/A	P2	Bryan Low
