# **Fire Risk Assessment**

## **Meadow Avenue (Willow).**

**Charlemont Farm, West Bromwich,  
B71 3EN.**

**Date Completed: 09/02/2026**

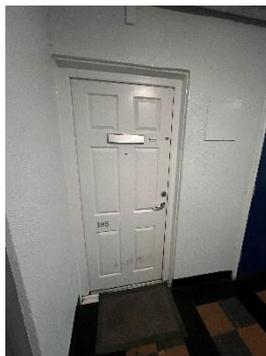
15) Individual floor mats were noted outside some flats. Fire rating of the mats is unknown but deemed to be of low risk.

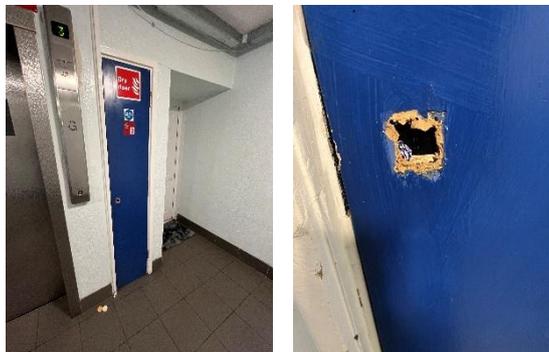
- 8) The escutcheon plate on the ground floor dry riser cupboard door leaf is missing, a replacement is required to be fitted. See action 10/8.

Question/ Ref No	Required Action	Supporting photograph	Priority	Timescale and Person Responsible	Date Completed
10/8	The escutcheon plate on the ground floor dry riser cupboard door leaf is missing, a replacement is required to be fitted.

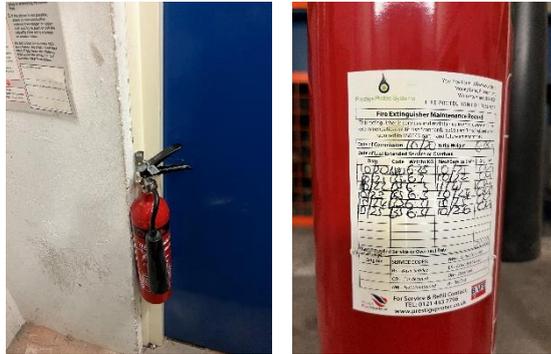
- 4) A portable fire CO<sub>2</sub> fire extinguisher is provided in the lift motor room. A contract is in place for maintenance of the extinguisher. The frequency for the maintenance checks is once (October) each calendar year. There is no extinguisher information sign. A CO<sub>2</sub> extinguisher information sign is required to be fitted. See action 11/4.

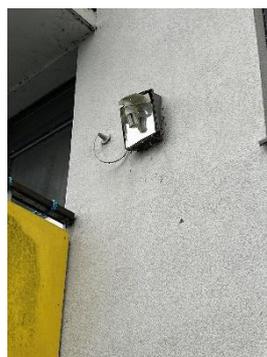
- 3) There is no current evidence of arson
- 4) **The perimeter of the premises is well illuminated. However, there is a damaged floodlight at the rear of the block, requiring repair. See action 17/4.**

P2	Asset Management 1 – 3 months.	
17/4	There is a damaged floodlight at the rear of the block, this light is required to be repaired.
