# **Fire Risk Assessment**

## **Wimberger House 1-36**

**Hallam Street, West Bromwich,  
B71 4HA.**

**Date Completed: 02/03/2026**

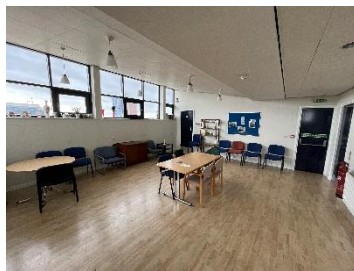
**The communal room is currently believed to be not in use. However, a service level agreement is required to be drawn up to control access to the communal room, agree terms of use and to formalise fire safety procedures. See action 7/18.**

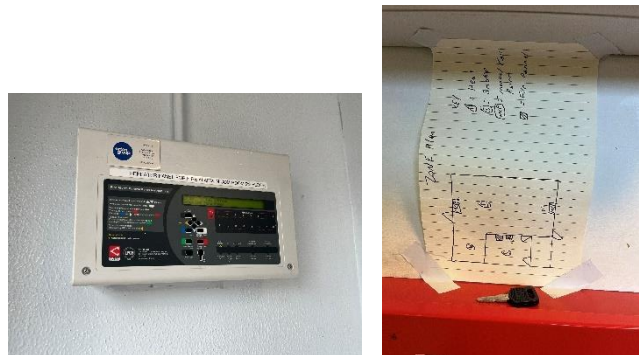
- 6) The AFA repeater panel in the front ground floor entrance foyer has no zone plan. The main AFA panel has a poor temporary zone plan. Suitable and sufficient zone plans are required to be fitted adjacent to both AFA control panels. See action 8/6.

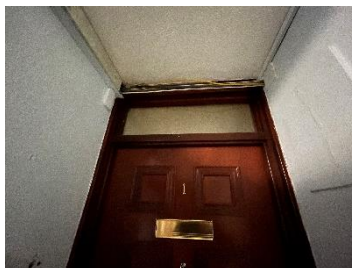
- 12) **There is a lid missing from electrical trunking above the flat entrance to flat 1 on the ground floor. A replacement lid is required to be fitted. See action 10/12.**

<p>P2</p>	<p>Electrical 1 – 3 months.</p>	
<p>10/12</p>	<p>There is a lid missing from electrical trunking above the flat entrance to flat 1 on the ground floor. A replacement lid is required to be fitted.</p>

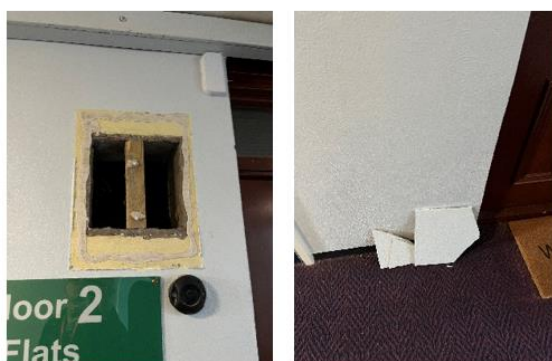
- 13) **Stop taps are secured behind a panel cupped and screwed near flat doors. The panel for Flat 12 is missing and is required to be replaced. See action 10/13.**

<p>P2</p>	<p>Electrical 1 – 3 months.</p>	
<p>10/13</p>	<p>The stop tap panel for Flat 12 is missing and is required to be replaced.</p>

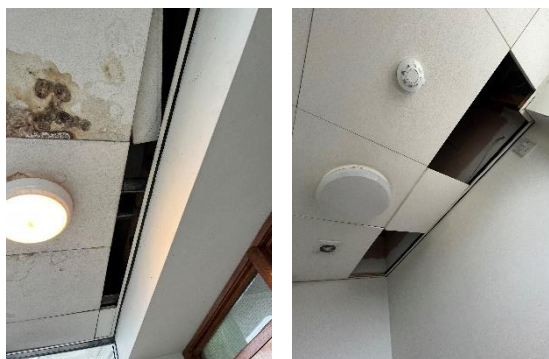
- 14) **Suspended ceiling panels are missing in the following areas; toilet and lift lobby in the communal room and at the top of the rear stairwell near the communal room entrance. Missing ceiling tiles can prevent or slow down smoke reaching detector heads. These tiles are required to be replaced. See action 10/14.**

<p>10/14</p>	<p>Suspended ceiling panels are missing in the following areas: toilet and lift lobby in the communal room and at the top of the rear stairwell near the communal room entrance. All missing ceiling tiles are required to be replaced.</p>

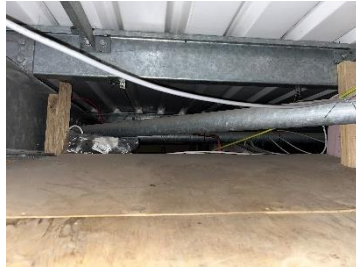
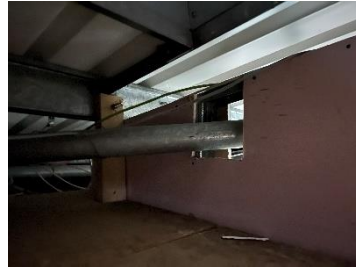
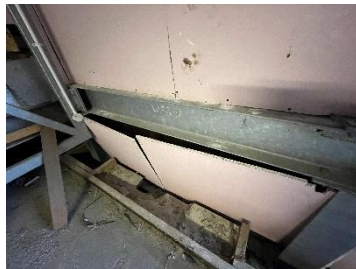
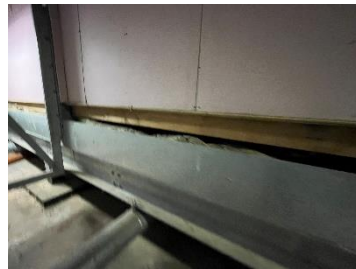
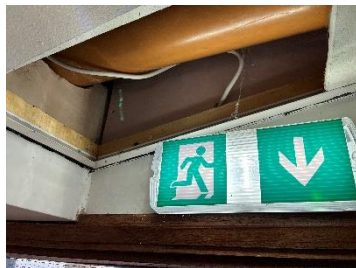
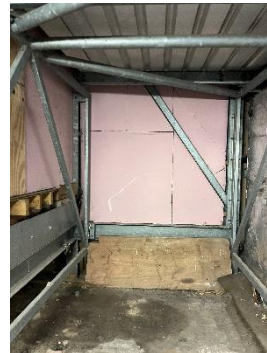
- 15) **Compartmentation above and around the communal room and on the outer side of both protected stairwells on the top floor is unsatisfactory and requires major rectification. It is recommended that the compartmentation above and around the communal room and on the outer side of both protected stairwells on the top floor and the disabled lift shaft receives major rectification by a suitably trained person. See action 10/15.**

<p>P2</p>	<p>Repairs 1 – 3 months.</p>	
<p>10/15</p>	<p>It is recommended that the compartmentation above and around the communal room and on the outer side of both protected stairwells on the top floor and the disabled lift shaft receives major rectification by a suitably trained person.</p>

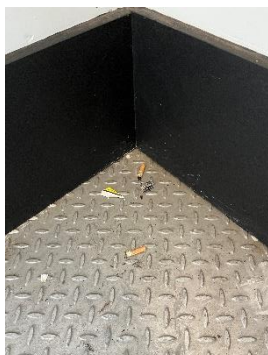
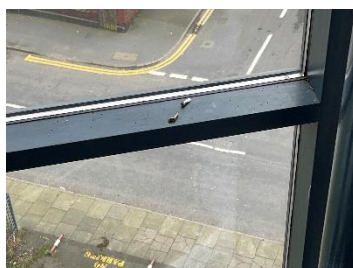
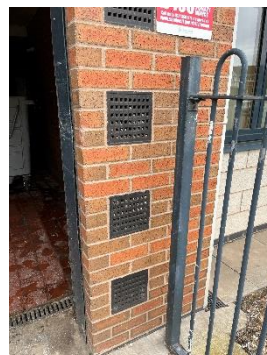
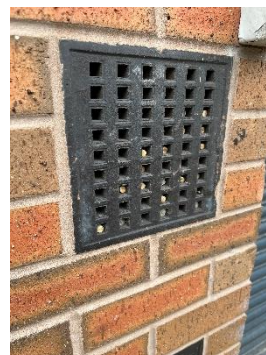
- 2) Evidence of smoking in the common areas was noted.
  - a) In the front stairwell towards the top floor and the rear stairwell on window ledges. The Housing Officer should communicate to residents regarding smoking in the block and the cleaning team should remove the cigarette butts. See action 14/2a.
  - b) Discarded cigarette butts can be seen in the airbricks near the bin store roller shutter. The housing officer should communicate to residents regarding smoking in the block and the cleaning team should remove the cigarette butts. The airbricks are required to be sealed to prevent discarded cigarettes entering the bin room. See action 14/2b.
