## Fire Risk Assessment

## Wimberger House 1-36

Hallam Street, West Bromwich, B71 4HA.

Date Completed: 13th February 2024

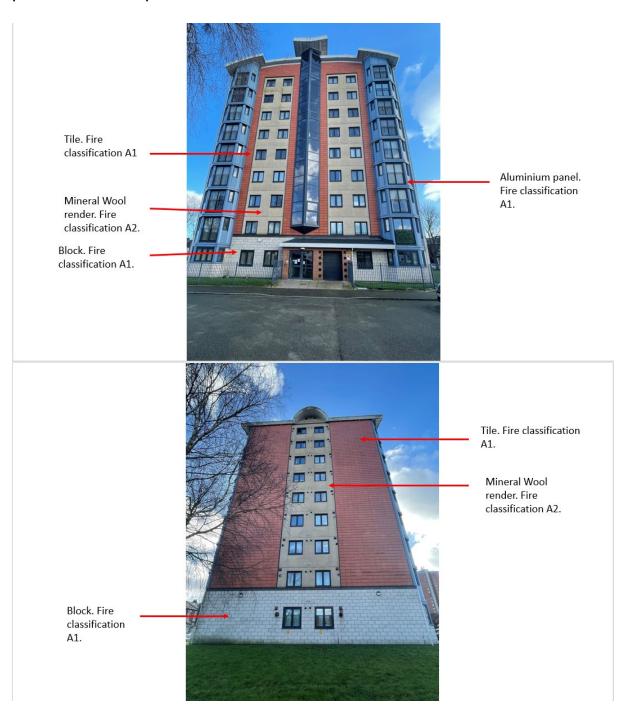
Below is a breakdown of the materials used within the external envelope and, as part of the external wall system of Wimberger House.

It is deemed that the combination and application of these materials present an acceptable level of fire risk.

1) Plastic screening was noted to the balcony of flat number 6 (front first floor right hand side). This should be removed as combustible. Email sent to housing manager on 14/02/2024.
