# Fire Risk Assessment

**Wyndmill Crescent (51-121)  
West Bromwich,  
B71 3QZ.**

**Date Completed: 03/03/2026**

**Officer: Adrian Jones Building Safety Manager**

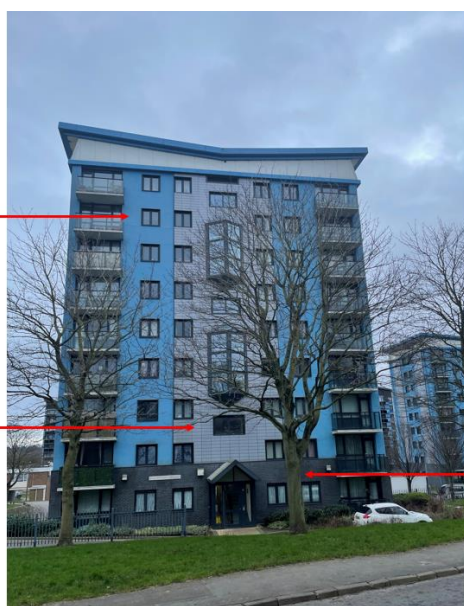
Rockwool insulated  
render. Fire  
classification A2

Tiles . Fire  
Classification A1

Brickwork. Fire  
classification A1.

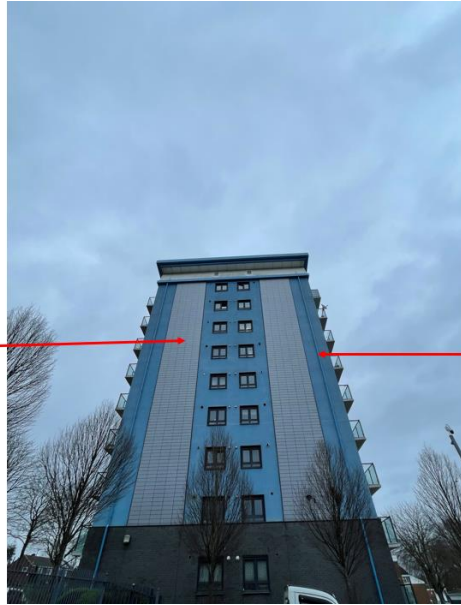
Tiles . Fire classification A1.

Insulated Rockwool render. Fire classification A2.

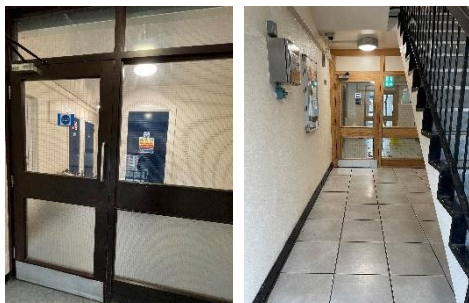
- 6) The communal landing / staircases are protected by use of Nominal FD30s fire doors with vision panels. These doors have previously been upgraded with a combined strip consisting of a cold smoke seal and intumescent strip.

It was noted that several staircase doors complete with side panels were warped, twisted and in need of replacement when any future refurbishment works are carried out.

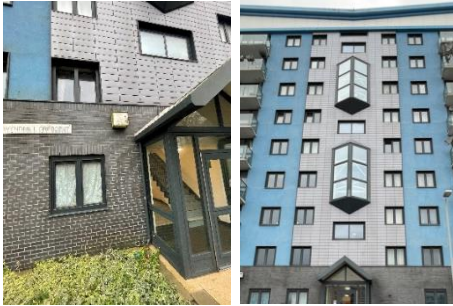
- 24) Glazing was noted within 1.8mtr of staircase. This also occurs on upper floors where glazing from resident bedrooms impacts on the staircase and subsequent means of escape. (within 1.8 mtrs)

Due to the issues identified in the previous point, a sprinkler roll out programme should be implemented as part of any future refurbishments.
