Fire Risk Assessment

Brookview

Stanhope Road,
Smethwick, B67 6HG

Date Completed: 08/09/2025

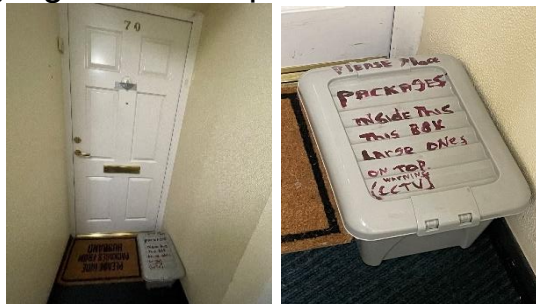
- 18) A plastic tub has been placed in the communal lobby adjacent flat 70 entrance door for the purpose of receiving parcels. The tub is combustible and therefore should be removed from the common area. This was highlighted in the previous risk assessment.

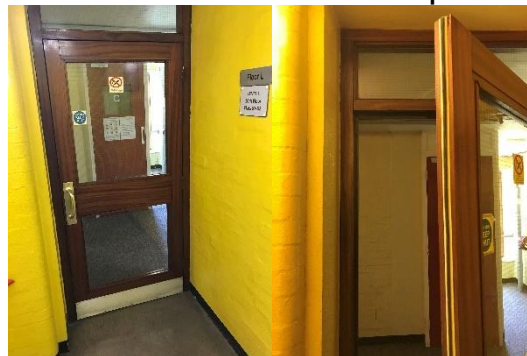
- 10) The corridors / staircases are protected by use of self-closing notional 44mm fire doors with combined intumescent strips / cold smoke seals and vision panels consisting of Georgian wired glazing. It was noted that some general wear and tear/ superficial damage could be seen on some of the communal doors within the block however this will not affect the doors performance.

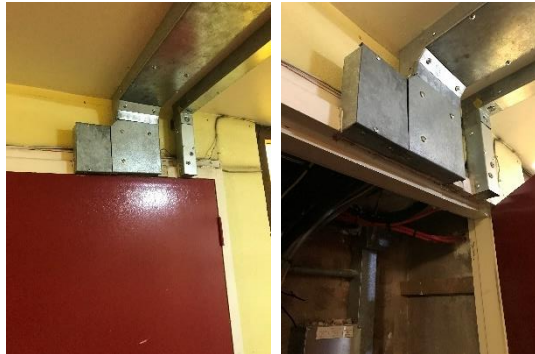
- 13) Ground floor and 11th - A wire for the AOV detection system has been installed passing through the frame of a fire door, Enhance fire stopping around the breach to restore the fire resistance of the door assembly. For future works, cabling should not be routed through door frames; alternative routes must be used to avoid compromising fire door integrity.**

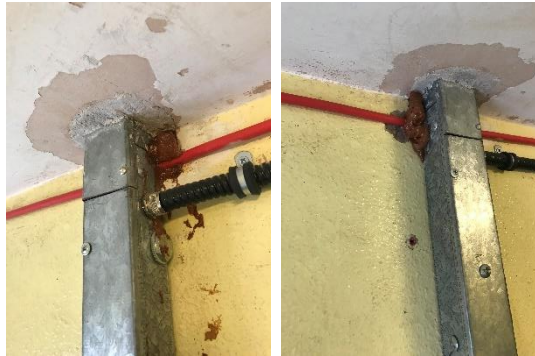
- 16) 9th floor insufficient fire stopping methods used where metal trunking reaches floor above, remove foam and enhance fire stopping.**

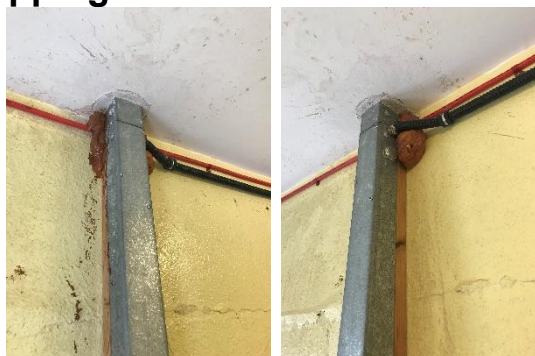
- 17) 8th floor Large hole in wall outside flat 46 this requires enhanced fire stopping.**

P2	1-3 months Fire Rapid Response	
10/17	8 th floor outside flat 46, enhance fire stopping where metal trunking meets wall to flat.
