# Fire Risk Assessment

## Lawrence Court

**Aldridge Road  
Smethwick,  
B68 OHB**

**Date Completed: 11/04/25**

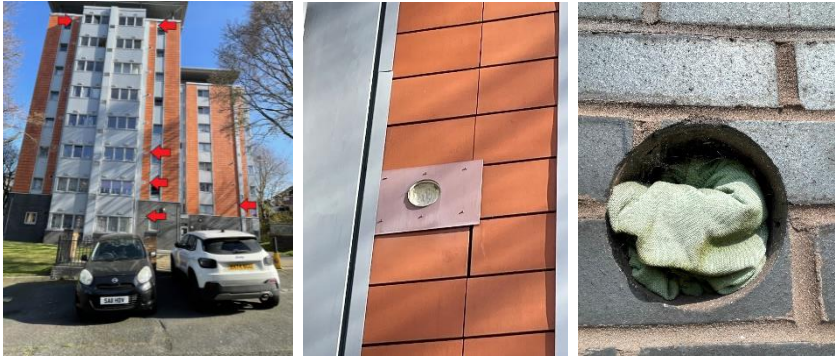
5. Blanked sleeves penetrating the external walls were noted adjacent some flat kitchen windows. It is believed this work was undertaken during the 2007 refurbishment in preparation for potential gas flue installations. It was not possible to identify the materials used to seal the penetration however, it appears an intumescent pillow has been used in one penetration at ground floor level. Further investigation will take place during the scheduled PAS 9980 FRAEW.

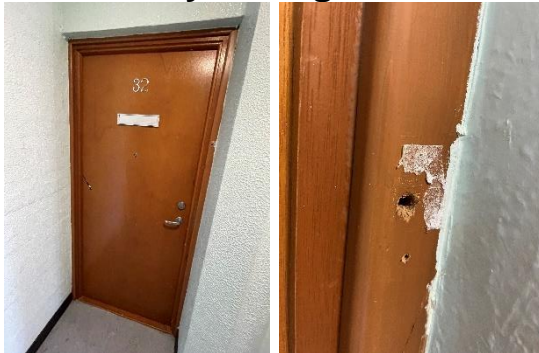
- B. Flat 32, small holes in frame where door bell has been removed to be filled with intumescent wood filler. Holes are not fully through frame.**

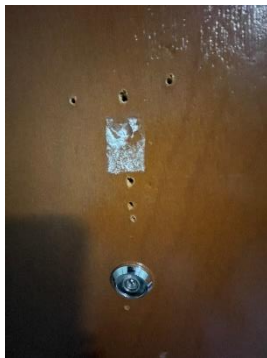
- C. Flat 33, access not gained however several small holes noted around door viewer to be filled with intumescent wood filler. Holes are not fully through door leaf.**

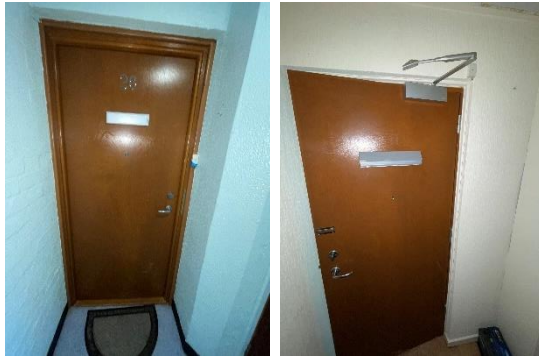
- E. Flat 26, **overhead self-closing device was found disconnected.**

P2	Within 1-3 months Fire Rapid Response	
7/18e	Flat 26 – re-attach overhead self-closer arm on flat entrance door.

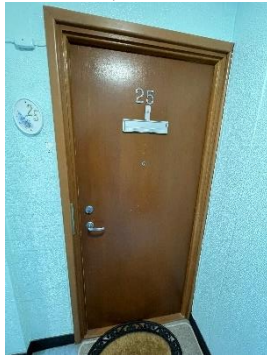
- F. Flat 25, **overhead self-closing device has been removed.**

P2	Within 1-3 months Fire Rapid Response	
7/18f	Flat 25 – supply and fit overhead self-closer to flat entrance door.

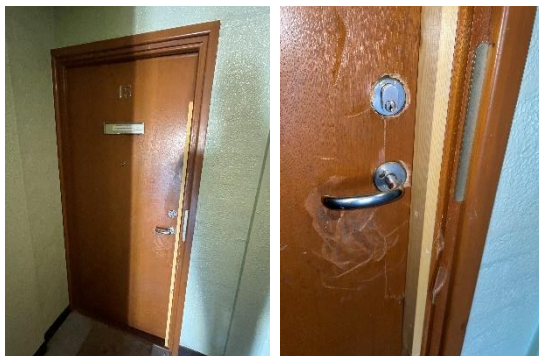
- G. Flat 15, **door has been damaged by forced entry and temporary repaired. Install new FD30s self-closing door set.**

7/18g	Flat 15 – replace damaged entrance door with new FD30s door set. <i>Approximate measurements 930mm x 2000mm</i>

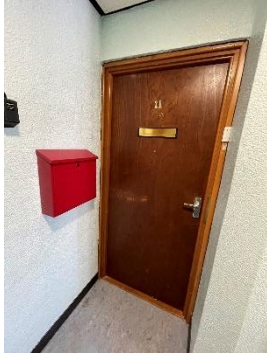
- H. Flat 11, **external mail box has been installed in communal means of escape. The mail box has no intumescent materials, and the common areas should**

**remain sterile.**

P3	Within 3-6 months Asset Management	
7/18h	Flat 11 – Resident to remove external letter box fixed to compartment wall.

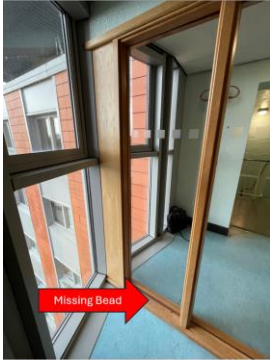
- 14) There is a section of hardwood beading missing from the 7<sup>th</sup> floor glazed partition wall / screen.

P2	Within 1-3 months Housing Manager	
10/14	7 <sup>th</sup> floor – replace missing section of hardwood beading to glazed partition wall with like for like.

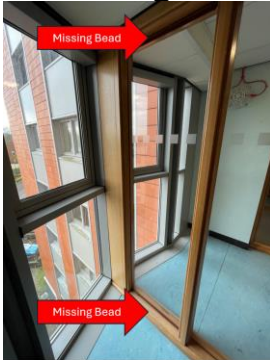
- 15) There are two sections of hardwood beading missing from the 5<sup>th</sup> floor glazed partition wall / screen.

10/15	5 <sup>th</sup> floor - replace the 2 missing sections of hardwood beading to glazed partition wall with like for like.
