Fire Risk Assessment

Oak Court

**Acacia Avenue, Yew Tree Estate,
WS5 4HB**

Date Completed: 10/03/2026

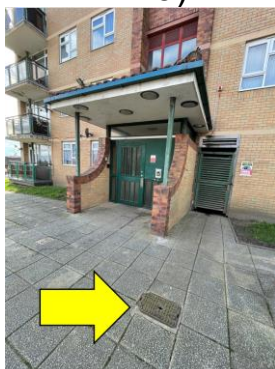
The nearest Hydrant is located adjacent to the rear access door by the car park. It was noted that the Hydrant lid is marked as Wash Out (see section 19).

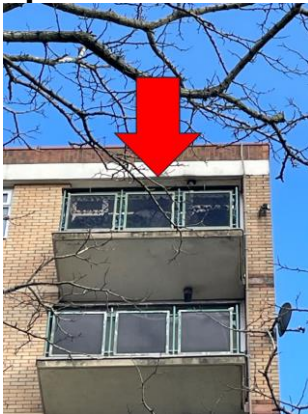
- 8) **Decorative trellis has been installed to the balcony of flat 69. Decorative trellis has the potential to support the external spread of flame.**

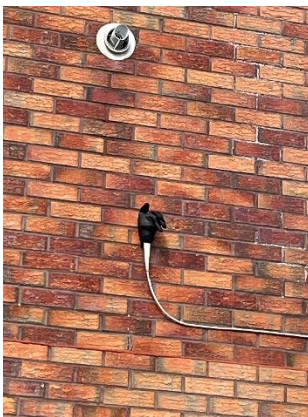
- 9) A photocell has been overridden with a rubber glove on the south facing side elevation. An electrical inspector has been requested to resolve.

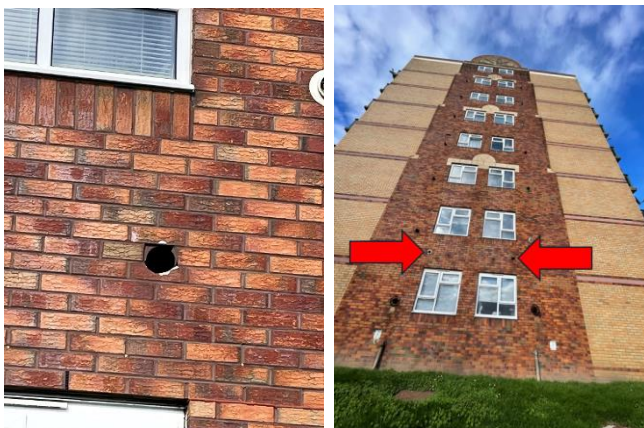
- 10) A number of extraction vents to the side elevations at 1st floor were noted as damaged with missing covers. The risk is deemed sufficiently low however the vents should be replaced via SMBC internal repairs system. 17/03/26 Email received confirming repairs have been resolved.

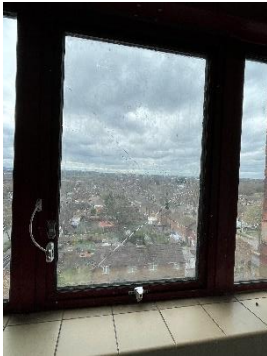
- 13) Communal windows can only be opened within the front staircase for the block. A protective film has been applied to a 7th floor window to secure a cracked pane. A repair has been raised – JM 18159535

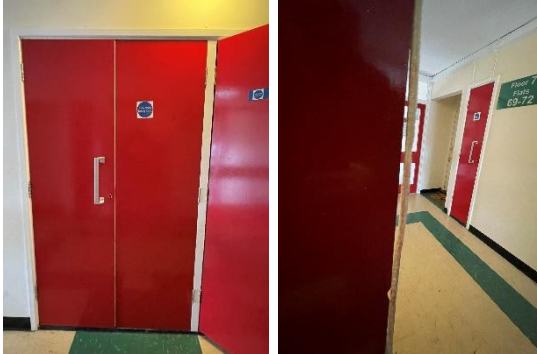
- 6) The right hand door to the left side service cupboard on the 7th floor has a defective cold smoke seal, replacement required.

10/6	7 th floor left hand service cupboard, replace defective cold smoke seal.

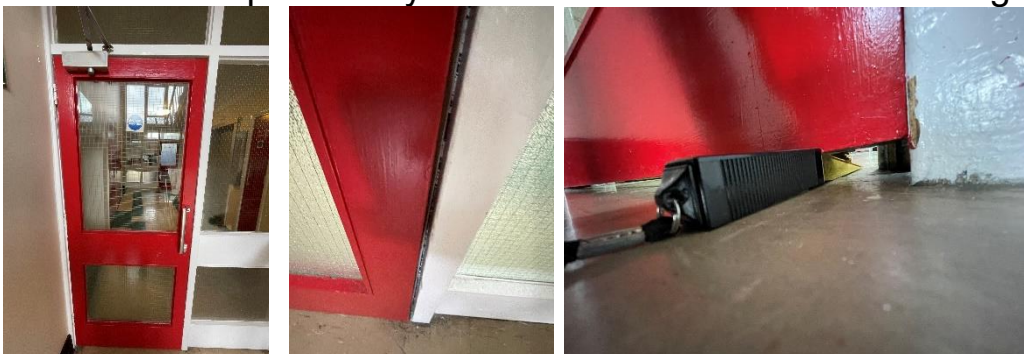
- 7) The communal landing & staircases are protected by use of upgraded notional self-closing 44mm 30-minute timber fire doors with vision panels and screens. It is recognised that these doors do not meet today's benchmark of a certified FD30s fire door install however, because they were installed at the time of the buildings construction and to the standard of that time they are deemed as acceptable so long as the doors are free of damage and function as they were intended to do so. Because the majority of the doors had excessive gaps, worn batwing smoke seals, and some worn hinges, the Building Safety Manager met on site with the Fire Rapid Response Team to review and agree a way of improving the doors.

As an interim measure, an action has been created for the Fire Rapid Response Team to improve the function of each communal landing door by, where necessary, re lipping, re aligning, removing old bat wings and oversized strips. Replace with new combined strips, new hinges, self-closers and address any defect beading if required.

The replacement of communal doors with certified FD30s should be considered as part of any future refurbishment to the building.

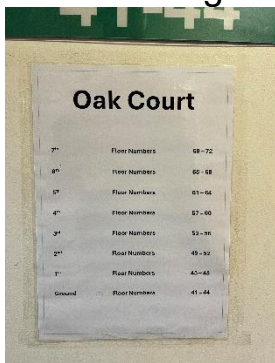
- 3) It was noted that there is no signage utilised to display the numbers and floors of all flats within the entrance foyer. Temporary signage has been installed (18/03/26) and an email request has been sent to Asset Management to source a permanent solution.

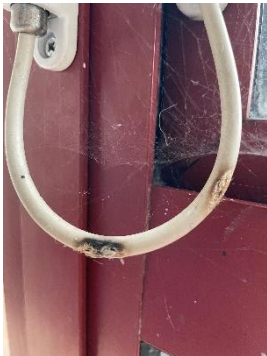
- 3) There are no provisions for CCTV within the block.
- 4) Small scorch marks were noted to a communal window restrictor.
